Aircraft Serious Incident Report

Runway Excursion During Landing Roll

B737-800, HL7780

Gimpo International Airport, Runway 14R

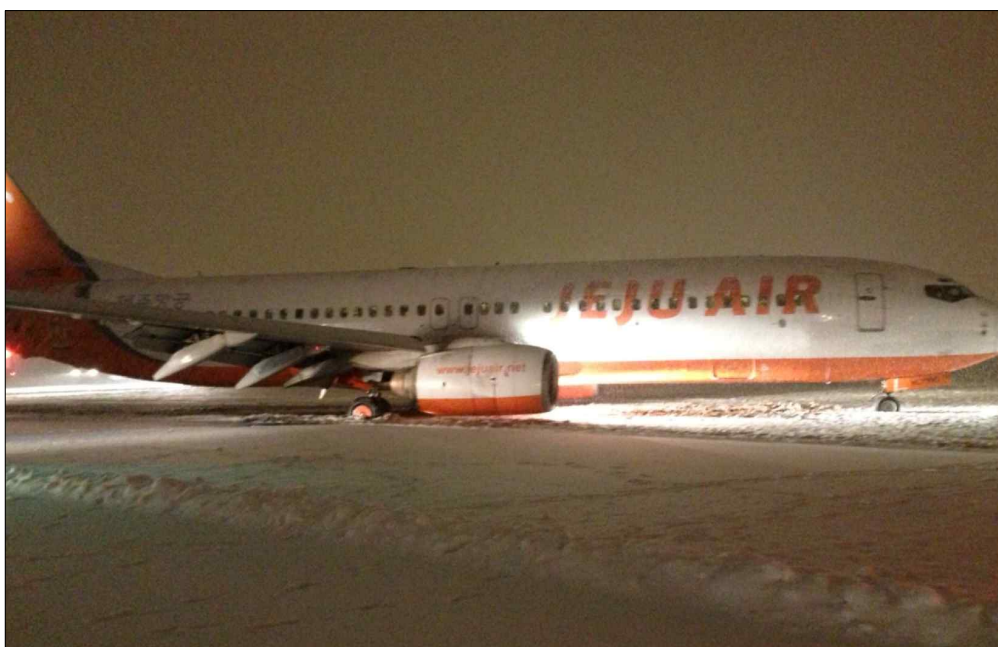
[Figure 1] Aircraft after Runway Excursion

As HL7780 veered off the runway as shown in [Figure 1], its nose and main landing gears entered the green zone, and about half the diameter of the wheels were buried under ground, but there was no damage to the aircraft and both

After HL7780 was towed to the ramp, its landing gear and brake assembly were placed under special inspection, which failed to discover any particular defect, but Jeju Air replaced all tires of nose and main landing gears, and the brake assembly of the main landing gear to eliminate the possibility of a potential defect.

The test flight was conducted in accordance with the maintenance manual⁷⁾ to check for the aircraft's conditions due to runway overrun, and the result showed that the aircraft functioned normally.

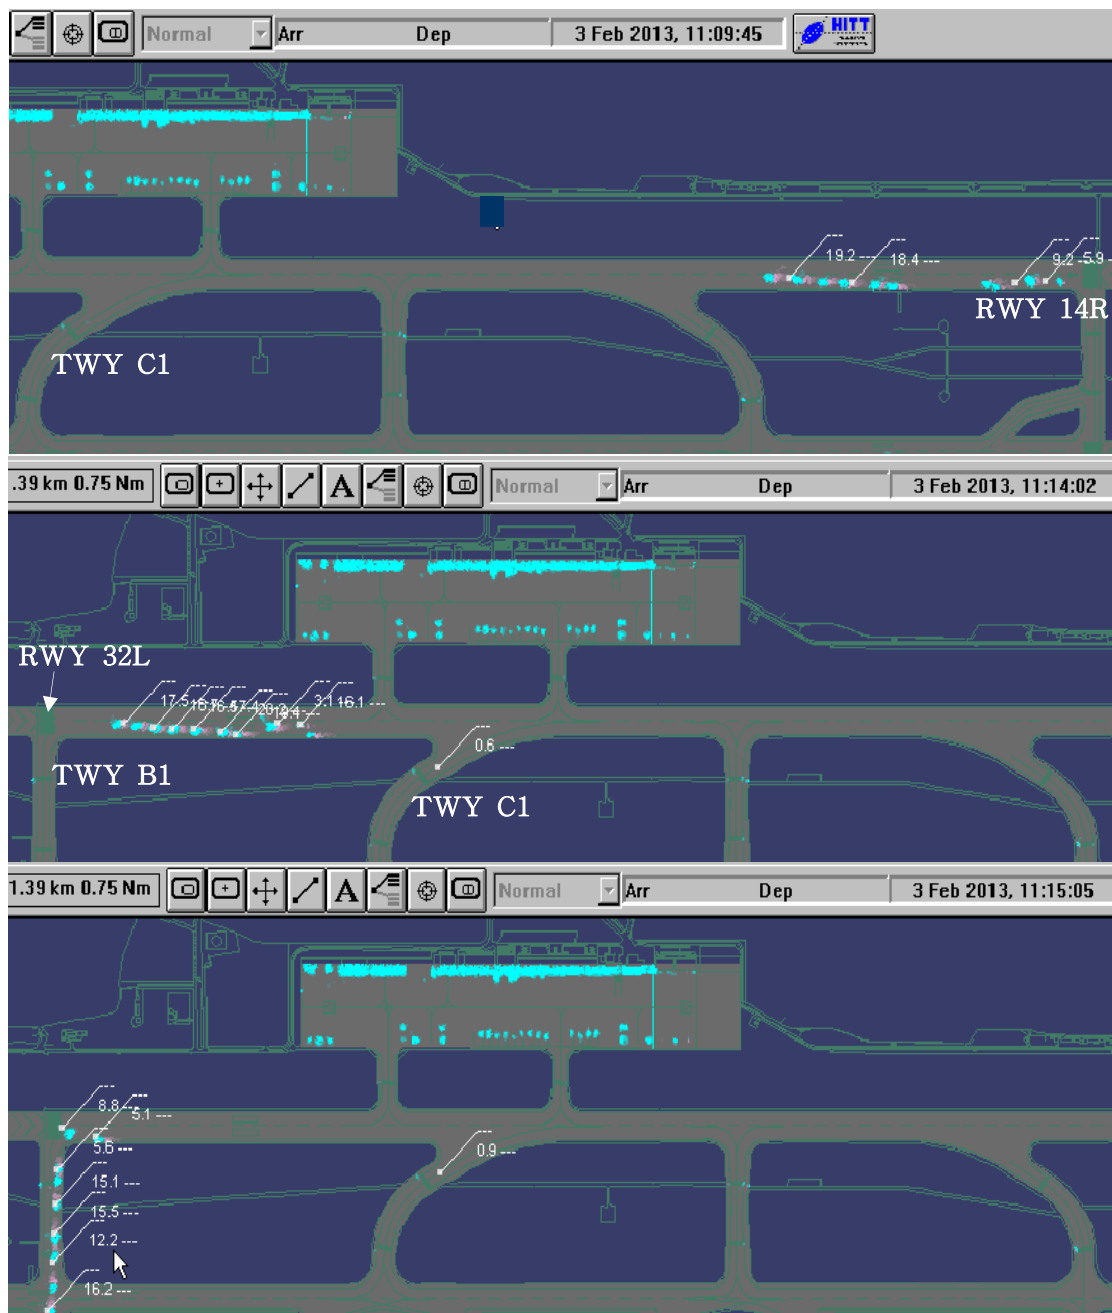
[Figure 8] Initial Snow Removal Operation on Runway 14R

The snow removal operations conducted by 8 snow removal trucks on runway 14R were recorded by the Airport Surface Detection Equipment (ASDE)'s video recorder, as shown in [Figure 8] and [Figure 9].

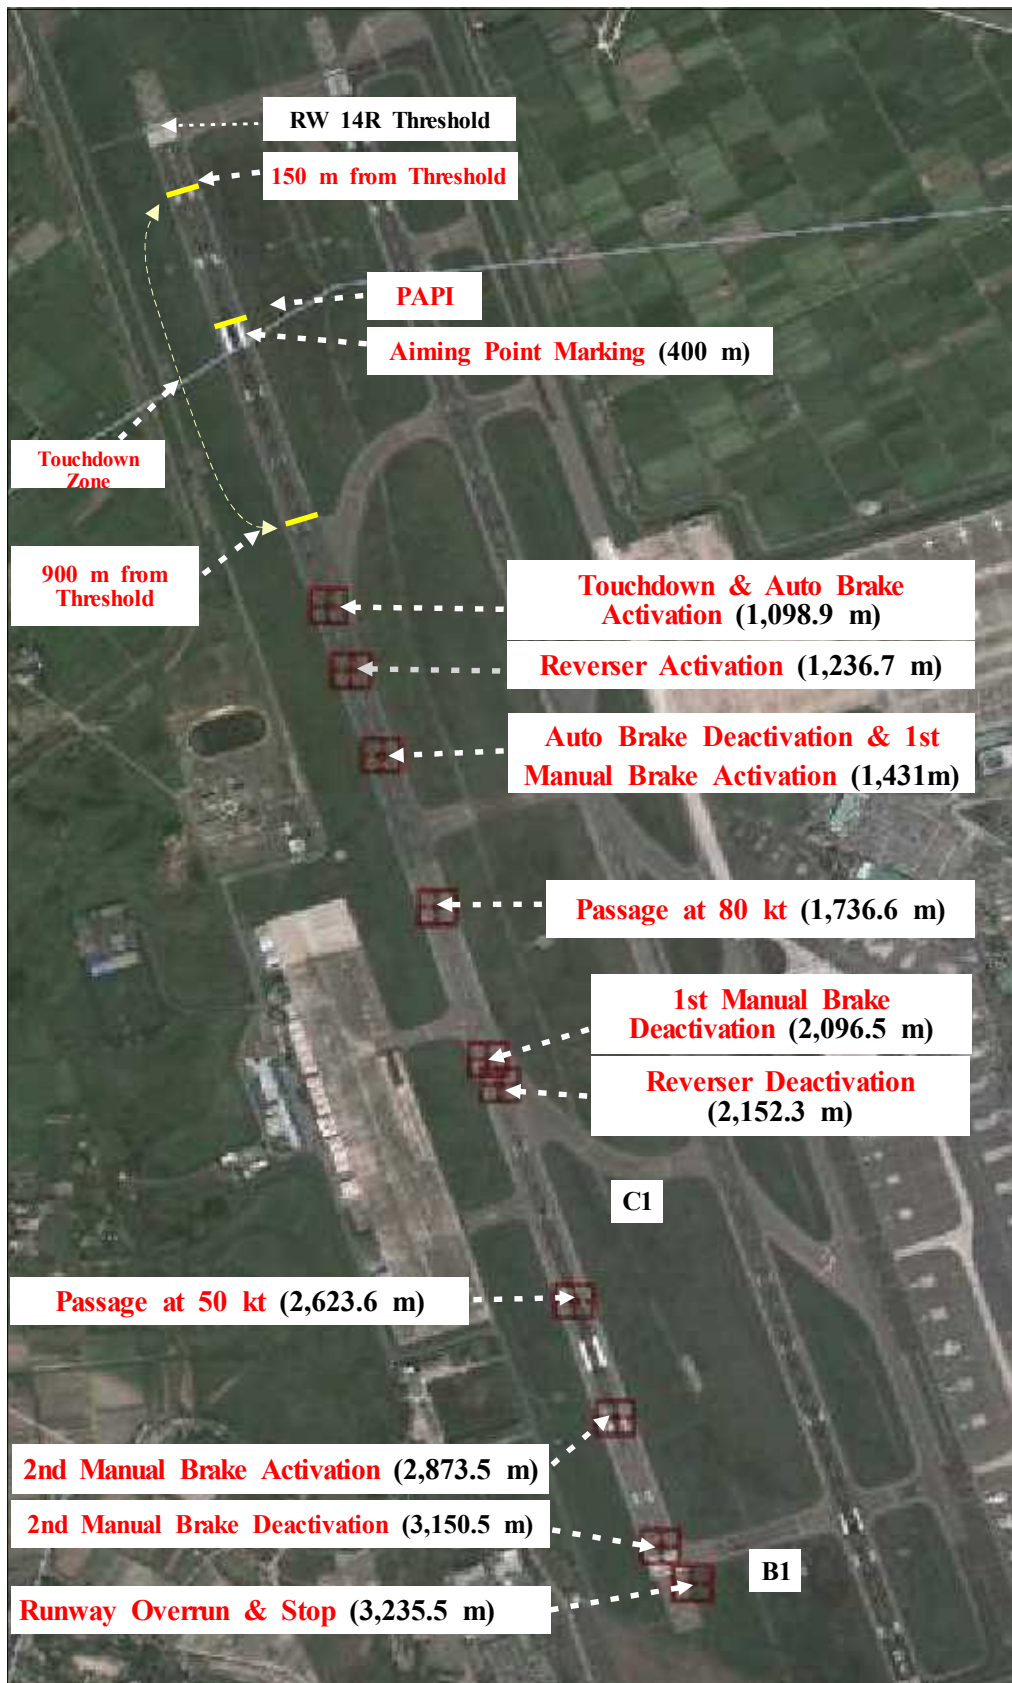
[Figure 11] Positions of the Braking System Operation During Landing

HL7780 touched down on the runway at 133.5 kt, lower and longer than normal, and its touchdown point³⁷⁾ was 1,098.9 meters from the runway threshold, which was 698.9 meters from the aiming point marking or 198.9 meters from the touchdown zone. This resulted in longer landing distance because HL7780 used the braking system about 700 meters later than normal touchdown.

When HL7780 approached Gimpo Airport, the PF selected "Auto Brake 3" considering the runway surface condition. At the time of the touchdown, the auto brake started to be activated, and in about 5 seconds when the manual brake started to be used, was deactivated (at ground speed of 114 kt).

It is determined that the PF's transfer to the manual brake after the use of the auto brake for 5 seconds (distance of about 333 meters) at a higher speed than when the runway condition was normal³⁸⁾ resulted from his inattention to the fact that the runway braking action was "Poor" with snowfalls.

As a result, the aircraft approached the end of the runway faster than the PF expected, and when it reached at about 44 kt, about 330 meters from the runway threshold, the PF realized that the aircraft ran too fast to vacate the runway via right angle exit taxiway B1 connected to the runway threshold, and used the manual brake for about 20 seconds. Yet the aircraft failed to slow down to the taxiing speed since the runway was covered with snow, with the distance to the runway threshold remaining short.
