AIRCRAFT ACCIDENT REPORT

CRASH WHILE APPROACHING THE WATER SURFACE
FOREST AVIATION HEADQUARTERS
S-64E, HL9467
IMHA-DAM IN ANDONG-SI, GYEONGSANGBUK-DO
9 MAY 2013

NOVEMBER 2014

AVIATION AND RAILWAY ACCIDENT INVESTIGATION BOARD

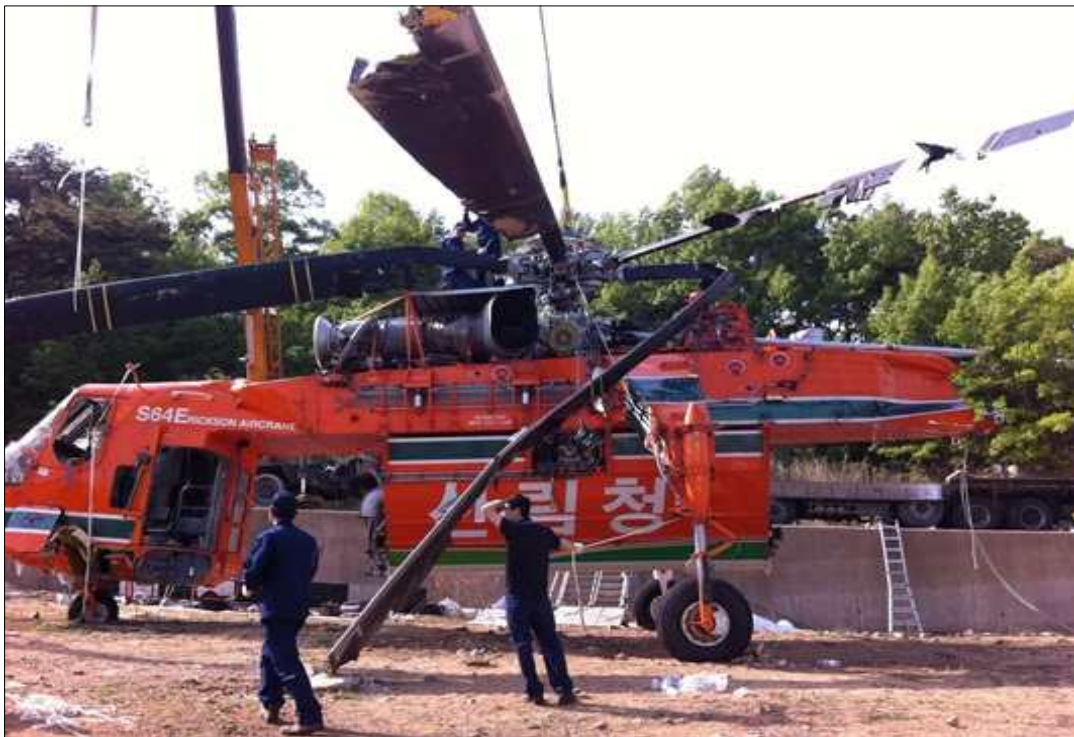
[Figure 2] HL9467's Wreckage Recovered after the Crash

As shown in [Figure 2], HL9467 was destroyed by the crash impact, which resulted in tail boom separation and main rotor damage.

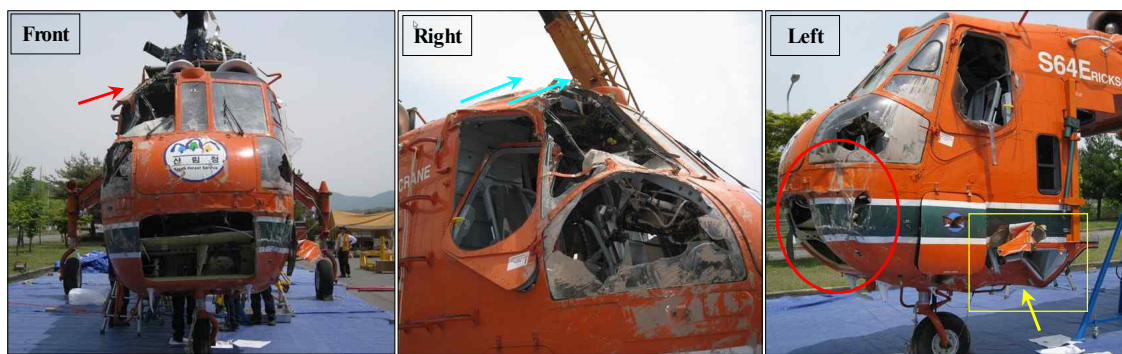
[Figure 5] Fuselage Damage

As shown in [Figure 5], the upper portion of the right pilot seat (red arrow) was damaged when it was hit by the main rotor blades. The left nose (red circle) was crushed and scraped when it was hit by the bottom of the reservoir. The portion below the mechanic seat (yellow arrow) was dented inwards by an external force caused by the snorkel.

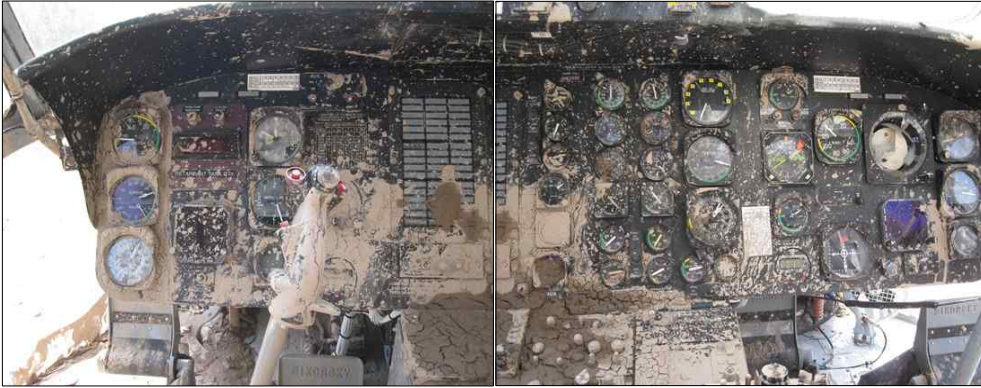
[Figure 6] Cockpit Instrument Panel Immediately after the Recovery

As shown in [Figure 6], part of the cockpit instrument panel and the floor was covered with mud, and the right pilot seat's attitude indicator and the both seats' N₂NR indicators were damaged by an external force.

Most of the indications were unreliable, but the fuel quantity indicator indicated the fuel quantity before power disconnection.

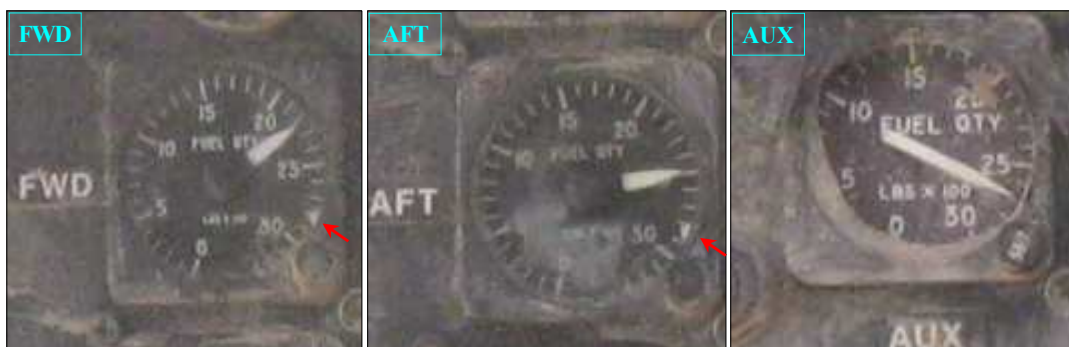
The fuel quantity of the fuel quantity indicator was reliable, considering the position of the Burg⁵⁸⁾ and the flight time after refueling. As shown in [Figure 7], 2,210 lbs, 2,500 lbs, and 2,700 lbs of fuel remained in the forward tank, aft tank, and auxiliary tank, respectively.

[Figure 7] Position of Burg on Fuel Quantity Indicator (red arrow) and Remaining Fuel

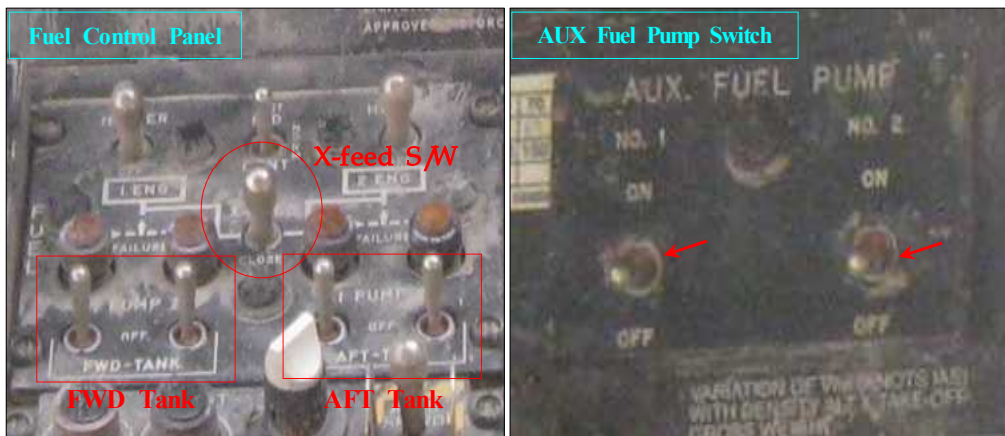
As shown in [Figure 8], switches of the forward and rear booster pumps were at the "on" position, whereas the cross feed switch was at the "off" position. The transfer pump switch of the auxiliary tank located at the top left of the instrument panel was at the "off" position.

[Figure 8] Fuel Control Panel Switches and Aux Fuel Pump Switch (arrow)

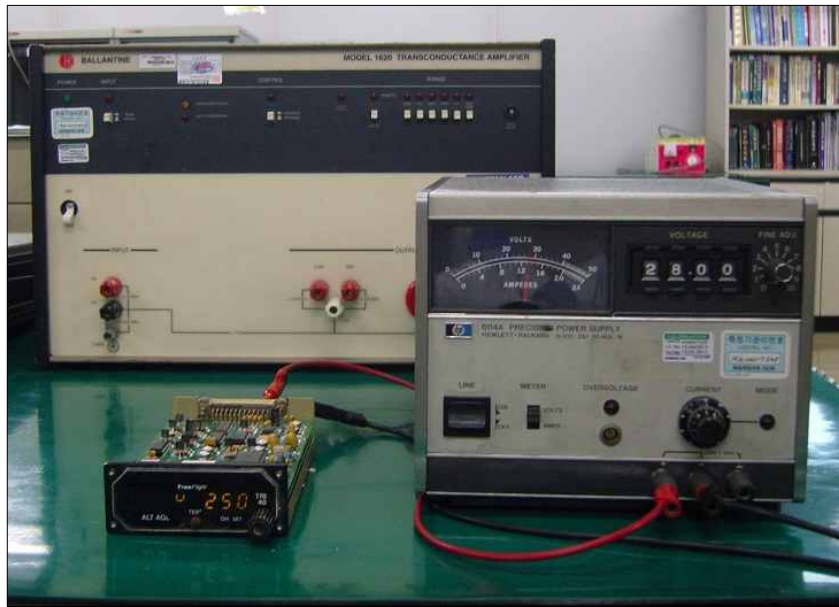
[Figure 9] Decision Height Set in the Radio-Altimeter

The decision height set in the radio-altimeter⁵⁹⁾ at the right of the instrument panel could not be confirmed since the device was submerged in water after crash. When it was dried and checked for circuit at the lab of Korean Air, then supplied with power, however, the decision height was set at 250 ft. Please refer to [Figure 9].

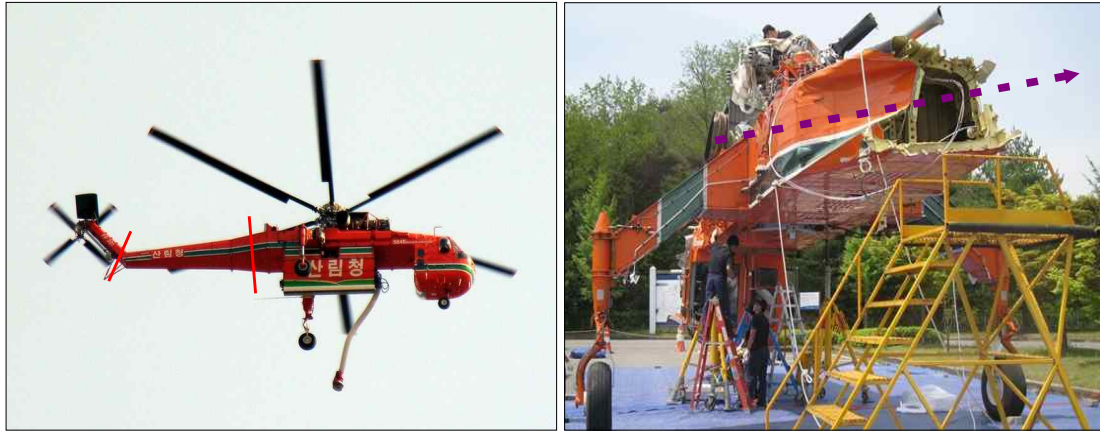
The tail boom was severed at two locations: the point at the junction aft of the auxiliary tank in the forward fuselage (Station 600 inch) was bent from left to right and fractured as shown in [Figure 10]; and the point where the tip of the tail rotor contacted the tail boom (Station 780 inch) was fractured by impact forces caused by the tail rotor blades.

The fracture surface of the forward severed portion displayed no damage by an external force, and the tail rotor driveshaft was also severed at the same location when it was bent from left to right without torsion caused by a rotational force.

[Figure 10] Tail Boom Fractures and Fracture Surface of the Forward Portion

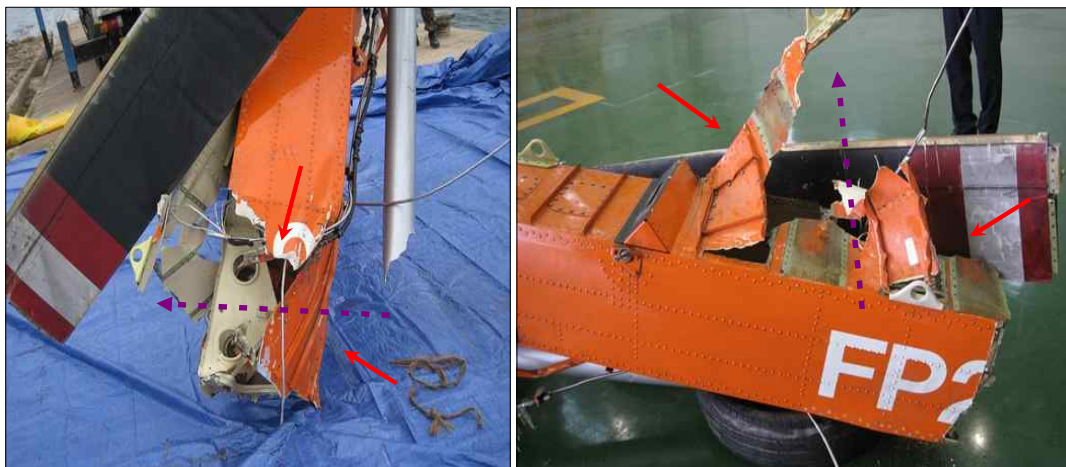
As shown in [Figure 11], the aft portion of the tail boom was severed at the point where it contacted the tip of the tail rotor. As the tail boom was struck by the rotating tail rotor, its metal skin and frame were torn or ripped off in the rotational direction of the tail rotor.

The aft portion of the tail boom driveshaft was not directly struck by the tail rotor, but it was fractured by a strong rotational force caused by the separation of the tail boom.

[Figure 11] Fracture Surface of the Aft Portion of the Tail Boom (red arrow) and Fracture Direction (purple arrow)

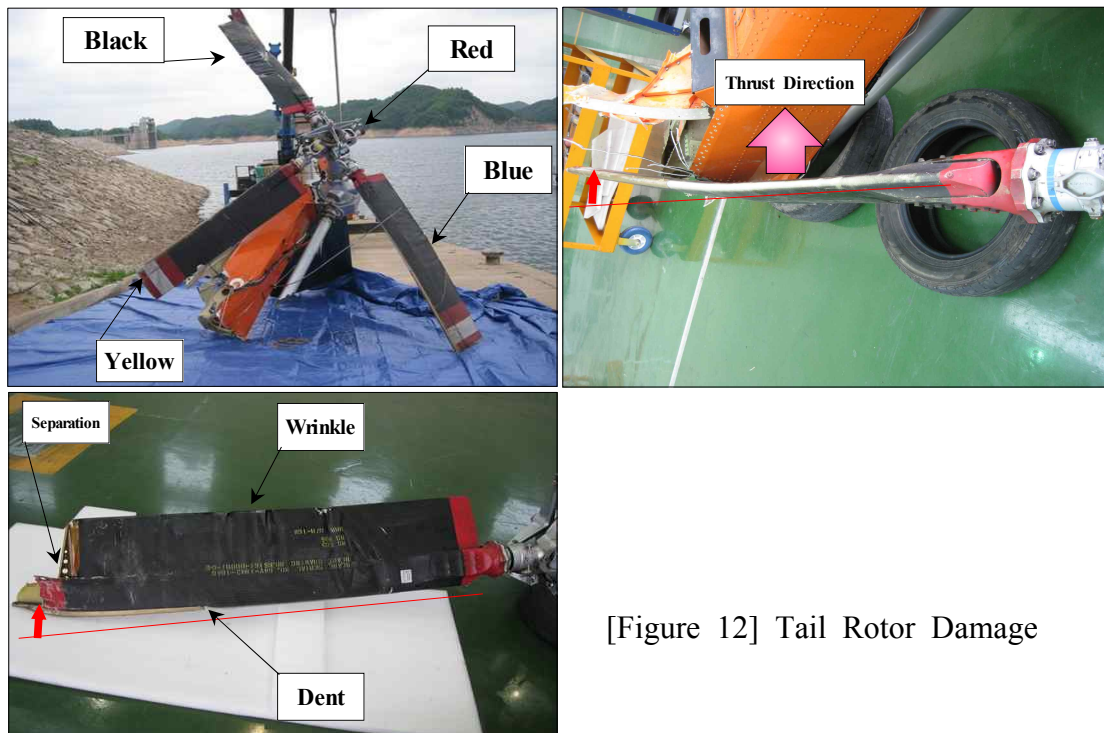
[Figure 12] Tail Rotor Damage

As shown in [Figure 12], three of the four tail rotor blades (black, yellow, blue) were bent in the thrust direction and in the opposite direction to the rotation. The tip and the leading edge of the tail rotor blades were separated, scraped, and dented by impact from the tail boom while the trailing edge exhibited wrinkles (red arrow) when it was bent in the opposite direction to the rotation. One tail rotor blade (red) was separated from its feathering hinge.

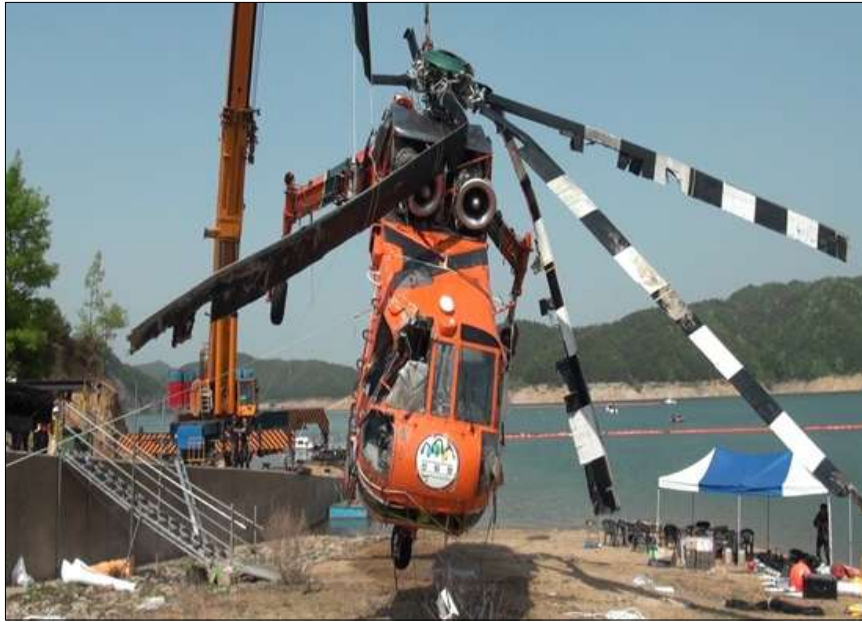
As shown in [Figure 13], out of the six main rotor blades, five (yellow, blue, red, black, white) were damaged but still attached to the mast after the accident, whereas one (green) was separated from the hub as it was raised upwards.

[Figure 13] Damage to Main Rotor Blades (during recovery)

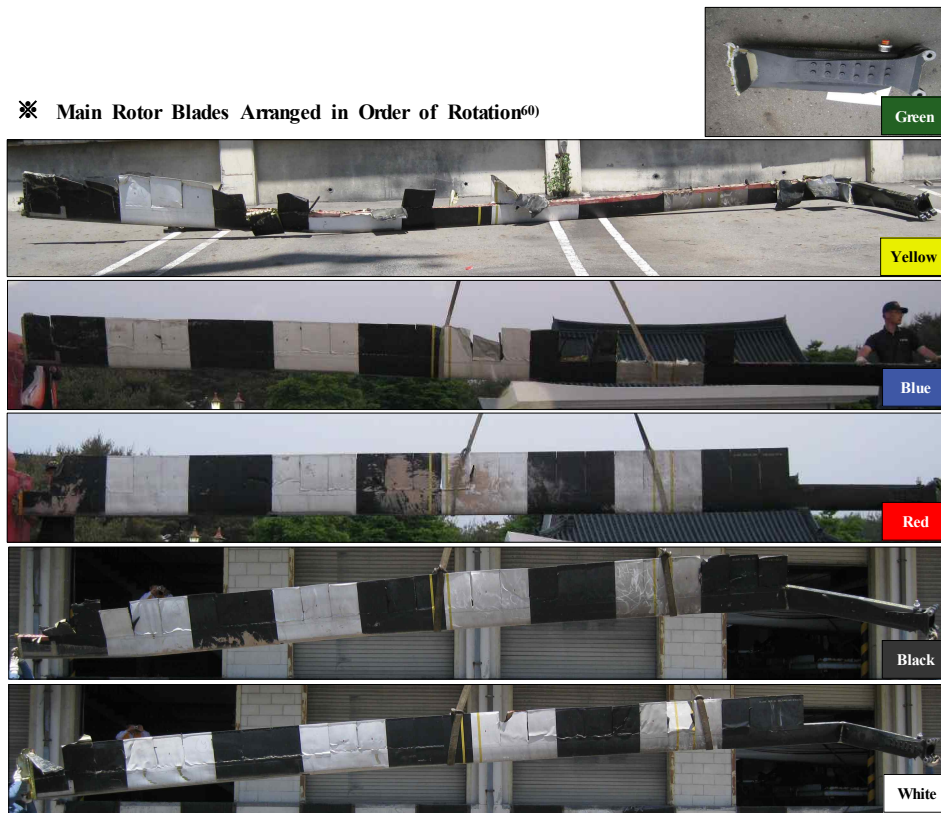
All main rotor blades were bent upwards (in the direction of lift) by strong flapping or at the hub (yellow, black, white). In addition, their leading edge exhibited dents caused by impact from the fuselage and engines, while the trailing edge was separated or wrinkled.

Main rotor blades were mostly damaged by impact from the surface of the water, and it is determined that dents on the leading edge were caused by impact from the engines and the upper portion of the right pilot seat.

[Figure 13-1] Damage to Main Rotor Blades (upper side)

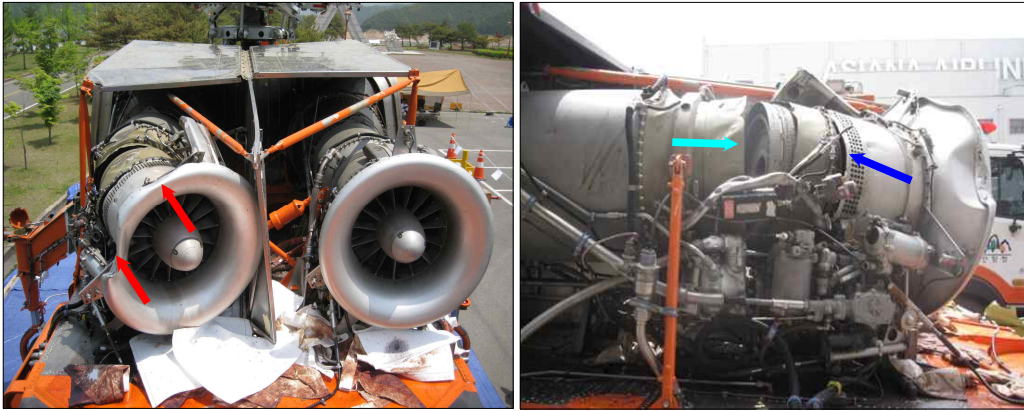
HL9467 was equipped with two engines on top of the fuselage. Post-accident wreckage examination revealed that, as shown in [Figure 14], the LH engine did not exhibit any significant external damage, whereas the right side of the RH engine's air inlet bellmouth (red arrow) was crushed by an external force.

[Figure 14] External Damage of RH Engine

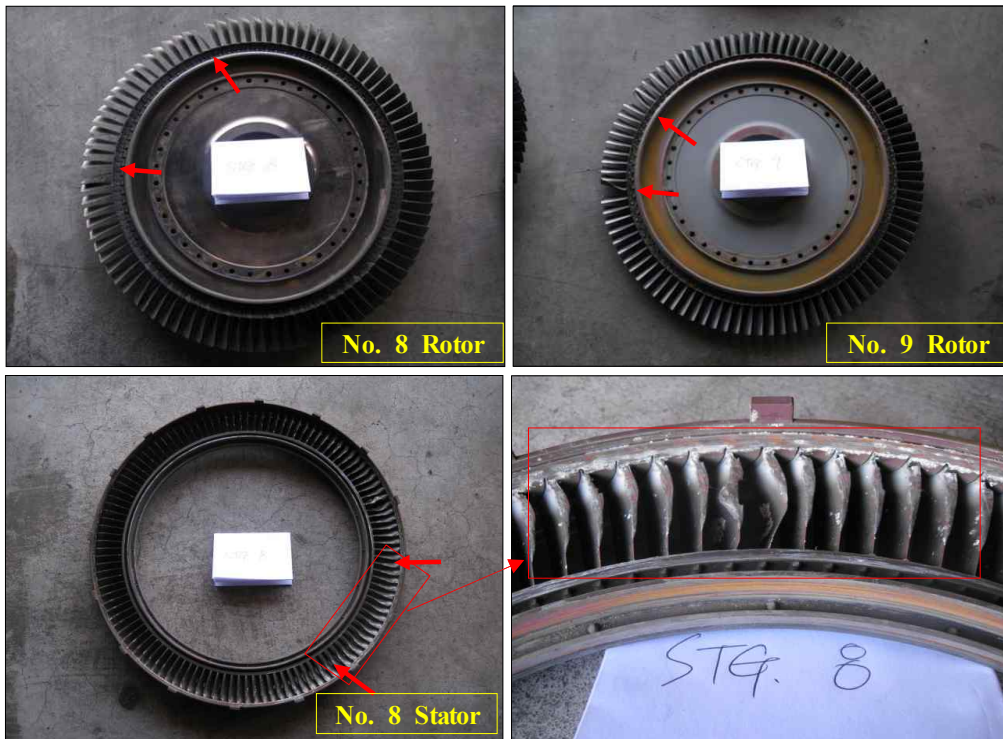
As the engine was fractured both at the flange attachment to the compressor inlet case (blue arrow) and at the attachment to the diffuser case (light blue arrow), 8th and 9th stages of the compressor blades were exposed, and the whole RH engine was twisted to the left. Further, 8th and 9th stages of the compressor blades were damaged as shown in [Figure 14-1].

[Figure 14-1] Damage to 8th and 9th Stages of the Compressor Rotor and Stator

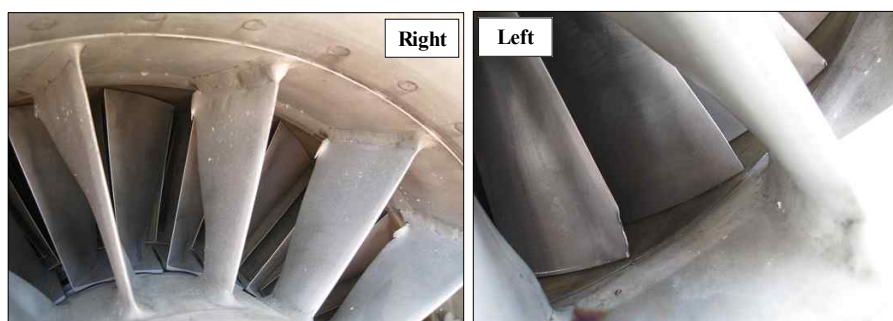
As shown in [Figure 15], the compressor inlet sustained damage as evidenced by the fact that the tip of the compressor blades was bent when the 1st stage of the compressor blades rubbed against the case.

[Figure 15] Damage to Guide Vanes and Compressor Rotor

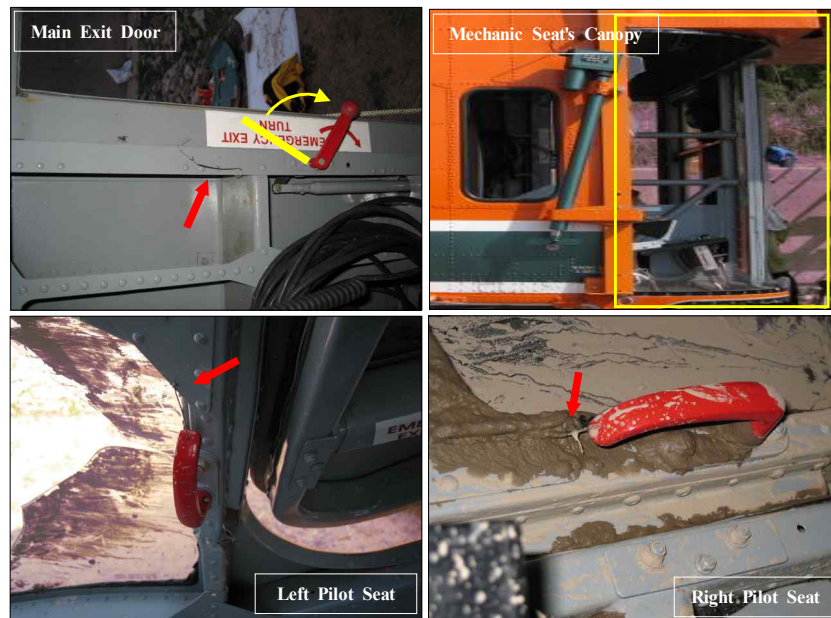
The crash impact damaged the left and right exit doors, the forward portion of the right pilot seat, and the canopy of the mechanic seat; separated the main exit door of the cockpit; and severed the safety wire installed on the emergency release handle of the main exit door.

[Figure 16] Emergency Handles, Safety Wires, and the Mechanic Seat's Canopy

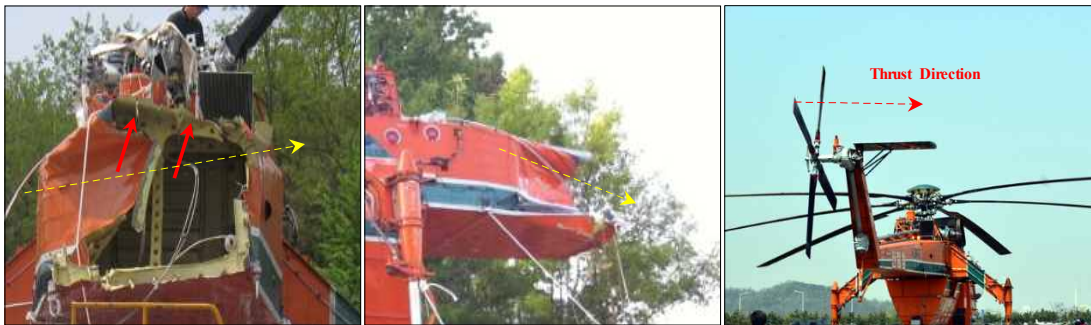
Considering the fracture patterns above, it is determined that the forward portion of the tail boom was fractured when the tail boom severely yawed to the right due to the tail rotor's strong thrust produced when HL9467's tail rotor hit the surface of the water during the final deceleration, and that the aft portion was fractured when the tail rotor, which was bent to the right by the strong thrust from its impact with the surface of the water, struck the tail boom.

This determination was based on the following as shown in [Figure 19]: ① the LH metal skin at the forward severed portion of the tail boom was fractured when pulled to the right, exhibiting no signs of external force; ② rivets at the attachment were fractured by a strong tensile force, and the metal skin was torn in the right direction (red arrow); ③ the rotorcraft is put into a tail low attitude^{e96)} when performing deceleration maneuvers during the final approach; and ④ the tail rotor's thrust is in the right direction.

[Figure 19] Forward Severed Portion of the Tail Boom and the Tail Rotor's Thrust Direction

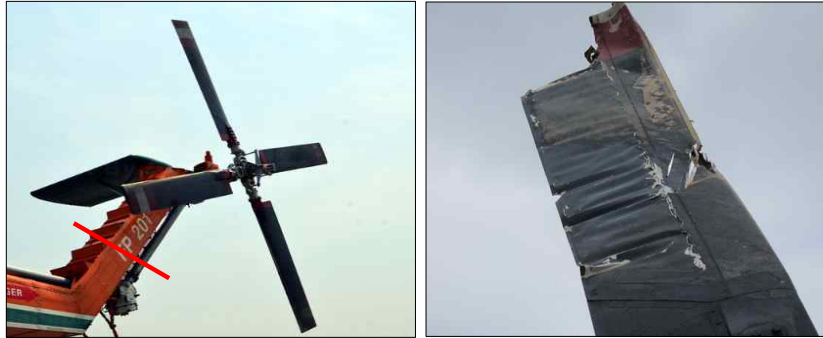
As shown in [Figure 20], it is determined that the aft portion of the tail boom was fractured by impact with the tail rotor on the basis of the following: ① the aft portion was severed at the point contacting the tip of the tail rotor;

② the aft portion was severed by impact with the tail rotor in its rotational direction; ③ the tail rotor was bent in the thrust direction, and the tip of it contacted the tail boom; and ④ the leading edge of the tail rotor was dented or scraped by impact with the tail boom.

[Figure 20] Aft Severed Portion of the Tail Boom and Tail Rotor Damage

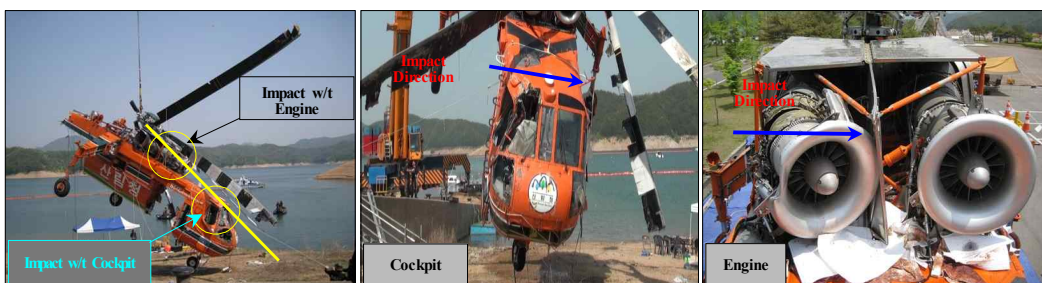
The RH engine and the upper portion of the right pilot seat were damaged when the aft main rotor blades of HL9467 first struck the water and strongly flapped upwards due to the aircraft's tail low attitude, thereby causing the forward main rotor blades over the nose to flap downwards in reaction and hit the RH engine and the upper portion of the right pilot seat.

As shown in [Figure 21], the aforementioned determination is on the basis of the following: ① the RH engine and the upper portion of the right pilot seat were aligned in a horizontal position to the main rotor hub; and ② the RH engine and the upper portion of the right pilot seat were damaged by impact from right to left.

[Figure 21] Damage to RH Engine and Upper Portion of Right Pilot Seat

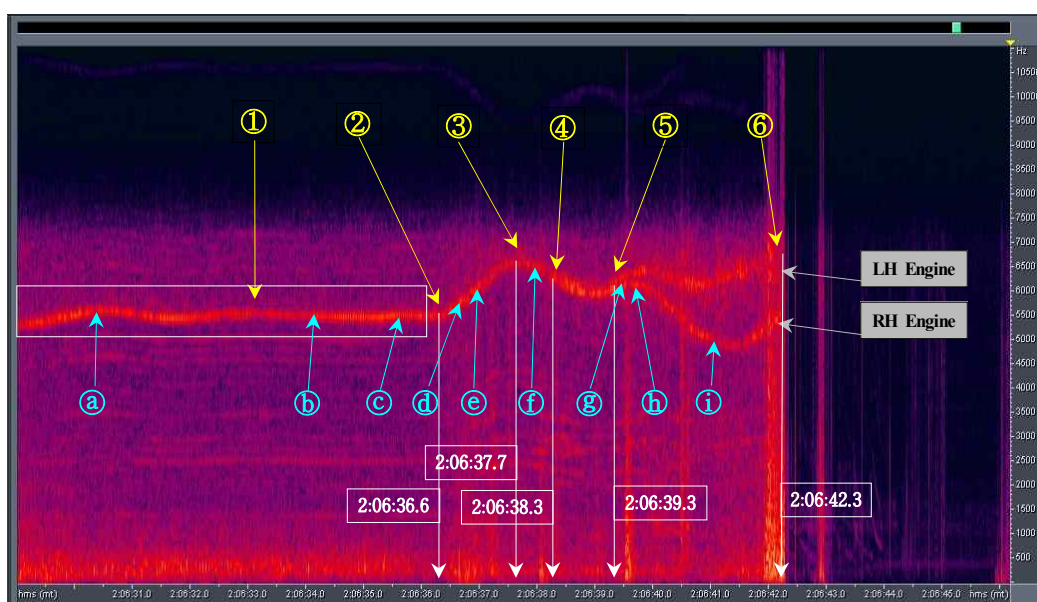
As shown in [Figure 22], the spectrum image of the engine sound recorded in HL9467's CVR is marked with changes in the engine sound (yellow) at major points and important voice communications (light blue) in chronological order in order to analyze the CVR recording.

[Figure 22] Changes in Engine Sound and Major Voice Communications

According to [Figure 22], an audible alarm warning indicating 100 ft was
