NATIONAL TRANSPORTATION SAFETY BOARD
Office of Aviation Safety
Washington, D.C. 20594

POWERPLANT GROUP CHAIRMAN'S FACTUAL REPORT

NTSB No: ENG13IA033

Aircraft: Korean Airlines Boeing B777-300ER, registration HL8275

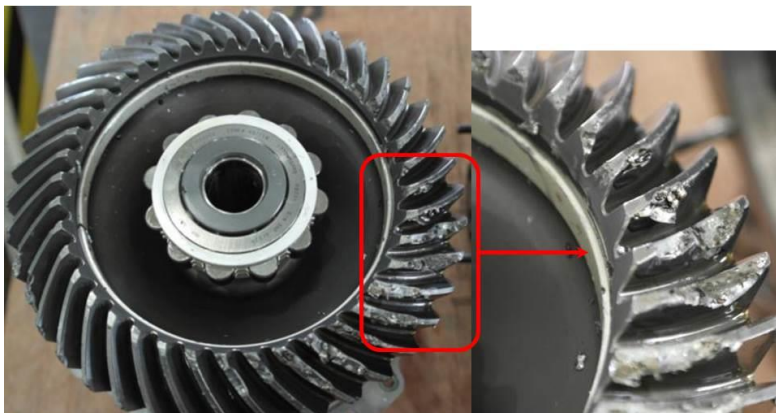
With the TGB removed and disassembled, examination of the horizontal bevel gearshaft (subsequently referred to simply as the horizontal gearshaft in this report) revealed that it was intact, the gear teeth displayed damage, and both sets of bearings appeared intact and in good condition ([PHOTO 1](#)). Examination of the radial gearshaft revealed that: 1) a 12-tooth section of the spiral bevel gear teeth and web had separated, 2) all 27 gear teeth were accounted for, 3) gear teeth were damaged, 4) the shafts (long and short) exhibited cracks and missing material, 5) the roller bearing elements were loose, the cage damaged, and the outer race was fragmented into several pieces, and 6) the ball bearing appeared intact and in good condition ([PHOTO 2](#)). The radial gearshaft was part marked as follows: part number (PN) 1995M24P02, serial number (SN) FIA0K63L, MD 5.3346, BL.0047 ([PHOTO 3](#)).

PHOTO 1: DAMAGED HORIZONTAL GEARSHAFT TEETH

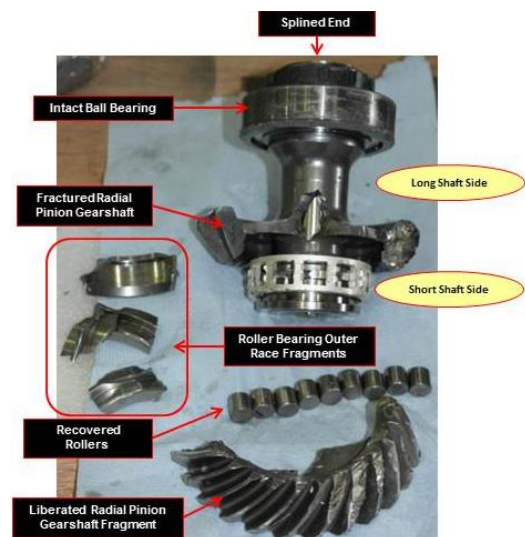
PHOTO 2: FRACTURED RADIAL GEARSHAFT

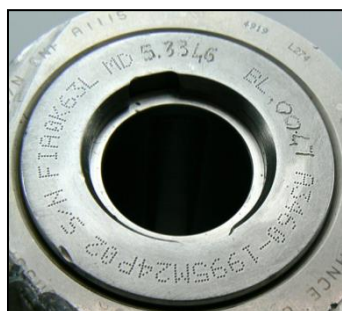
PHOTO 3: RADIAL GEARSHAFT MARKINGS (INNER DIAMETER – OUTER DIAMETER IS BEARING RACE)

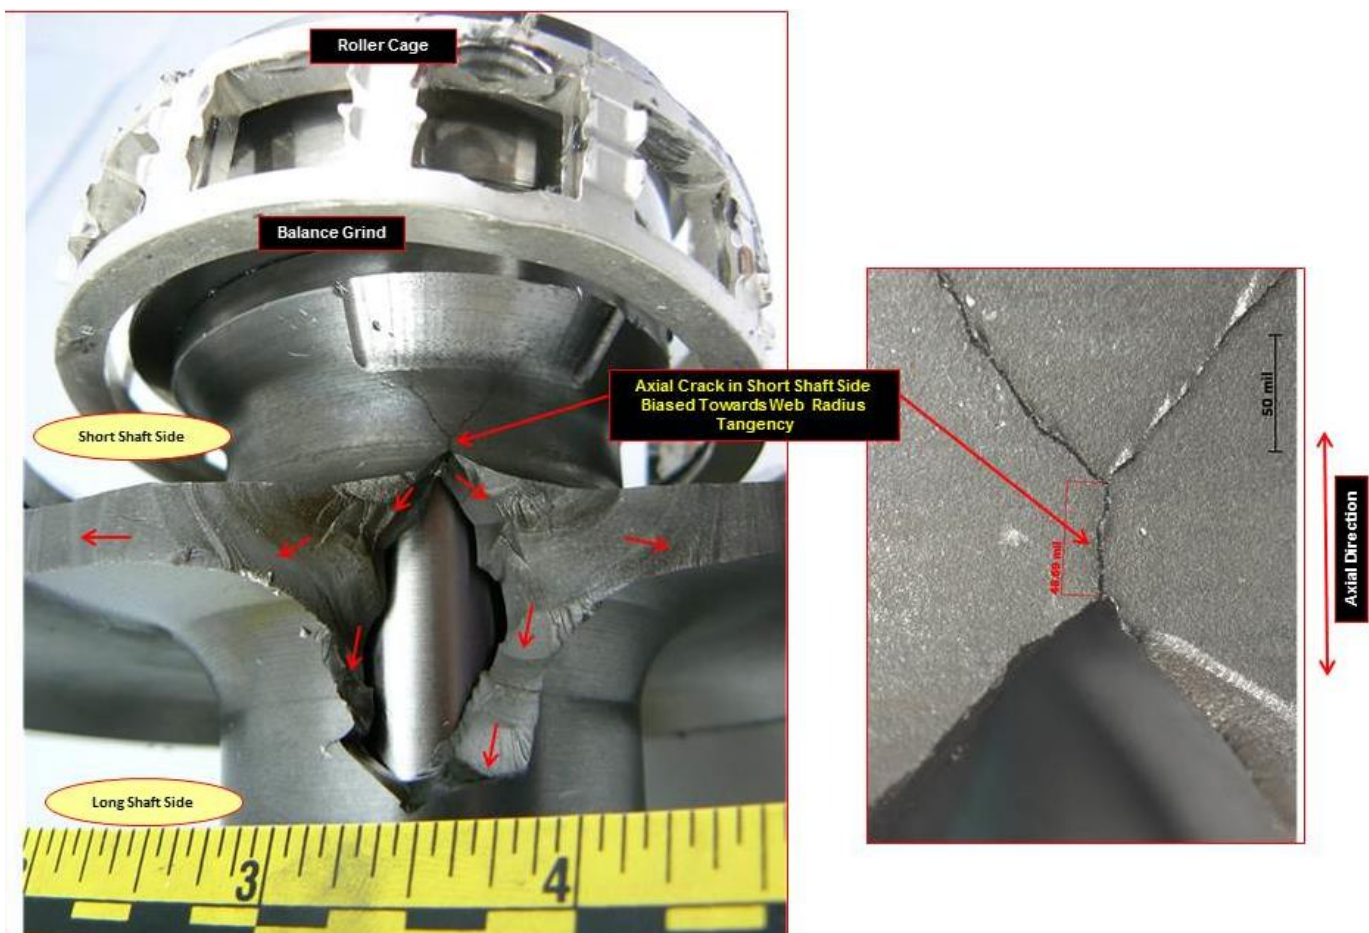
Initial visual examination revealed that the gear teeth contact surfaces revealed no evidence of fatigue spalling damage or unusual contact wear patterns. An X-shaped crack was observed in the short shaft side outer diameter at the shaft-to-web transition radius where part of the bevel gear and long shaft material was missing (**PHOTO 4**). In this area, an axial crack that measured about 0.049-inches (49 mils) in length was also noted. Fluorescent penetrant inspection (FPI) of the rest of the radial gearshaft revealed two additional X-shaped cracks in the short shaft side of the shaft-to-web transition radius region. According to GE, the X-shaped nature of cracking supported at least some torsional or biaxial stress influence during initial cracking. Published literature for fatigue cracking under torsional and/or biaxial loading conditions was consistent with the X-shaped cracking observed on the fractured radial gearshaft. GE subjected several AISI 9310 steel test bars to various biaxial fatigue loading conditions in an attempt to reproduce fracture features observed within the axial fracture. The results of the testing indicated biaxial loading conditions could reproduce features observed in the axial fracture.

PHOTO 4: X-SHAPED AND AXIAL CRACK RADIAL GEARSHAFT SHORT SHAFT SIDE

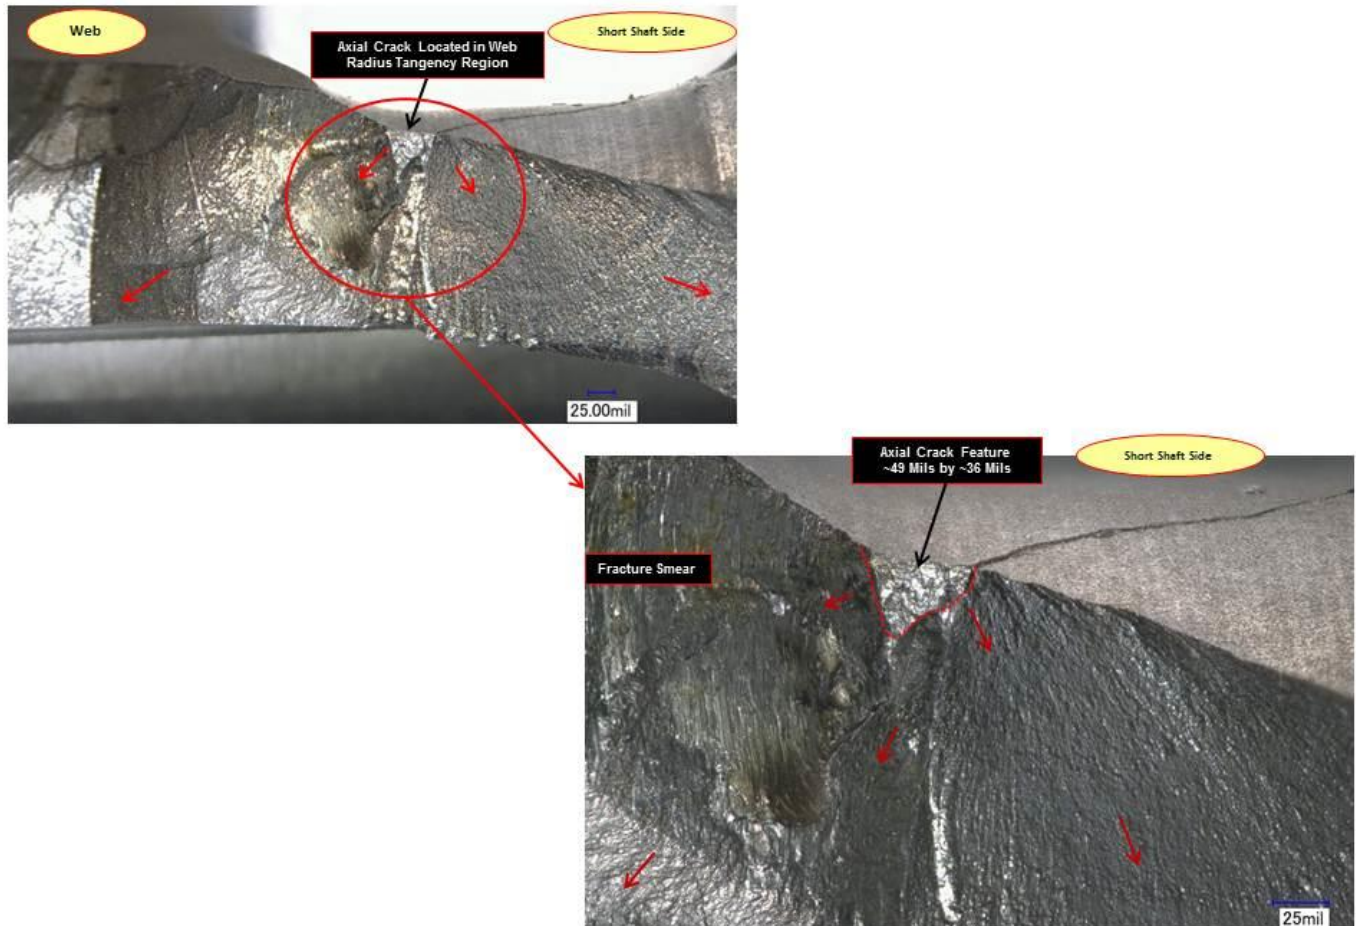
Scanning Electron Microscope (SEM) inspection of the axial fracture region revealed: 1) striation features indicative of fatigue propagation, 2) no evidence of any unusual surface anomalies such as impact or heavy scoring was associated with the axial fracture, 3) no appreciable oxidation was observed on the axial fracture region indicating fracture was not exposed to elevated temperatures such as from forging or heat treatment, 4) did not exhibit morphology typical of axial-axial induced fatigue fracture surfaces, such as interpretable flow lines pointing back to a single origin location, but instead

was more consistent with initial fatigue initiation occurring under a torsional and/or biaxial stress condition, 5) fracture morphology exhibited features consistent with tensile shear dimples indicating exposure to high shear stresses, and 6) no additional secondary cracks were observed adjacent to the primary axial fracture (**PHOTO 5**). According to GE, the axial crack was considered the primary crack initiation site for the fractured radial gearshaft with the crack continuing to propagate leading to the X-shaped crack. The axial and X-shaped cracks were consistent with torsional and/or biaxial fatigue mechanism. The fracture morphology outside of the axial fracture region exhibiting a “feathery” appearance and according to GE is more consistent with axial-axial fatigue, typical of lower alternating stress fatigue (high cycle fatigue) mechanisms attributed to the gear meshing stresses experienced by the gearshaft during engine operation.

PHOTO 5: FATIGUE PROPAGATION FROM AXIAL CRACK

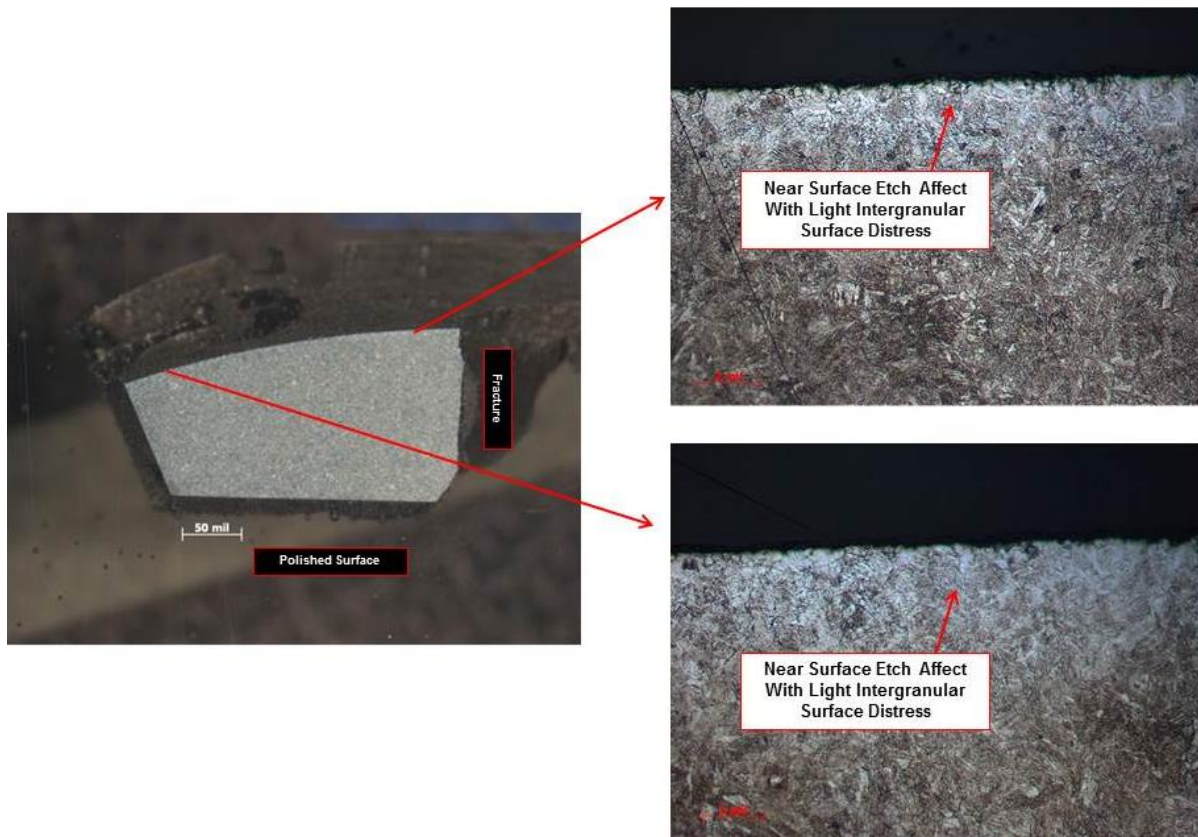
Etching³ of a cross-section through the short shaft side revealed a near surface etch affect (lighter shading) on the outer diameter surface both at and away from the axial fracture location (**PHOTO 6**). Microhardness tests were performed on the radial gearshaft and a corresponding reduction in near surface hardness was measured within the lighter etching region with near surface hardness loss beginning at about 4 mils (**FIGURE 2**)⁴. The core hardness averaged HRC 40.4 (Rockwell Hardness on the C Scale) which met the part drawing requirement of HRC 32-44.

PHOTO 6: ETCHING OF SHORT SHAFT SHOWING NEAR SURFACE LIGHT INTERGRANULAR DISTRESS
 (Pictures Courtesy of GE-Aviation)

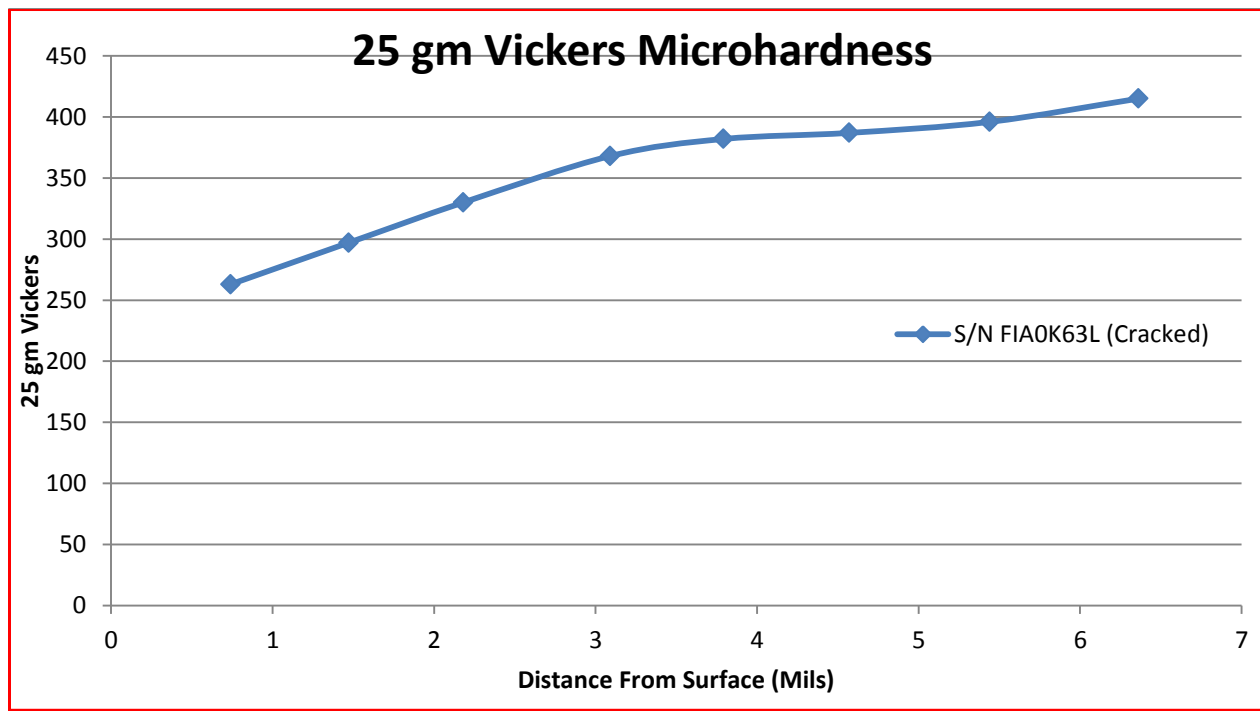
FIGURE 2: NEAR SURFACE MICROHARDNESS MEASUREMENTS NEAR AXIAL CRACK LOCATION
 (Graph Courtesy of GE-Aviation)
