Aircraft Accident Report

Crash While Transporting Cargo

Ka-32T, HL9400

April 4, 2011

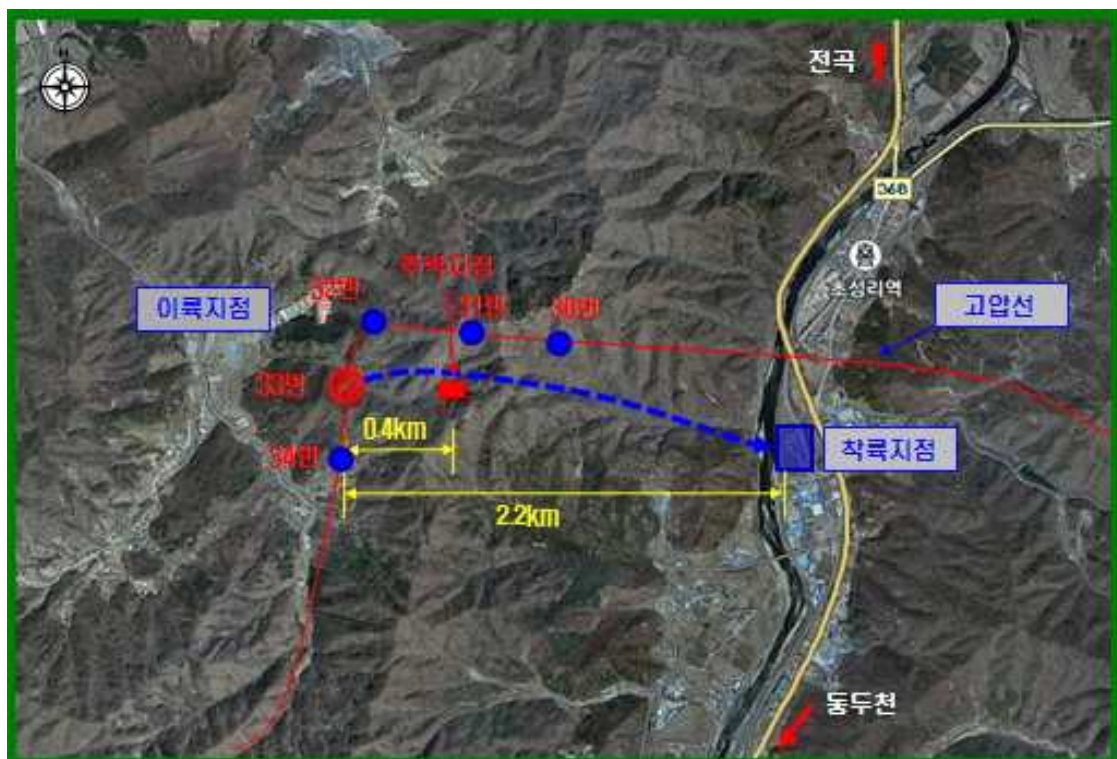
[Figure 1] Accident Site and Flight Path

After refueling, HL9400 resumed transporting cargo, and from take-off to the crash, RH tank fuel shortage warning continued. Without landing, HL9400 made its shuttle flight three times, and during the fourth shuttle flight, crashed after two engines almost simultaneously shut down while returning to the helipad from the tower.

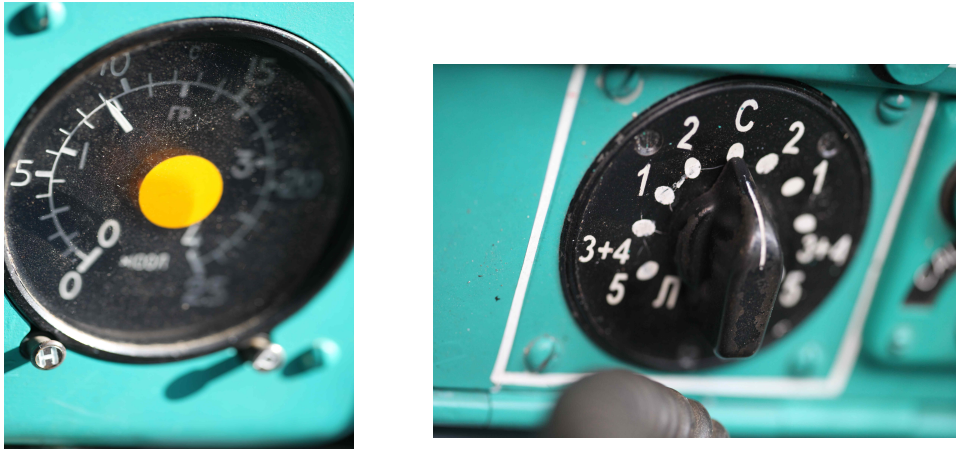
[Figure 3] Fuel Quantity Indicator & Fuel Quantity Indicator Selector Switch

The fuel quantity indicator selector switch in the cockpit indicated "C¹⁵)" as shown in [Figure 3], and the fuel quantity indicator showed about 900 liters of fuel.

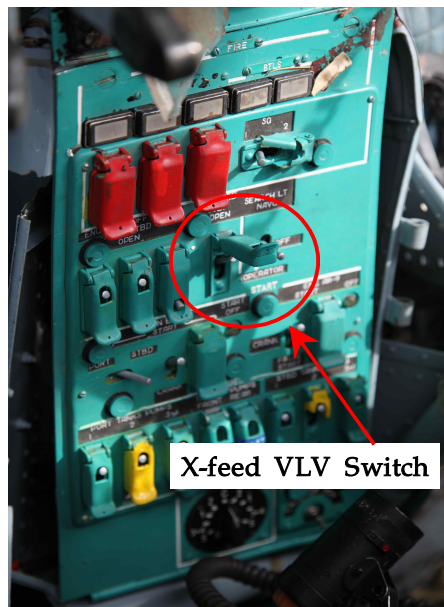
[Figure 4] Fuel X- feed Valve Switch

The fuel cross-feed (X-feed) valve switch was in the open¹⁶⁾ position as shown in [Figure 4]. When the switch is open, the fuel in LH and RH service tanks can be cross-fed so that, in case of a level flight, the fuel quantity of LH and RH service tank can get eventually similar to each other.

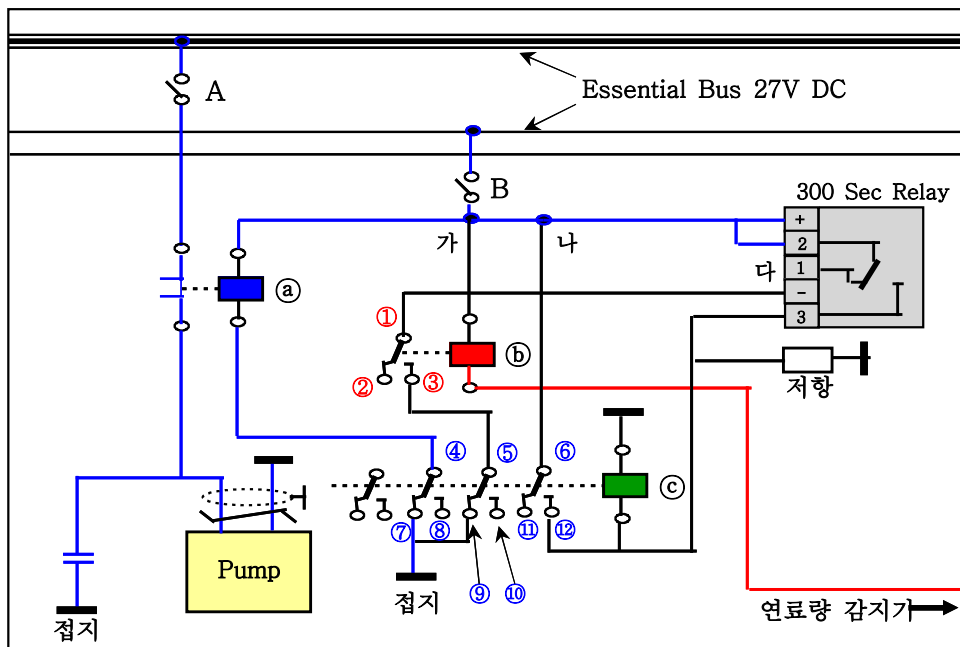
[Figure 5] Diagram of the Fuel Transfer Pump Protection Circuit

Each transfer pump protection circuit consists of 28V DC power supply circuit breaker, 300 sec relay, and relay using the fuel quantity transmitter signal as shown in [Figure 5].

In case that the pump continues to operate without fuel, the pump will be failed since its motor cannot be cooled down. It is designed, therefore, that 300 sec relay is activated to stop the pump 300 seconds after fuel depletion, thereby preventing a pump failure.

When the fuel pump switch B is "ON" with the circuit breaker switch A "ON", (a) relay gets magnetized, thereby activating the transfer pump. When fuel depletion activates (b) relay, terminal ① in (b) relay is shorted, thereby activating 「300 sec relay」 .

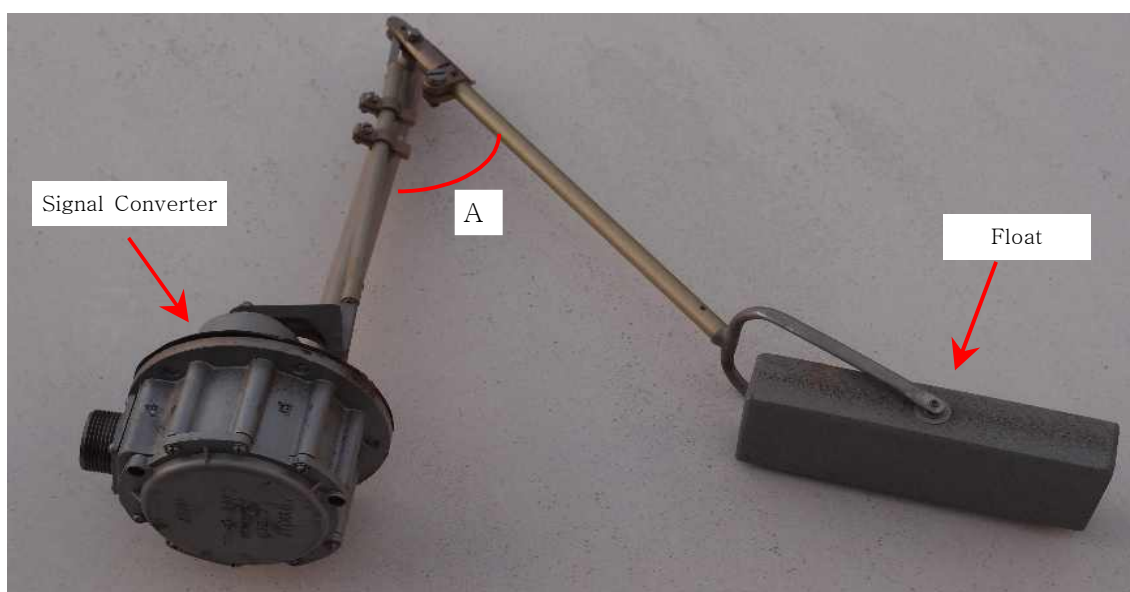
[Figure 6] Fuel Quantity Transmitter

angle "A" changing in accordance with the fuel level. The signal converter carries out this function. During the flight on the day of the accident, the fuel quantity transmitter of the LH tank No.2 had a malfunction.

A fuel shortage of the left tank was not detected due to the fuel quantity transmitter's malfunction, and thus, "125 LTR PORT TNKS" warning light in the cockpit did not come on, and "LEFT TANKS' ASSEMBLY EMERGENCY FUEL" was not recorded by the FDR.
