ARAIB/AAR2102

# Aircraft Accident Investigation Report

Cabin Crew Injured due to In-Flight Turbulence  
Asiana Airlines  
B767-300, HL7528  
En-Route over Yesan, Chungnam During Climb  
28 May 2021

28 November 2022

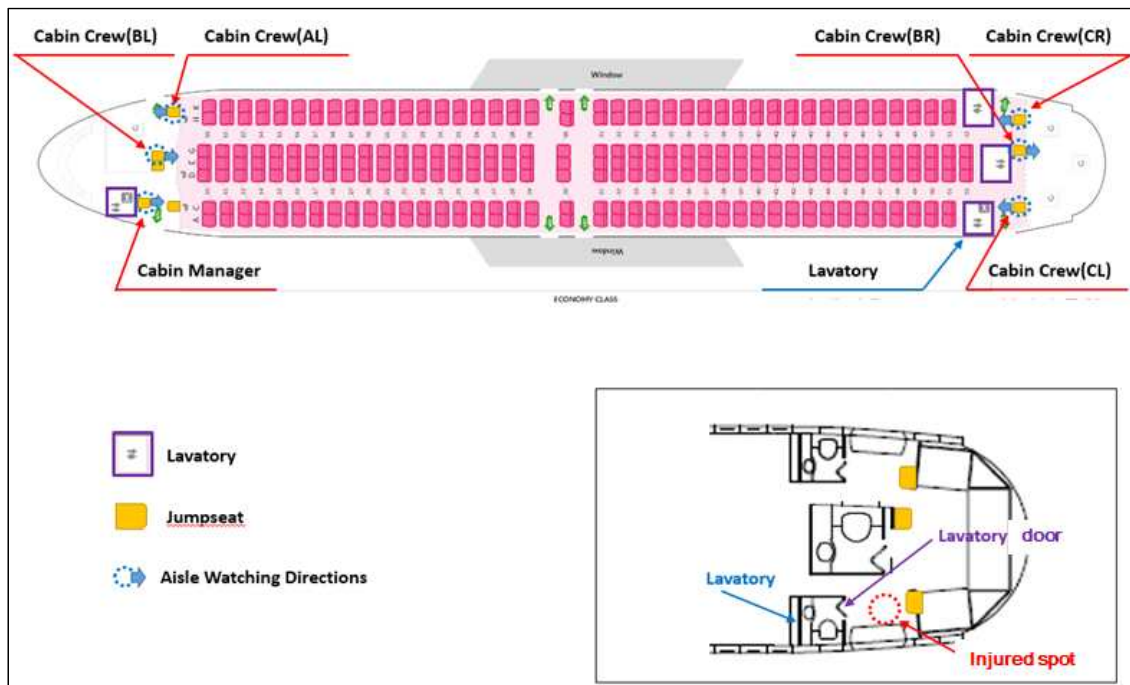
[Figure 1] HL7528 Cabin Seats and Crew Injured

The cabin attendant was slightly thrown up by one more severe turbulence. Her ankle bore weight and she fell down on the floor. Her injury was too serious that she couldn’t even move at all and complained of severe pain when the purser checked her condition.

The following [Figure 1] shows HL7528 cabin seat arrangement and place where the cabin attendant injured.

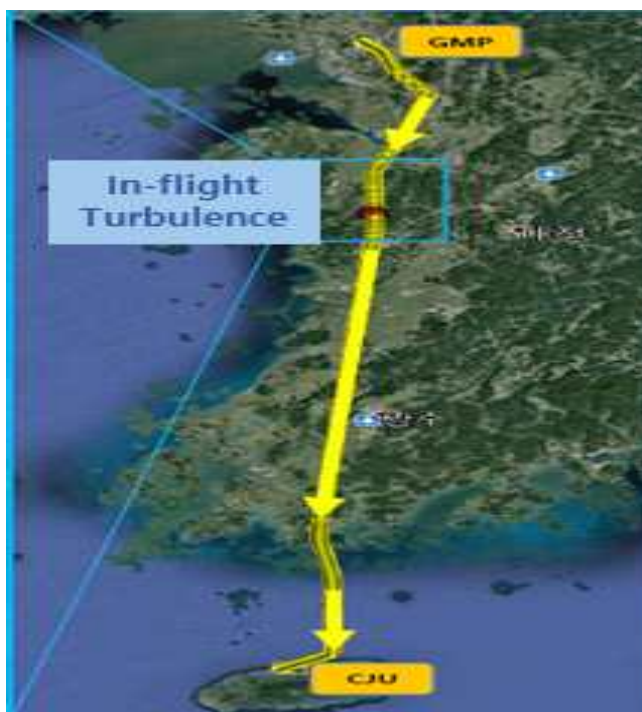
[Figure 2] HL7528 Flight Route on the Day of Accident

After the aircraft went through severe turbulence and was clear of cloud layer, it soon became stabilized. The captain ascertained no other damages to the aircraft were found. The flight route of HL7528 from Gimpo to Jeju is as shown in [Figure 2].

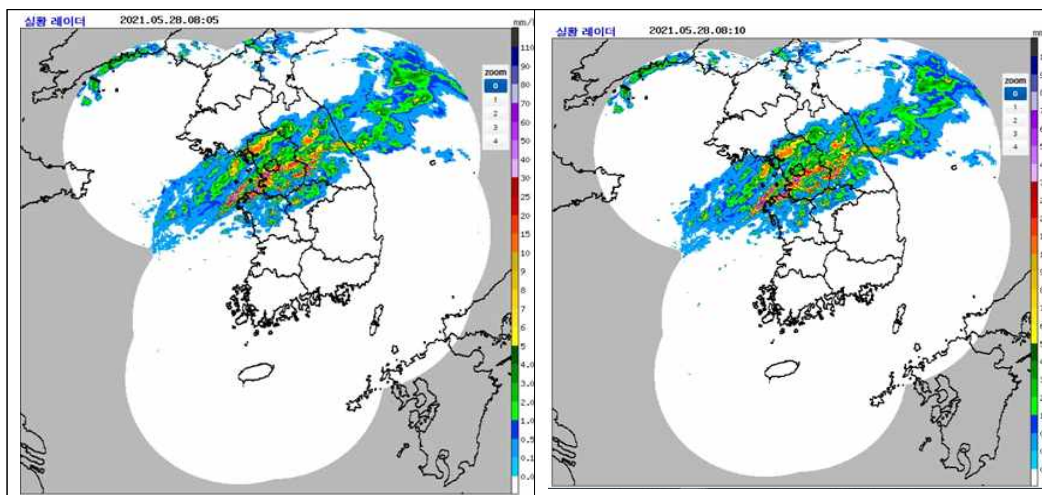
[Figure 5] Meteorological Radar during Turbulence

At 08:00 on 28 May (the day of the accident), a turbulence weather map over the Korean Peninsula announced by the AMO is as shown in [Figure 5].

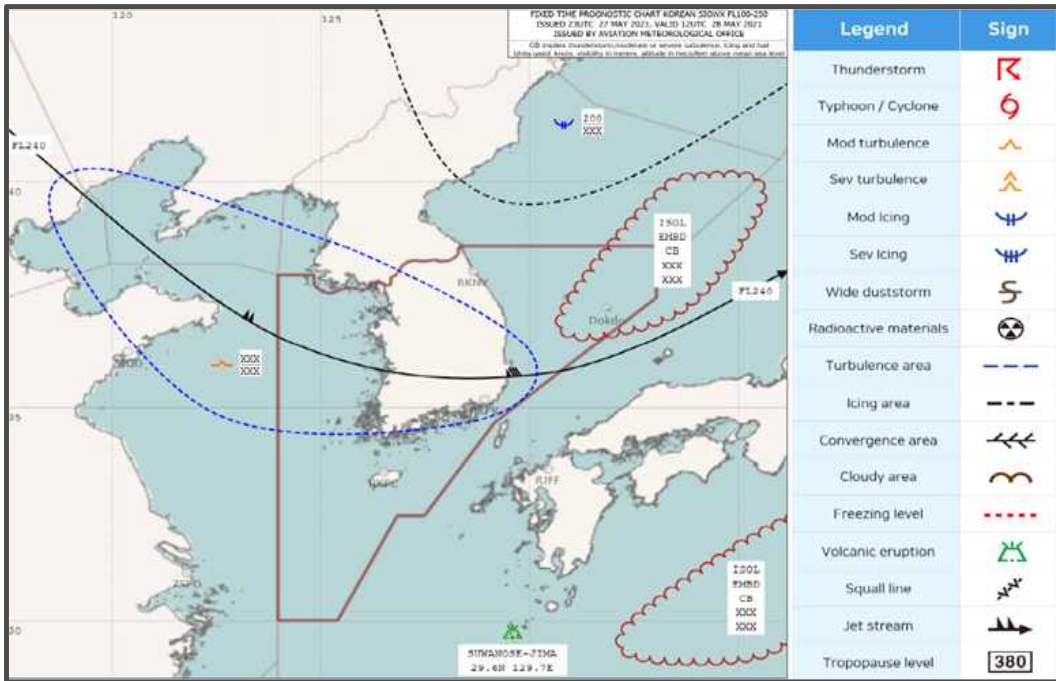
[Figure 7] Distribution of Weather Elements at Medium Altitude (SIGWX)

According to the weather chart(SIGWX) showing dangerous weather conditions announced by the AMO on the day of the accident, a turbulence from 10,000 to 25,000ft in central district of the Korean Peninsula is expected to occur.

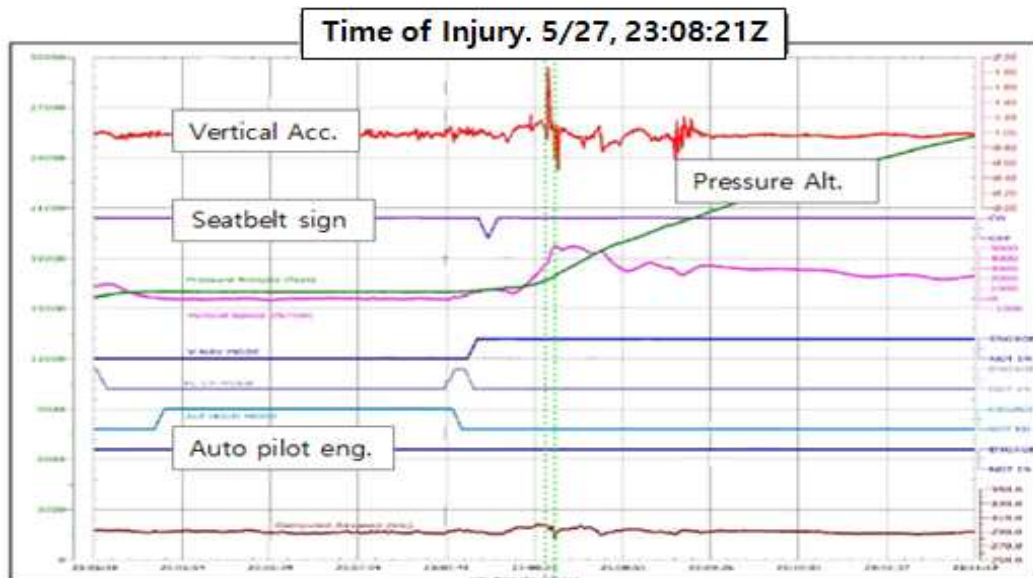
[Figure 8] FDR 5 Minutes Before and After Accident

When passing over 16,736ft, the center of gravity reached 1.86G at maximum and maintained 1.0G after it decreased to the lowest of 0.5G. When the center of gravity reached the highest level, the climb speed recorded at 5,100 fpm at that moment. Afterwards, the aircraft maintained 3,000 fpm. The auto-pilot continued to operate during cruise and there was no notable change in outdoor temperature, wind and angle of attack.

Data saved in the flight recorders(flight data recorder and cockpit voice recorder) are recorded based on the coordinated universal time(GMT, nine hours behind KST). Flight crew’s control of the aircraft and turbulence influence of each time zone are demonstrated as shown in [Figure 8].

Based on the data retrieved from the flight data recorder, the impact at turbulence encounter while HL7528 was climbing. Captain turned chime twice about 14 seconds he began climbing at 16,000ft at 23:07:43.
