Aircraft Serious Incident Report

One Engine In-Flight Shutdown

B777-200F, F-GUOB

March 14, 2012

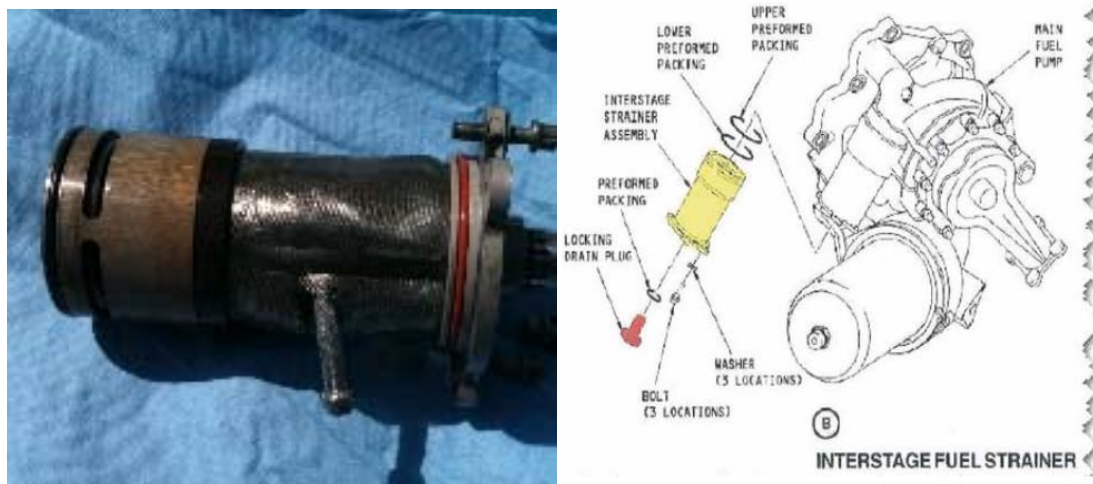
[Figure 6] Interstage Strainer and Bolt

interstage strainer installed in the main fuel pump. One bolt was found between the strainer and the housing. The bolt was embedded in the strainer screen.

As shown in [Figure 6], when the ARAIB inspected the main fuel pump interstage strainer shortly after the serious incident, one bolt was embedded in the strainer screen, and many metal chips were found in the screen. It was

confirmed that the bolt was used to install the main fuel pump on the bench support plate.

The ARAIB analysis lab analyzed the bolt and the metal chips. The analysis revealed that the elements of the metal chips were similar to those of the bolt and the strainer gear. Thus, it is determined that the metal chips were generated when the bolt was abraded in the fuel pump and damaged the interstage strainer.

Develop and implement the measures to prevent foreign objects, including bolts used for a test bench, from ingesting into the fuel pump when the fuel pump is maintained at a component repair shop (AIR-F1201-1).

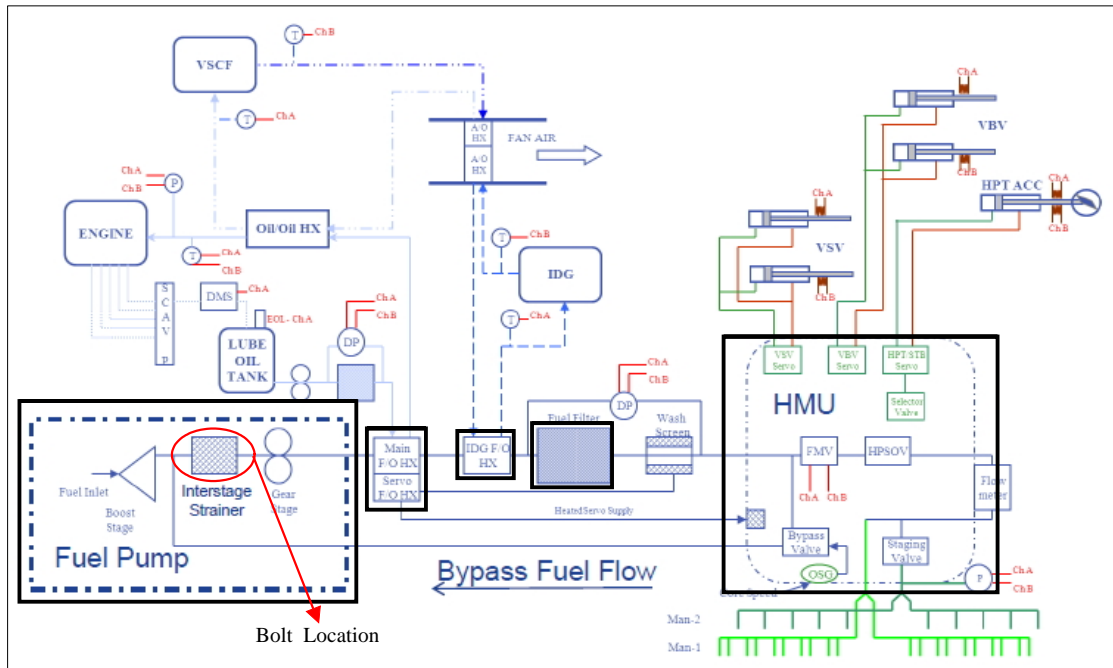
[Figure 8] Engine Fuel System

The schematic diagram of the engine fuel system is shown in [Figure 8]. The bolt was embedded in the metal screen of the interstage strainer, fuel filter between boost stage and gear stage of the fuel pump. Many metal chips were also found in the fuel filter.

The schematic diagram of the engine fuel system is shown in [Figure 8]. The following parts in black rectangles in the figure were replaced for

troubleshooting: fuel pump; lube-servo fuel/oil cooler; IDG fuel/oil cooler; fuel filter; and the HMU. As metal chips were filtered by the fuel filter, the wash screen and the HMU installed aft of the fuel filter were not contaminated.

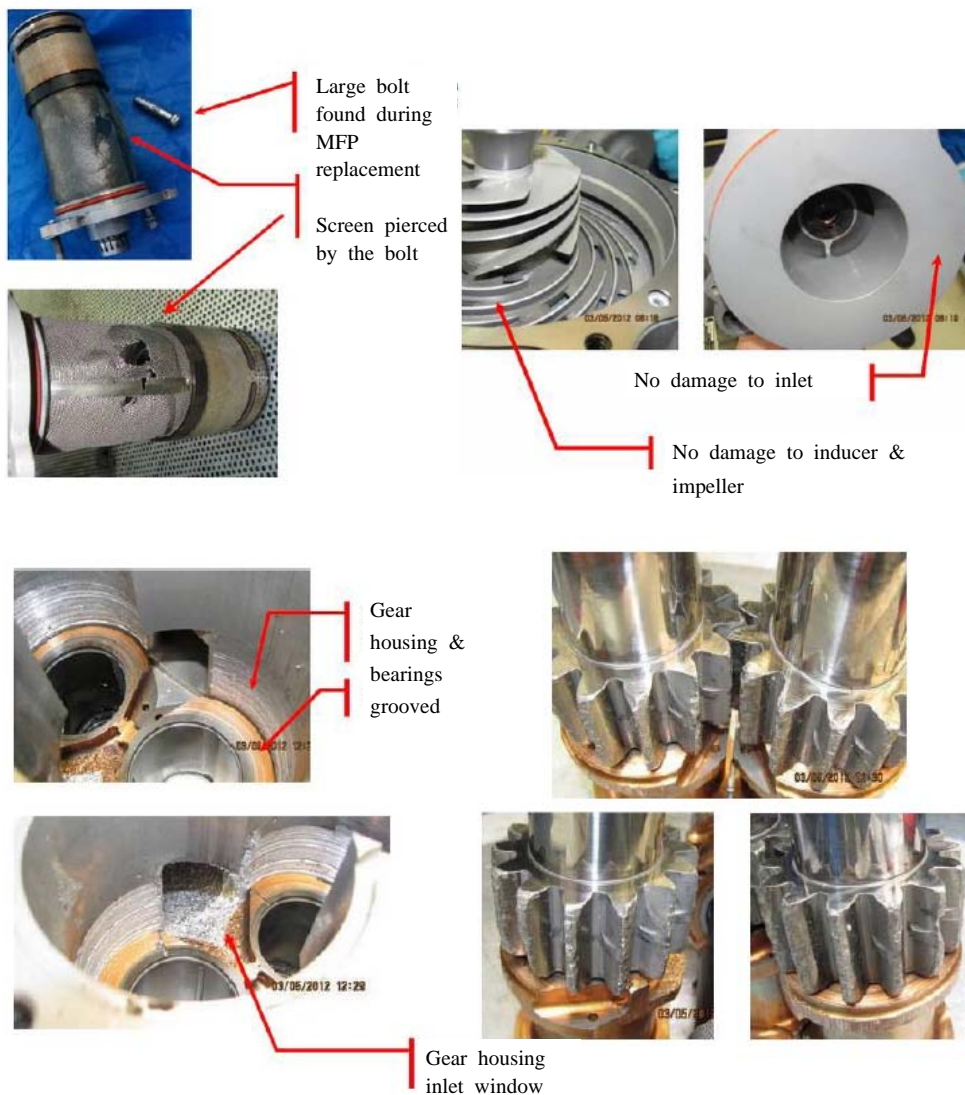
[Figure 9] Inspection of the Fuel Pump

There was no external damage to the main fuel pump, and gears turned freely. Also, shafts, lube flow screen, and bearing plate sustained no damage. As shown in [Figure 9] Inspection of the Fuel Pump, a large bolt found between the housing and the strainer during the fuel pump replacement perforated the strainer, and the material of the perforated section was missing.

There was no damage to the inducer, impeller, and inlet housing, but the gear set was damaged to the point of being very difficult to disassemble. The fuel pump failed to pressurize fuel normally due to damage, which caused abnormal fuel supply to the engine. The operator scrapped the fuel pump.

9. The inspection of the main fuel pump revealed that the gear set was damaged to the point of being unable to disassemble and that the gear housing was also severely damaged. Thus, the main fuel pump was scrapped.

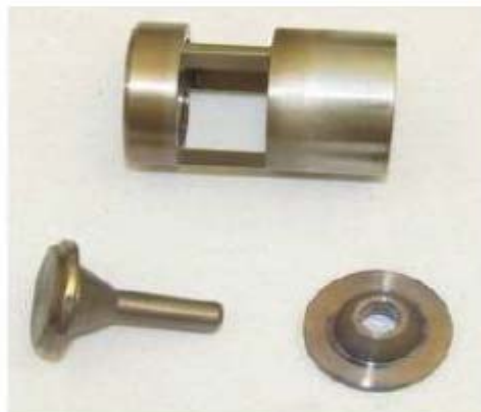
[Figure 10] Differential Pressure Check Valve

The HMU was disassembled for examination. The examination revealed that the differential pressure check valve was in good condition with nothing else significant found as shown in [Figure 10].

This indicated that the HMU was not contaminated.

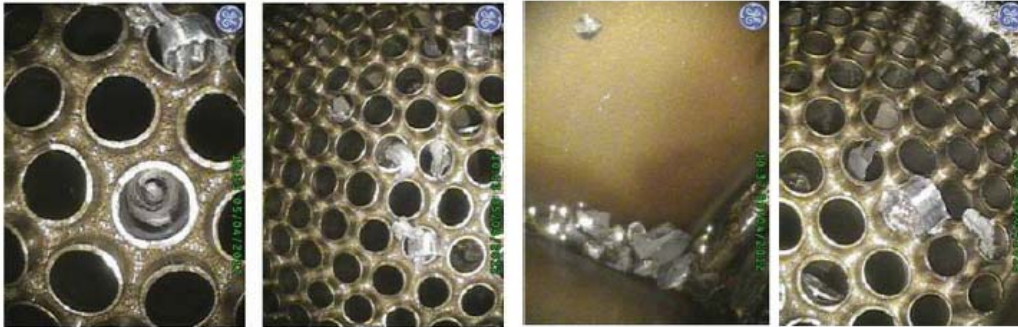
[Figure 11] Fuel/Oil Cooler Contamination

metal chips were indeed found in the servo in port as shown in [Figure 11]. The boroscope inspection showed that all tubes internally on the servo side of the unit were completely plugged with metal chips.

The operator was unable to remove any of these contaminants since they were packed in the tubes. To remove them, the company attempted various methods such as power flushing, vacuuming, and air pressure and vibration but to no avail.

The lube-servo fuel/oil cooler was scrapped since it was determined beyond physical repair. The unit was internally contaminated by metal chips. As the tubes were internally plugged with metal chips, the internal damage to the tubes could not be determined.

10. The inspection of lube-servo fuel/oil cooler revealed that the tubes on the servo side of the unit were internally plugged with metal chips. The unit was determined to be beyond physical repair and subsequently scrapped. The internal damage to the tubes could not be determined.

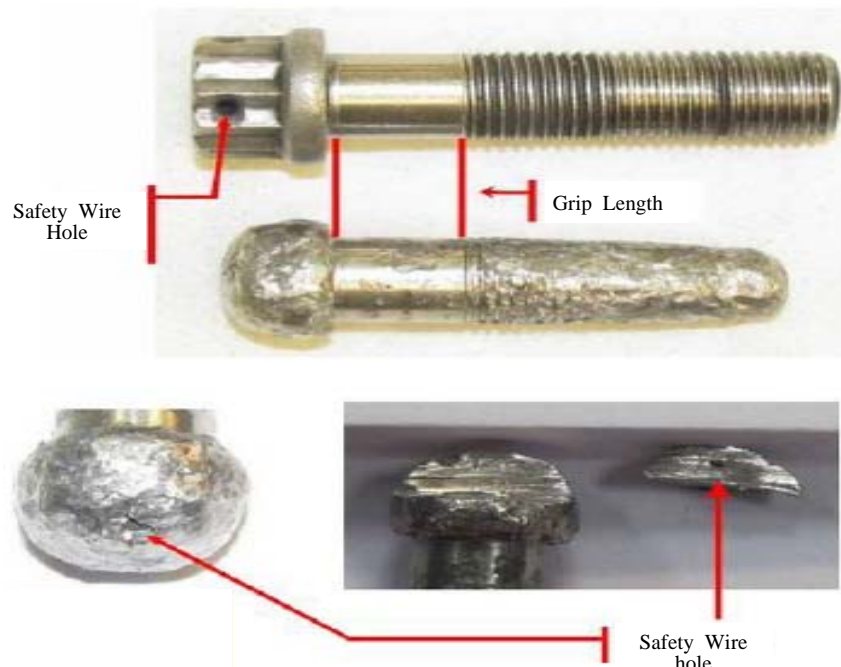
[Figure 12] Bolt Comparison

The design of the bolt was almost similar to part no. J646P21B. This bolt is used to install the main fuel pump on the bench support plate. It was not recorded in GE90 IPC, but was recorded in CF6-80C2 IPC.

As shown in [Figure 12], the bolt matched J646P21B when it comes to diameter, thread, and grip length. It also had a safety wire hole. Examination using an electron microscope revealed that the elements of both bolts coincided.

11. The bolt found in the fuel pump is used to install the main fuel pump on the bench support plate. The bolt matched one used for the bench test when it comes to diameter, thread, and grip length. It also had the same safety wire hole. Examination using an electron microscope revealed that the elements of both bolts coincided.

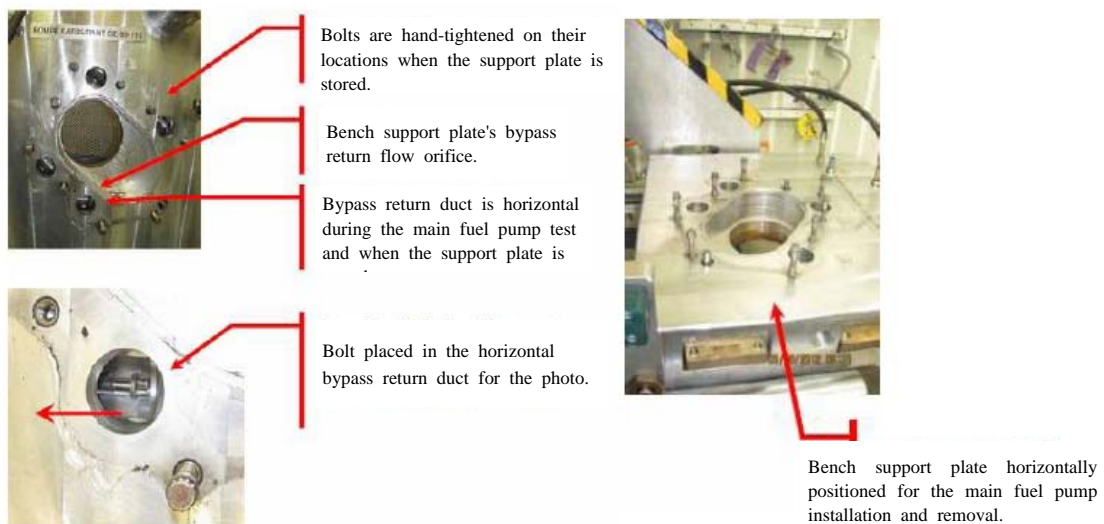
[Figure 13] Support Plate for the Main Fuel Pump Bench Test

As shown in the right photo of [Figure 13], the main fuel pump bench support plate is a device on which the main fuel pump is installed and fastened. The top left photo of [Figure 13] shows the bench support plate viewed from right above. The bottom left photo of [Figure 13] is a close shot of the bypass return duct in which the bolt is placed. The duct is long enough to hide the bolt.

The hypothesis about the engine in-flight shutdown (IFSD) caused by the bolt is as follows: the bolt was ingested into the main fuel pump strainer although the timing of the ingestion cannot be accurately identified. The strainer was not removed after the final bench test³²⁾ to avoid damaging the O ring and a leakage, but this procedure was not requested by the OEM documentation³³⁾.

12. The bolt for installing the main fuel pump on the test bench was ingested into the main fuel pump through the bypass return duct. The pump still with the bolt inside was installed on the aircraft. The bolt was abraded in the fuel pump due to high fuel pressure caused by the fuel pump operation, which generated metal chips. These metal chips damaged the gear set, which caused low fuel pressure, and as fuel pressure got lower, fuel was not supplied to the engine, thereby resulting in one engine in-flight shutdown.
