Report No. ARAIB/AAR-F0901

# Aircraft Accident Report

**A passenger got burnt during flight**

**Japan Airlines Flight 950**

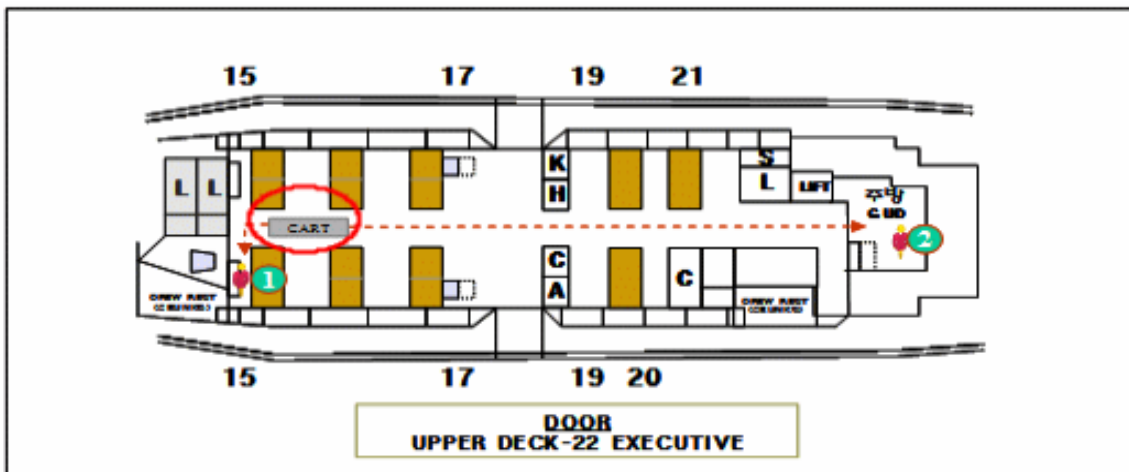
[Fig. 1] Upper deck situation map

At about 10:04, the cabin attendant in charge of the upper deck brought a cart carrying meals and beverages to the aisle of row 16. She was taking out the table of the passenger on seat 15A after applying the front brake<sup>5)</sup> of the cart, as the cabin attendant in charge of the galley applied the rear brake and went to the galley to fetch a sticker<sup>6)</sup> for a sleeping passenger. (See Fig. 1)

As Flight 950 started climbing, the pitch became high, and the cart slid backwards exceeding its maximum brake capability. As the cart hit the seat 19H, the cart tumbled towards the seat 19C, and the hot beverage on the cart was spilt on the right arm of the passenger in seat 19C.

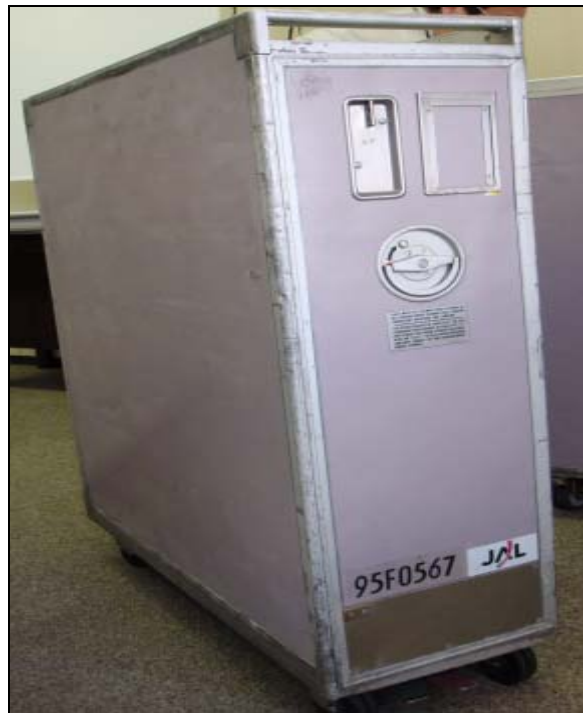
[Fig. 2] Cart of the same type as the lost one

The relevant cart is the same type as 95F0567 made by Showa Aircraft Industry Co., Ltd. (Fig.2). The cart could not be found after it was handed over to a cart cleaning company of Japan Airlines after arrival at Narita Airport.

According to the manual of this cart, the tare weight of the cart is 48lb, and the maximum loadable weight is 152lb. This cart has two brake systems, and the capability of its brake system is at least 8 degrees at the time of manufacturing when the total weight<sup>22)</sup> of the cart is 200 lbs.

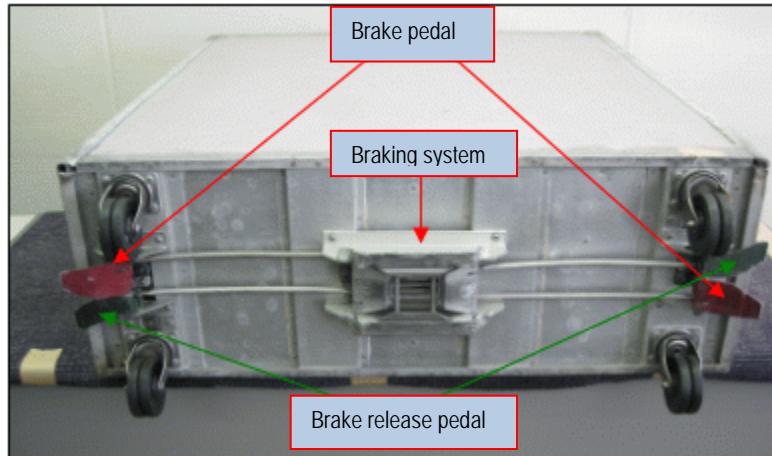
[Fig. 3] Braking system

As shown in Fig.3, the cart has its braking systems in the center of the bottom and one pair of brake pedals (red) and brake release pedals (green) on both sides. Brake is applied and released by stepping on either brake or brake release pedal as shown in Fig.4.

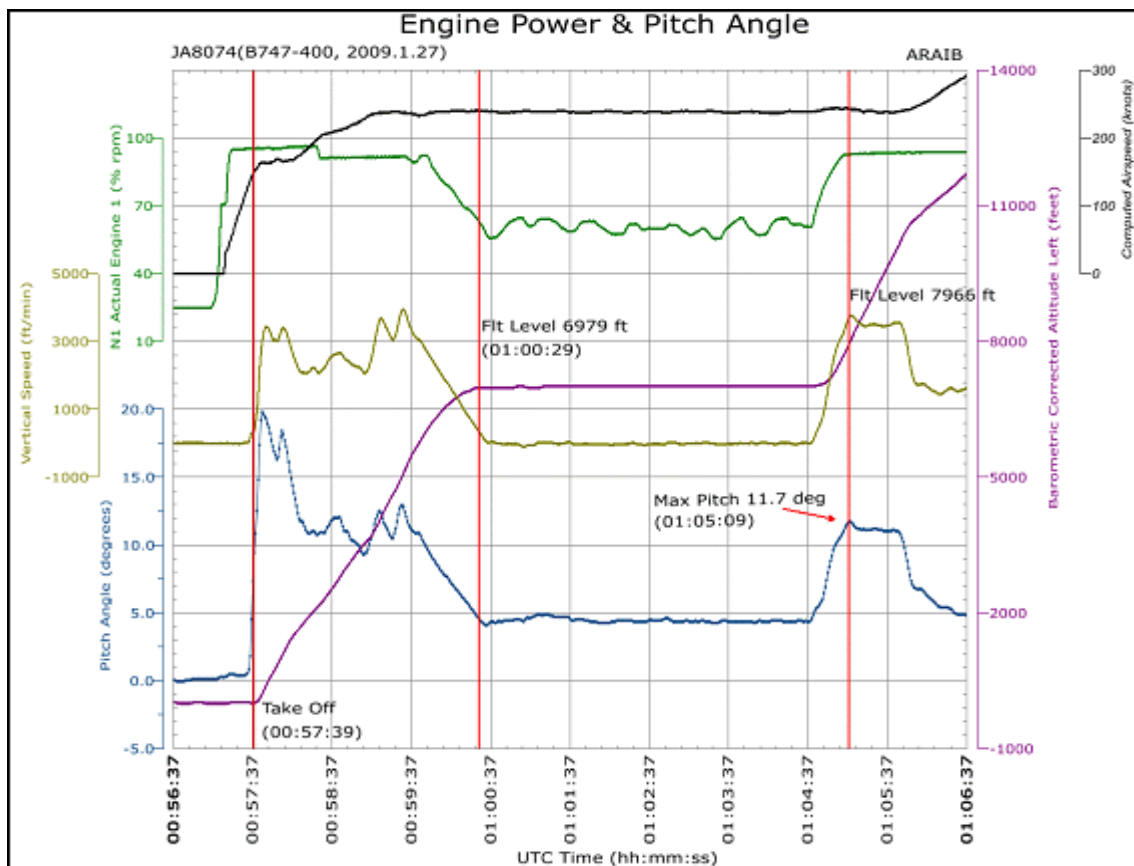
[Fig. 6] Major parameters of the flight data recorder

As shown in the altitude and pitch parameters in Fig.6, Flight 950 took off at 09:57:39 and reached 7,000 feet at 10:00:29. After maintaining level flight, it started to climb to 23,000ft at 10:04:41 with the pitch up again.
