**Report No. ARAIB/AAR0904**

# **AIRCRAFT ACCIDENT REPORT**

HELICOPTER CRASH DURING AIRLIFTING OF CARGO  
THE CHANGWOON AVIATION, REPUBLIC OF KOREA  
KA-32A, HL9405  
MT. JEOMBONG, INJE-GUN, GANGWON-DO  
6 NOVEMBER 2009

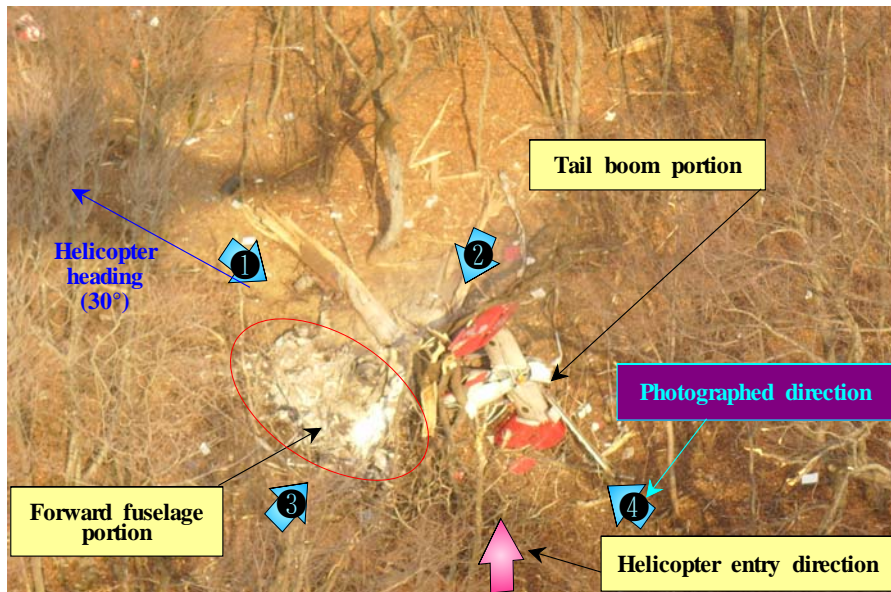
[Photo 2] Helicopter wreckage after fire was extinguished

But the tail boom was separated from the forward fuselage and was overturned to right, and the skin was torn or bent due to impact on crash, but they were not burned as they were off from the burning point.

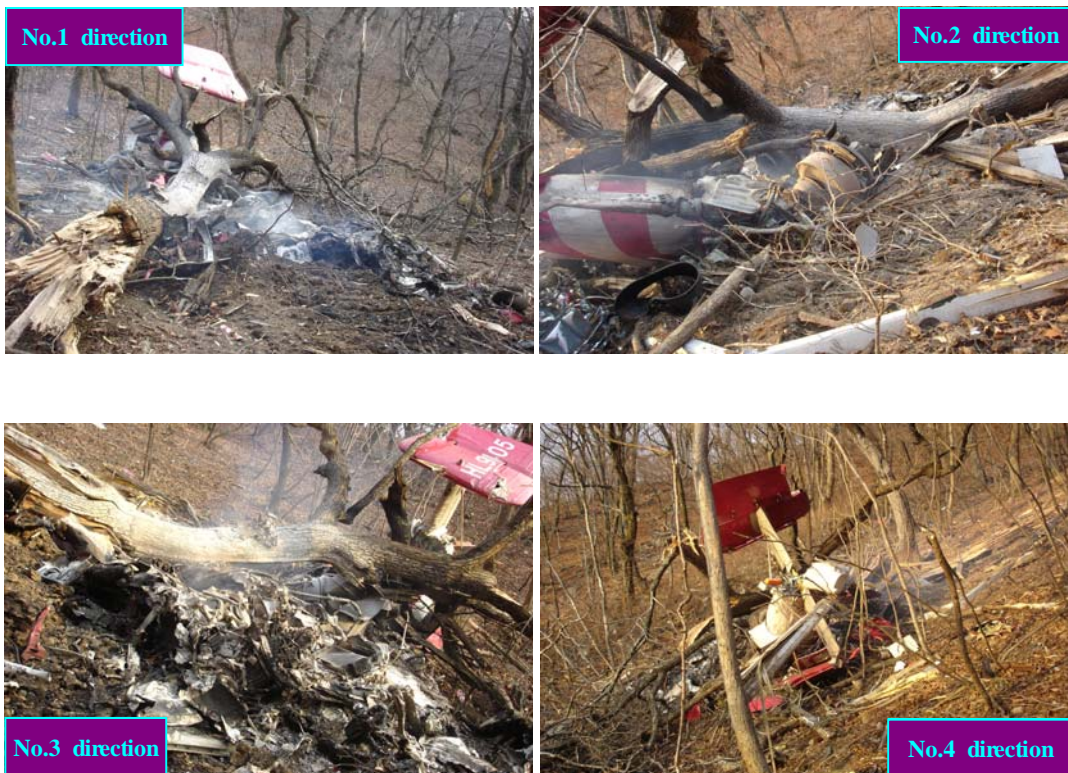
[Photo 3] Wreckage immediately after accident, photographed from each direction, Also see Photo 2

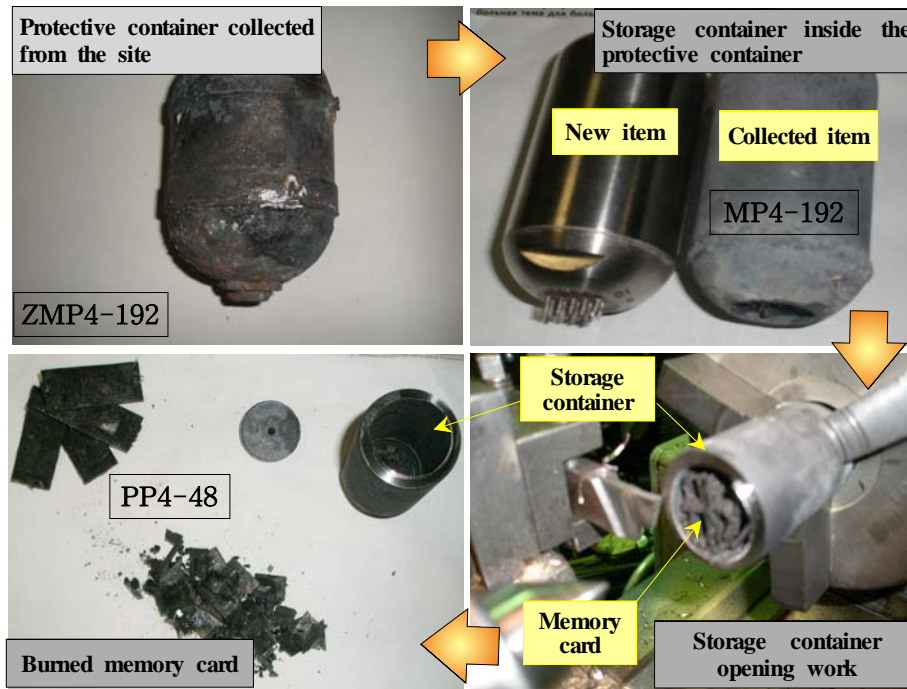
Subsequently the protective container was opened to take out the memory card storage container (MP4-192)<sup>38)</sup> for exterior check, and it was found that the color and shape of the outer titanium case of the storage container were also deformed by heat.

Finally the titanium case of the storage container was cut by using lathe, but the flight data memory card (PP4-48) was already burned inside the storage container to be transformed into black fragments and powder, so the extraction of the flight data was failed.

[Photo 4] Protective container collected from the site and the oxidized memory card

Despite that the forward fuselage was completely destroyed by a fire after crash, the tail boom was not damaged by the fire. Therefore, if the FDR had been installed toward the tail boom, it could have been protected against the fire. So it is necessary for the manufacturer to re-consider the installation location of FDR and improve on the problem.

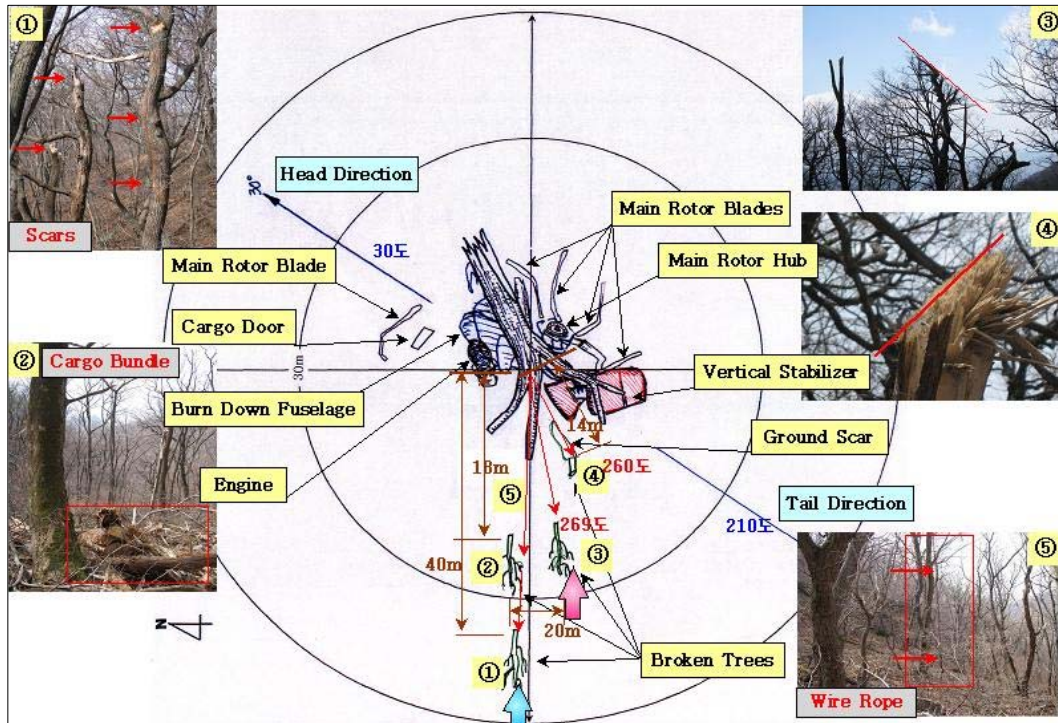
- On the accident site, there were two rows<sup>41)</sup> of tree damage by cargo and aircraft, and the traces were formed in parallel toward the crash point in a width of about 20 m.

- The pickup wire rope remained connected to the aircraft until after crash, and the wire end to the cargo was separated<sup>42)</sup> from the cargo and put on tree branches (⑤) about 11 m away from the crash point.

- The position at which the aircraft hit the trees first was in the direction of 269 degrees and 22 m (③) from the crash point, and the upper portion of the trees were cut by the lower main rotor blades in an about 30 degree left inclined form.

[Photo 6] Wreckage distribution and photos of major points

41) The red arrow (aircraft) and blue arrow (cargo) marked in Photo 6 above

42) The magic rope was cut by a strong tensile force to be separated.

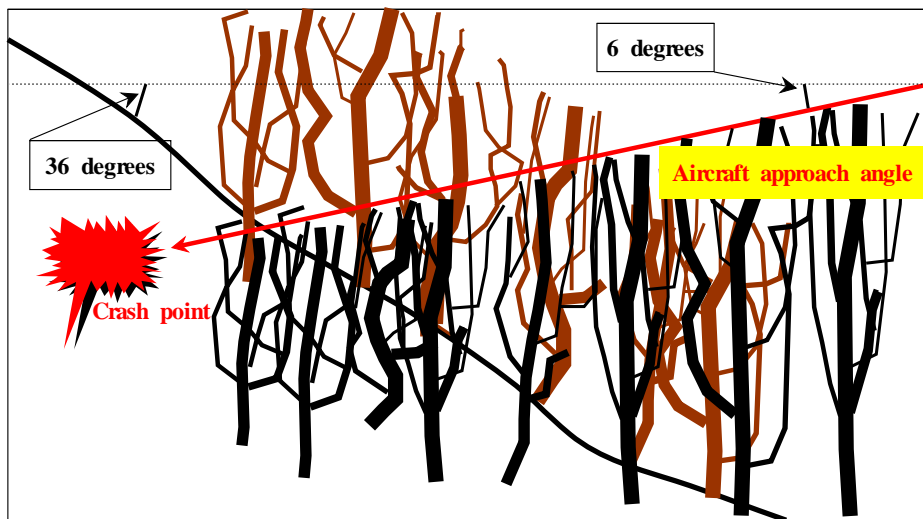
- The trees (diameter about 12 cm) that the aircraft hit lastly was the point (④) in the direction of 260 degrees and about 14 m from the crash point, and the height about 30 cm from ground was cut by the lower main rotor blades and the cross-section of the tree was in a 40 degree right inclined form.
- The ground scar that the main rotor blades left first on the ground was formed in an about 40 cm wide and about 2.5 m long size in the direction of crash point from the lastly cut trees.
- The ground impact angle of the aircraft reckoned by the extended line drawn from the top end of the tree cut by the aircraft is -6 degrees of the horizon and the direction is 89 degrees of the magnetic north. See Fig. 1.

[Fig. 1] Approach angle when aircraft collided with ground

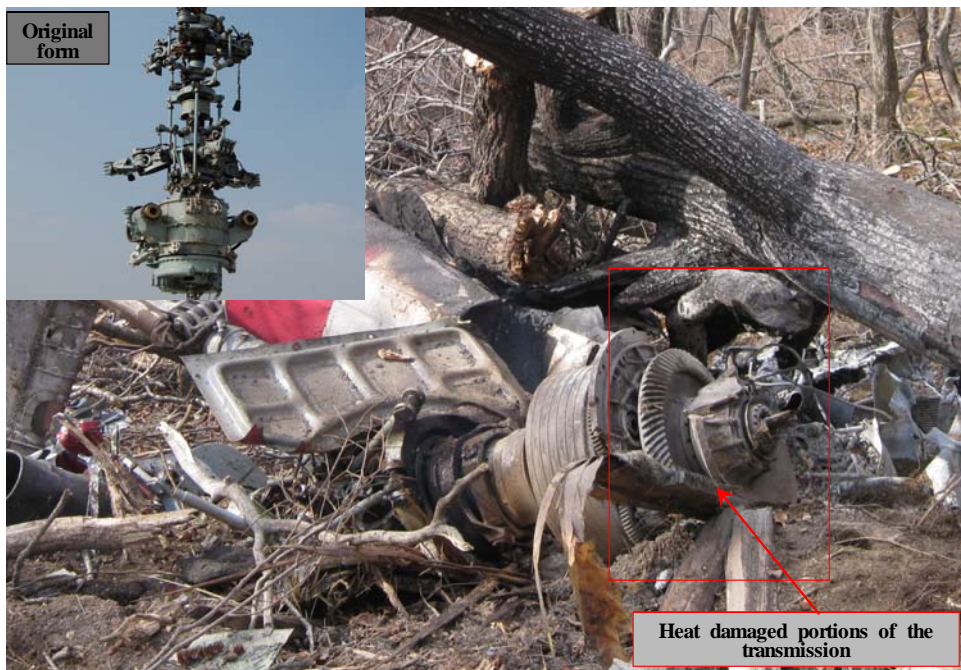
And the transmission, main rotor hub, mast, etc. were separated from the fuselage by a severe external shock along with physical damage, and the transmission outer case was partly damaged by heat, as shown in photo 6.

[Photo 6] Damaged portions of the transmission and mast

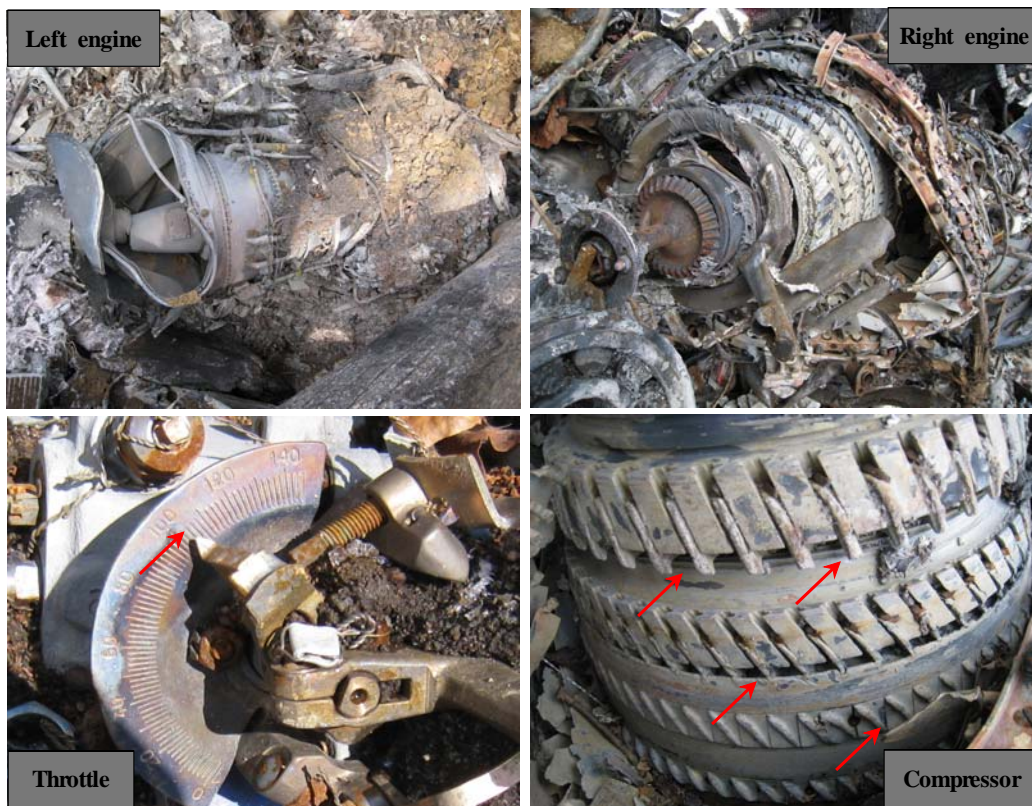
was exposed outside, and the right engine was buried in the heap of wreckage. The left engine had the appearance preserved relatively well and the right engine was severely damaged by the impact on crash.

The throttle position of the left engine was at the 103% position, and the front portion of the compressor was under the horizontal forward force to be bent rearward. The right engine had all the root portion cut as the rotor blades of the compressor had rotation damage.

[Photo 7] Damage to left and right engines

And considering that the ground collision entry angle of the aircraft was -6 degree, that rotation damage appeared on the engine compressor, and that the aircraft attitude changed rapidly at the short moment of crash, ARAIB considered<sup>58)</sup> that the engines did not stop.

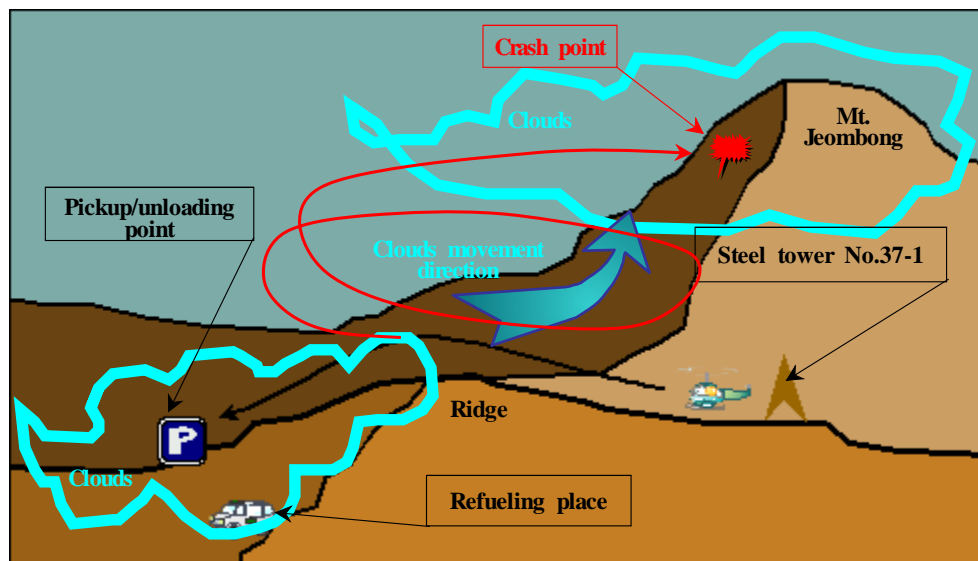
And the Mt. Jeombong ridge passes north to south of the central point from the steel tower number 37-1 position to the pickup and unloading position, so the pickup and unloading point and crash point are not seen from the position of the steel tower. See Fig. 2.

[Fig. 2] Mission area terrain and cloud movement direction

wind observed at the Inje Weather Station blew. And based on such a fact, the ARAIB can reckon that low clouds made in the west of the mission area were moving to the northeast at a fast speed.

Therefore, at the time when HL9405 took off from steel tower number 37-1, the clouds covering the pickup and unloading point were not directly observed, but at the moment that the helicopter flew over the ridge in hazy fog, there is a possibility that the helicopter advanced into clouds embedded in mountain fog.
