Report No. ARAIB/AAR0905

AIRCRAFT ACCIDENT REPORT

**HELICOPTER CRASH ON THE LAKE DURING TRAINING
FOREST AVIATION HEADQUARTERS
KA-32T, HL9413
YEONGAM LAKE, YEONGAM-GUN, JEOLLANAM-DO
23 NOVEMBER 2009**

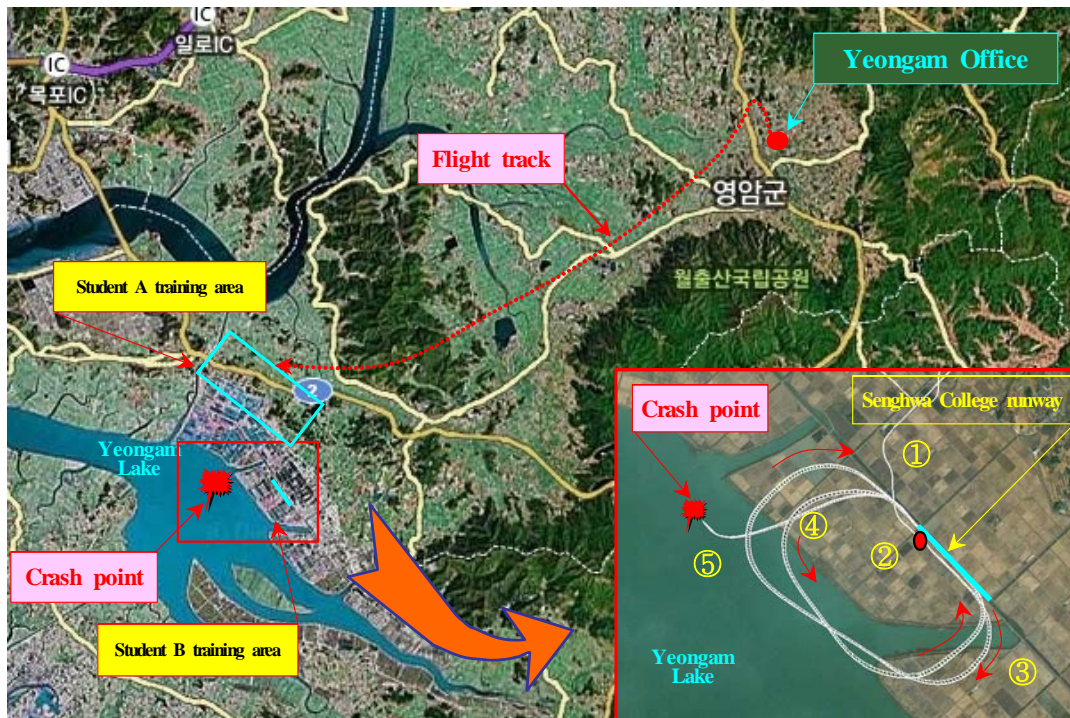
[Photo 1] Training area and flight track

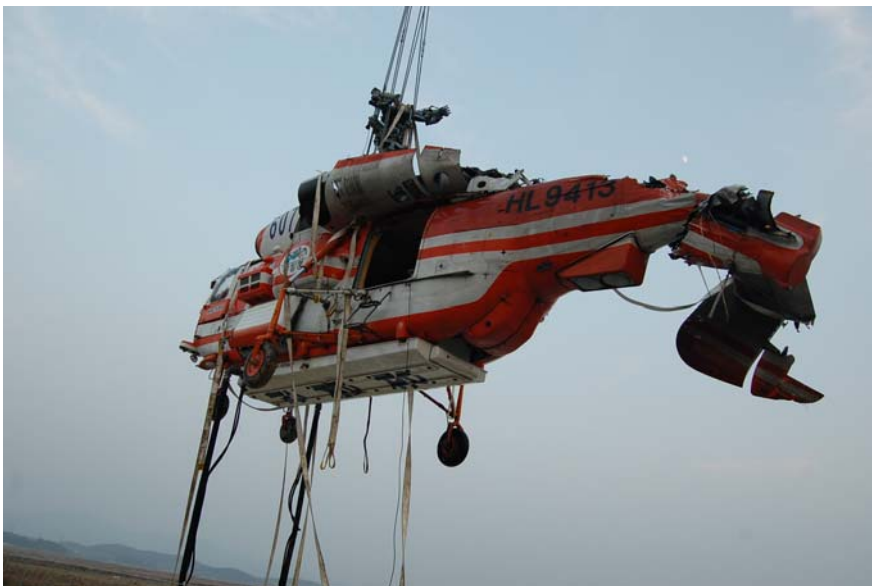
The aircraft was totally destroyed due to the impact on crash. HL9413 subscribed¹¹⁾ to hull insurance¹²⁾ and passenger accident insurance¹³⁾, which were within the term of validity at the time of the accident. Photo 2 below shows the aircraft under salvage work.

[Photo 2] HL9413 under salvage work

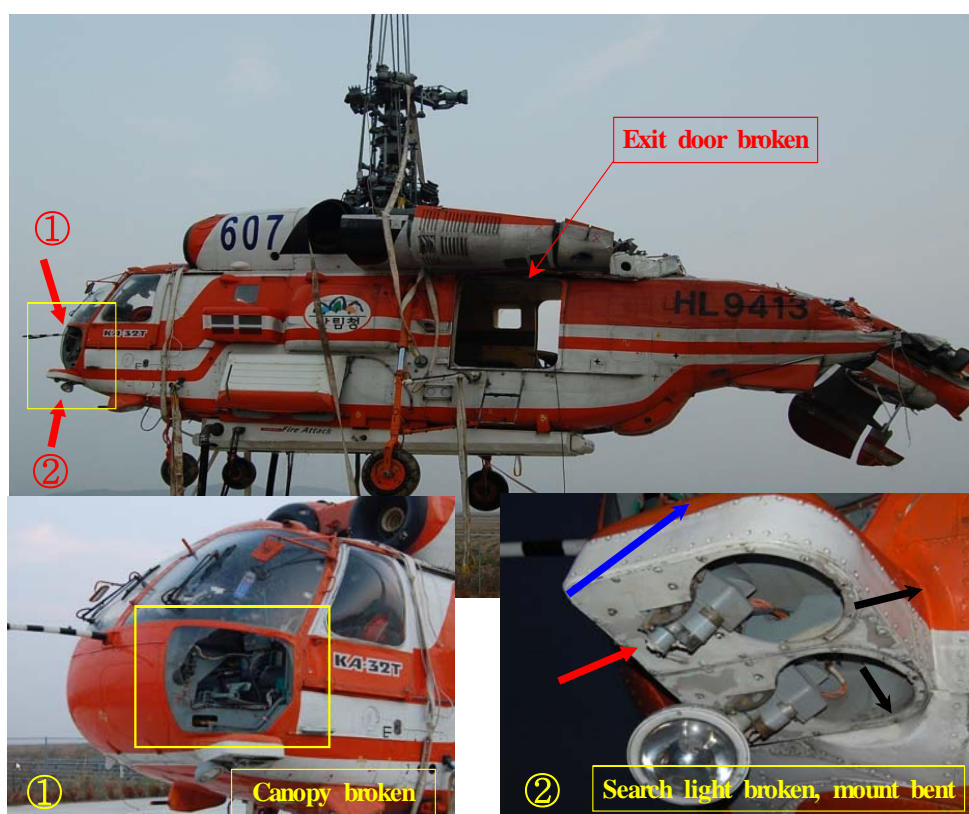
[Photo 3] Main damaged portions of fuselage

The fuselage had the canopy (①) to the left bottom of the catapin's seat broken as shown in Photo 3 and the search light (②) broken and the search light mount pushed to the rear upward (blue arrow) to squash (black arrow) the surface of the fuselage. And the left cargo room door was judged to have broken away by impact on crash, but we could not collect it from the site. Other than that, we could not find any special damage.

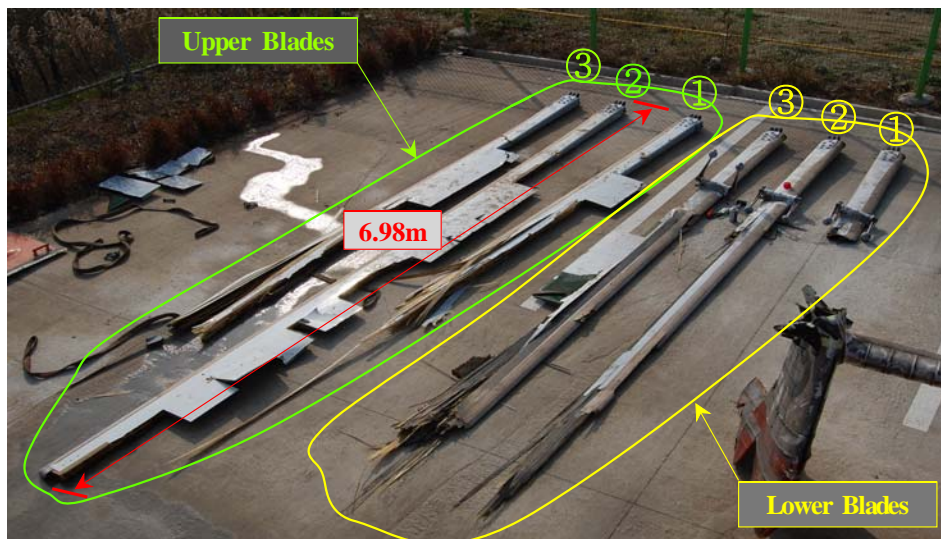
HL9413 has six coaxial reverse main rotor blades with three upper blades and three lower blades, and all the six were damaged by external impact on crash.

During salvage work, lower blade number 1 of the six blades had the pendulum³⁹⁾ broken away so it could not be collected it, and the other five blades were broken from blade end to center portions. Photo 4 shows each of the blades damaged.

[Photo 4] Main rotor blades damaged

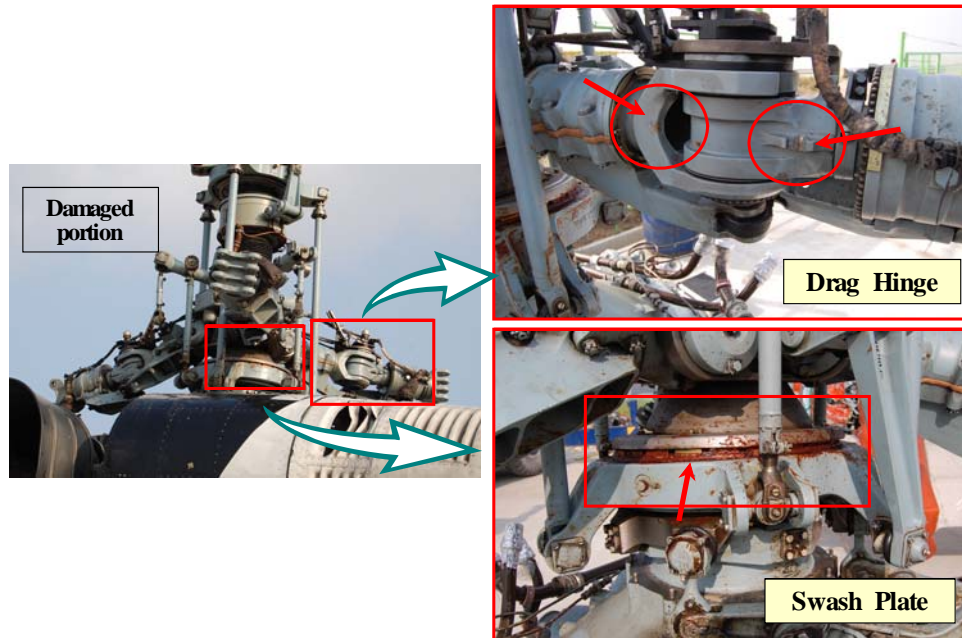
As shown in Photo 5, the mast had one (Number 1) of three lower main rotor blade hubs folded backward of the rotation direction to collide with the drag hinge to be depressed.

The lower swash plate had damage of the gap between top and bottom widened by

external impact. Such damage was judged to have been caused as the rotor blade was folded in the opposite direction of rotation by strong resistance generated when the rotor blade collided with the water surface.

[Photo 5] Damage around the mast

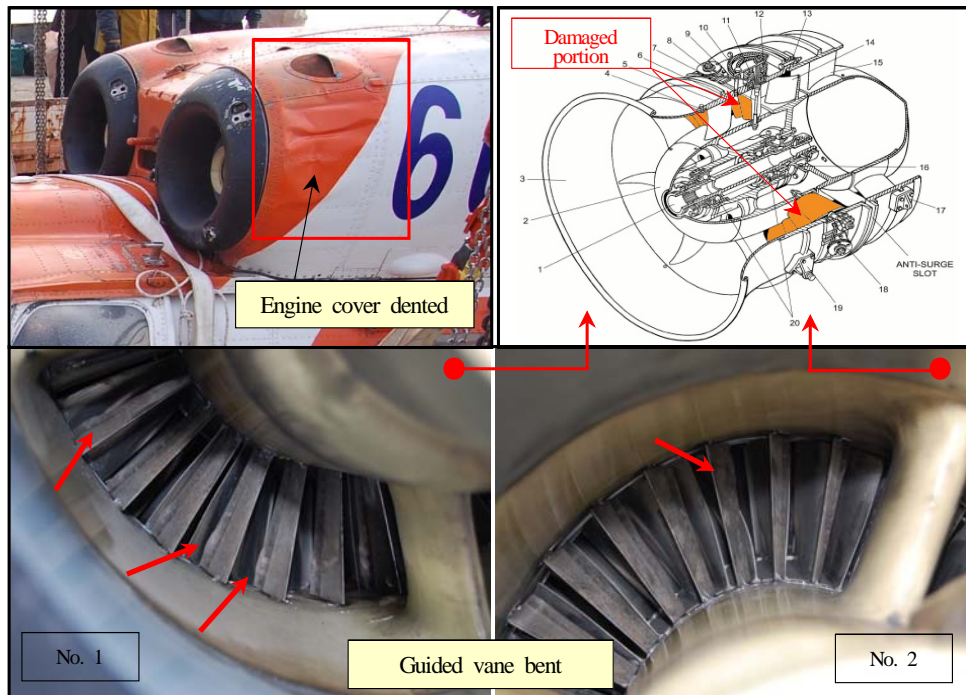
By checking the exterior of the engines, no damage other than that the upper cover of the left engine air inlet was bent by being pressed by the rope that tied the aircraft to lift it up was found.

But the air inlet guide vane⁴⁰⁾ of two engines had the weld broken away and bent forward but it had no FOD, and various lines (pneumatic, fuel, oil and electric wiring, etc.) and control rod were normally connected and no external damage was found. Photo 6 shows the damage to engine portions.

[Photo 6] Damage to engine

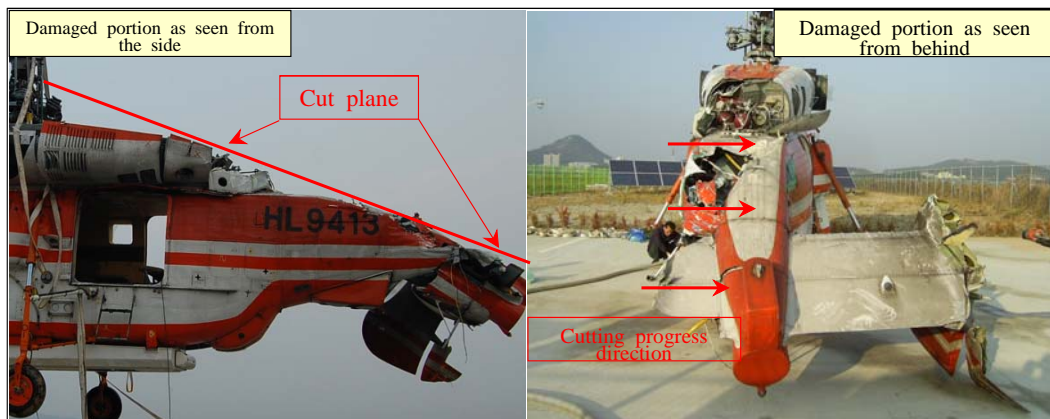
The tail boom was cut away in a straight line from the air outlet cover to the vertical stabilizer of the fuselage top as seen from the side, and the cutting progressed from left to right of the nose direction. Photo 7 shows the damage to the tail boom.

[Photo 7] Damage to tail boom and cutting progress direction

Such damage is judged to have been caused as the lower main rotor blades came downward with strong flapping due to impact on crash, and the tail boom was cut by the

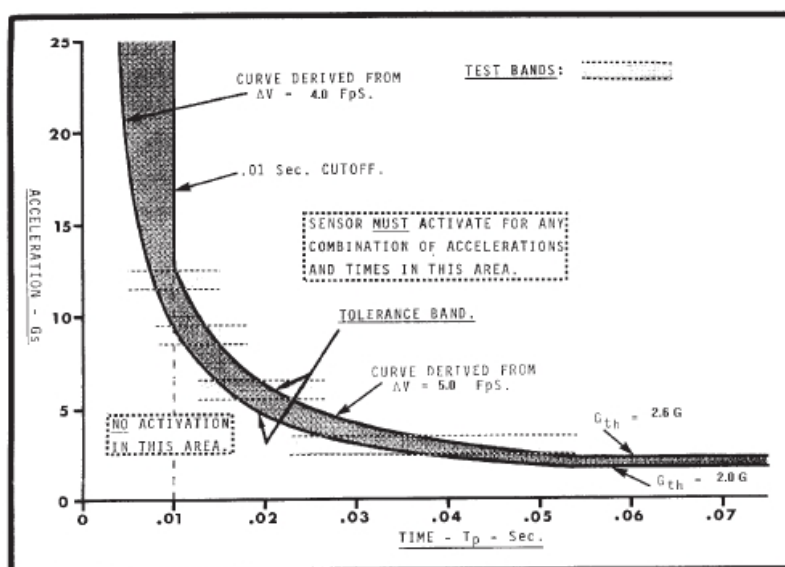
The ELT installed on HL9413 was a C406-2HM model manufactured by the Artex Company of the United States. The activation condition is that the combination of the gravitational acceleration (G) value and time which is contained within the dark colored part on the graph presented in Fig. 1 below.

The maximum value of gravitational acceleration (G) at the moment of crash recorded finally in the FDR was -2.06G, and the cockpit ELT function switch was at the "Arm" position⁵⁴⁾.

[Fig. 1] ELT activation condition graph G-Switch Curve

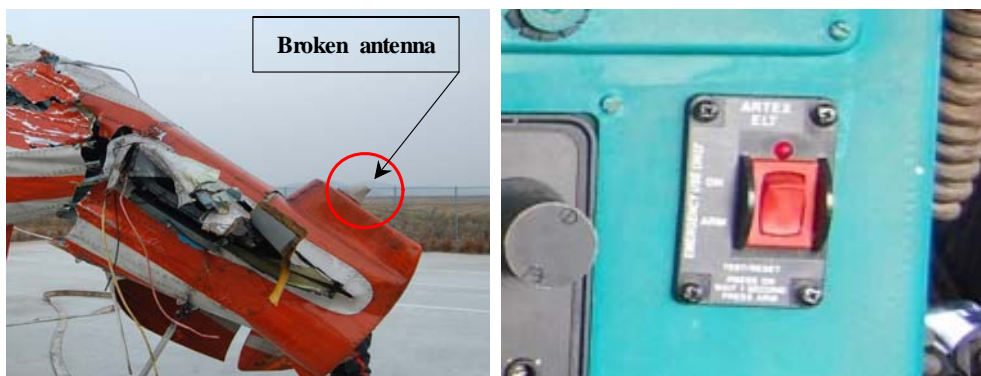
The ELT antenna mounted on the tail boom was broken along with the tail boom by the lower main rotor blades.

[Photo 8] Damage to ELT antenna and switch condition

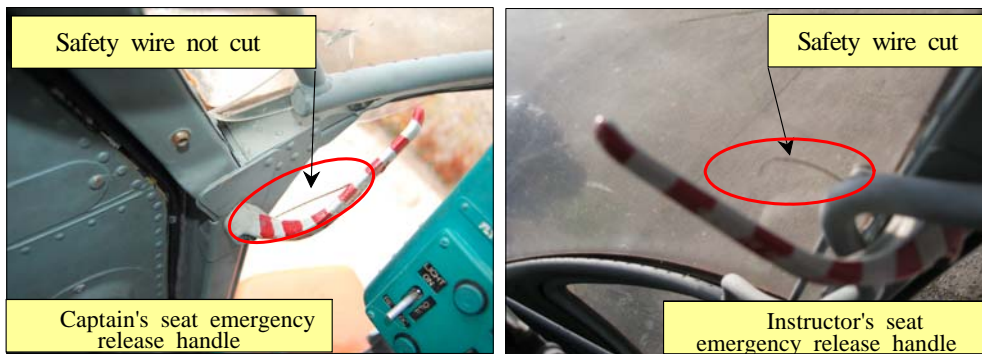
The emergency release handle safety wire of the right exit door (instructor's seat) was cut but the emergency release handle safety wire of the left exit door (student B's seat) was not cut. See Photo 9.

[Photo 9] Exit door emergency release handle safety wire condition

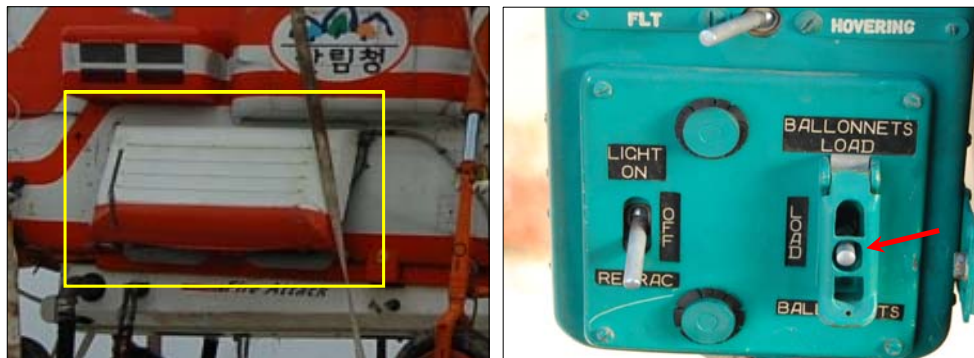
The ballonets mounted on HL9413 were not expanded (yellow rectangle), and the ballonet selection switch on the left instrument panel of the cockpit (captain side) was at the "Load" position (red arrow.) See Photo 10.

[Photo 10] Ballonets not expanded and switch position

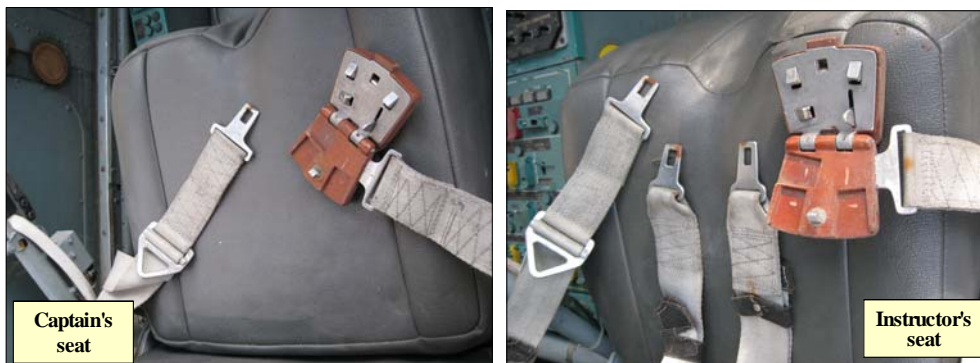
The pilot belts were checked on site to find that the aircraft was operated without the captain's shoulder harness on and the pilot belts of all seats were unfastened and there were no functional abnormalities.

[Photo 11] Cockpit seat belts of captain's seat and instructor's seat

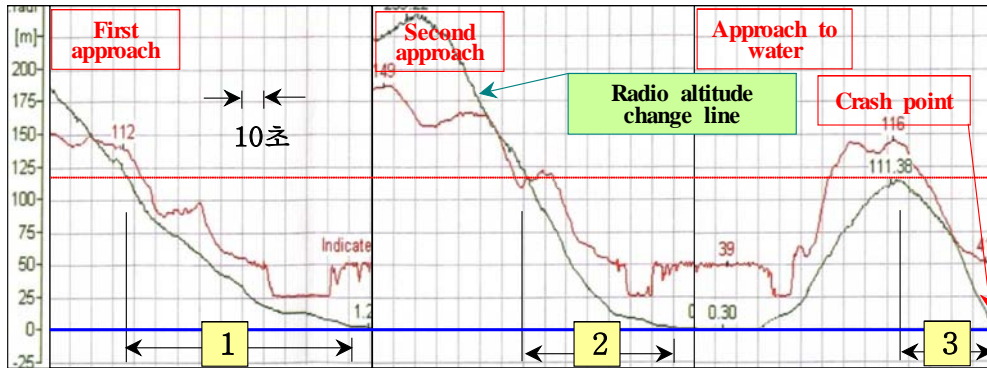
As shown in the graph, it took about 70~100 seconds to approach (①, ②) the Seonghwa College runway from reference altitude⁶⁵⁾ (red dotted line) to ground but it took about 43 seconds to approach (③) the water of Yeongam Lake.

[Fig. 4] Radio altitude change lines in the final approach phase

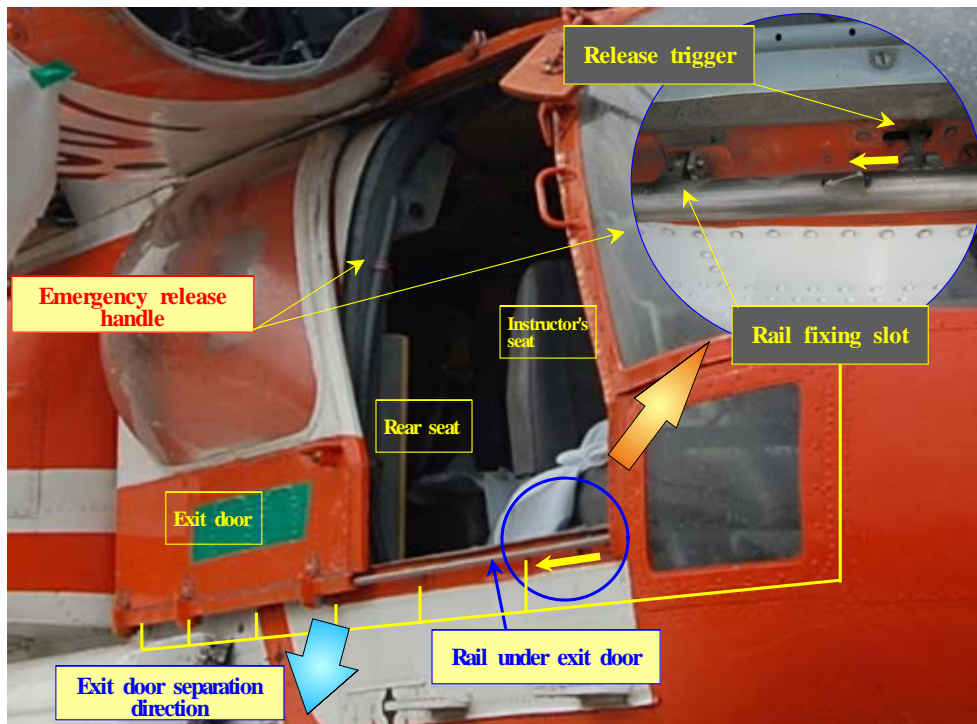
[Photo 12] Rail under exit door and exit door separation direction

Therefore, in order to ensure safe escape and survival of pilots at crash on water, it is necessary that all pilots must receive underwater emergency escape training and carry specified emergency equipments or furnish them on board, and they are fully familiarized with the emergency escape procedures by practicing the exit door emergency release by type of aircraft.
