Report No. ARAIB/AAR-1003

AIRCRAFT ACCIDENT REPORT

HULL LOSS DURING FORCED LANDING

CESSNA T206H, HL1094

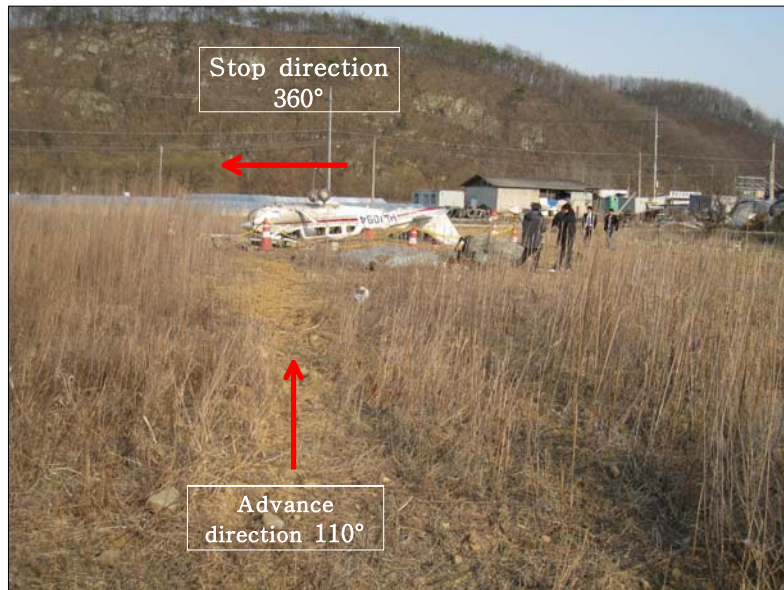
As shown in [Photo 1], the HL1094 touched down at the entry into a free space about 70 meters long and about 50 meters wide, and advanced about 40 meters with the nose gear caught by a heap of cover for the heat conservation of hotbed before it capsized to the right as the nose slipped to the left.

[Photo 1] Advance and stop directions after touchdown

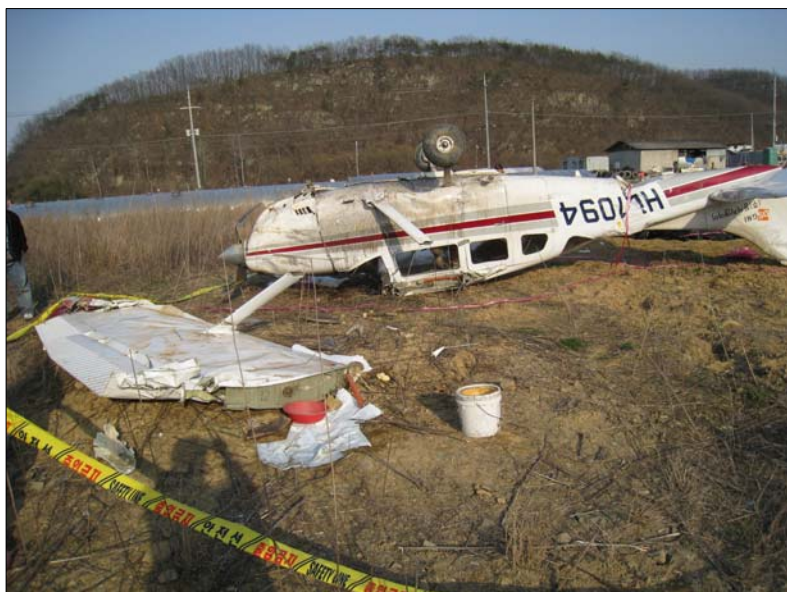
[Photo 2] Damage of the aircraft after capsizing

As shown in [Photo 2], in the process of the HL1094 being overturned after a forced landing with the engine stopped, the 3-leaf propeller was all bent backward without any rotation damage, and the right wing and the nose gear were broken and fell off, and the hull was pressed and crushed.

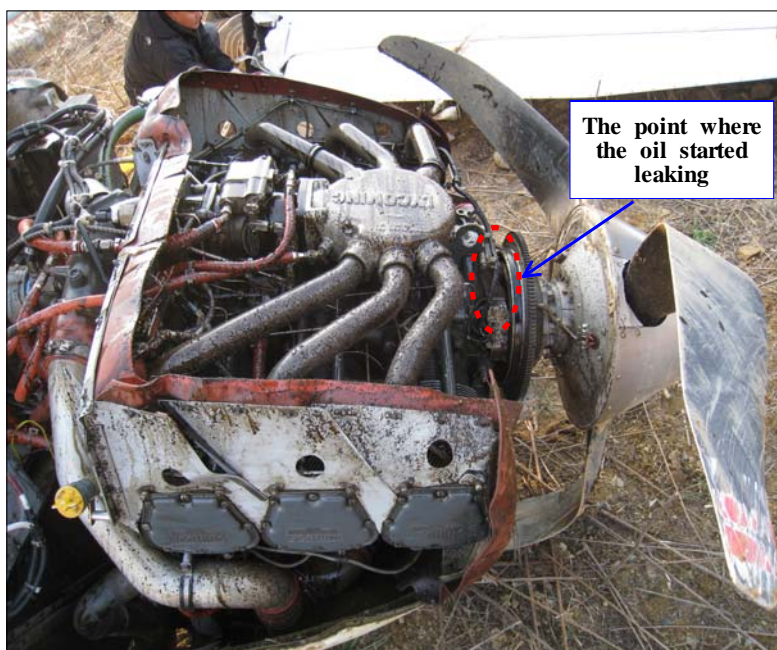
The engine oil that leaked out from the back of the propeller hub as shown in [Photo 3], was sprayed on the engine, the windshield of the cockpit and the surface of the hull.

[Photo 3] Engine oil leakage

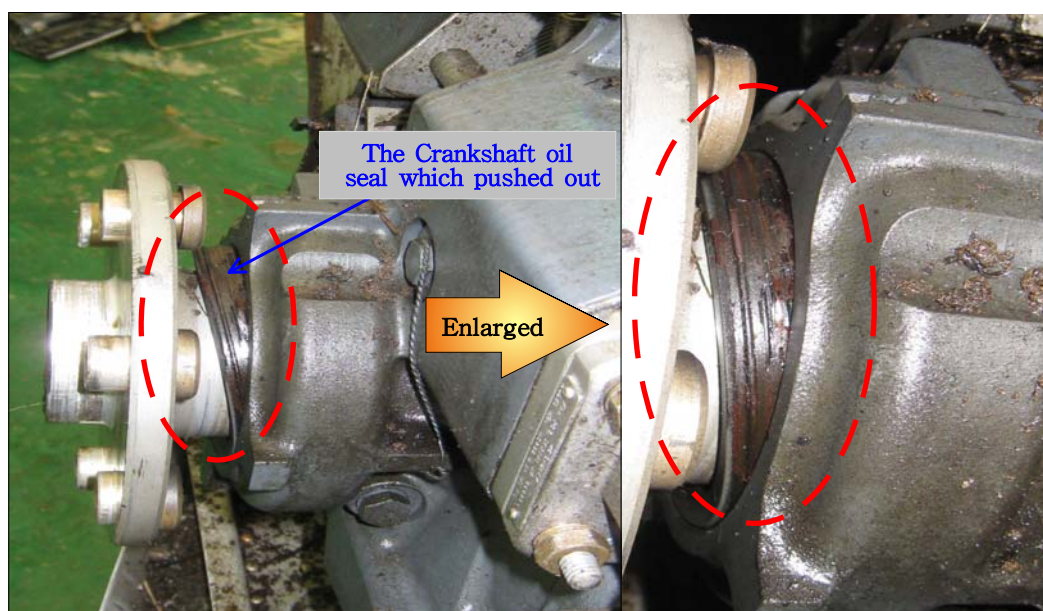
[Photo 4] The Crankshaft oil seal which pushed out

- As shown in [Photo 4], it was found that the upper portion of the crankshaft oil seal which was located between engine crankshaft and propeller hub was pushed out.
- The retaining plate that supports the crankshaft oil seal to prevent it from being pushed out was not installed.

The upper portion of the crankshaft oil seal which located between the engine crankshaft and the propeller hub was pushed out. This is judged to be because the oil seal could not overcome the oil pressure in the engine, so engine oil leaked out during the flight to make the engine cease eventually.

1. Devise a scheme for mounting a retaining plate that physically supports the crankshaft oil seal to prevent it from being pushed out. (AAR1003-1)
2. Devise a scheme for specifying the check time and method in the maintenance manual so that the crankshaft oil seal can be checked more effectively. (AAR1003-2)

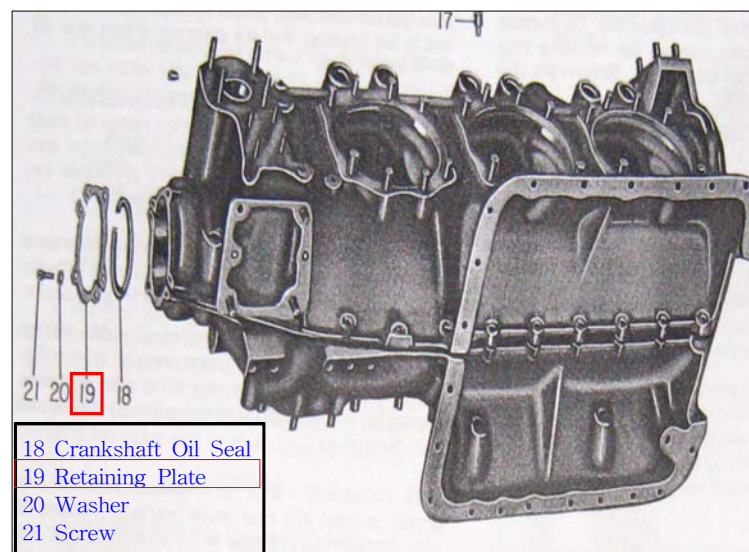
[Fig. 4] Oil seal and retaining plate of other engine

A retaining plate was not installed as like the number 19 of [Fig. 4] that supports the crankshaft oil seal to prevent it from being pushed out. Because of this, it is judged that it was not possible to physically prevent the force pushing the crankshaft oil seal out from acting when the oil pressure inside the engine increased.
