ARAIB/AIR-0908

AIRCRAFT SERIOUS INCIDENT REPORT

COCKPIT WINDSHIELD CRACKED IN FLIGHT

A330-300, HL7551

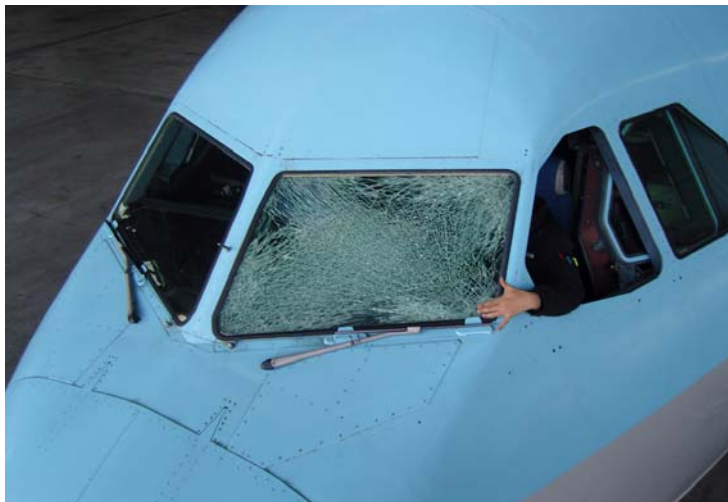
As shown in [Photo 1], a serious cracks occurred on the inside of L1 windshield.

[Photo 1] L1 windshield damaged

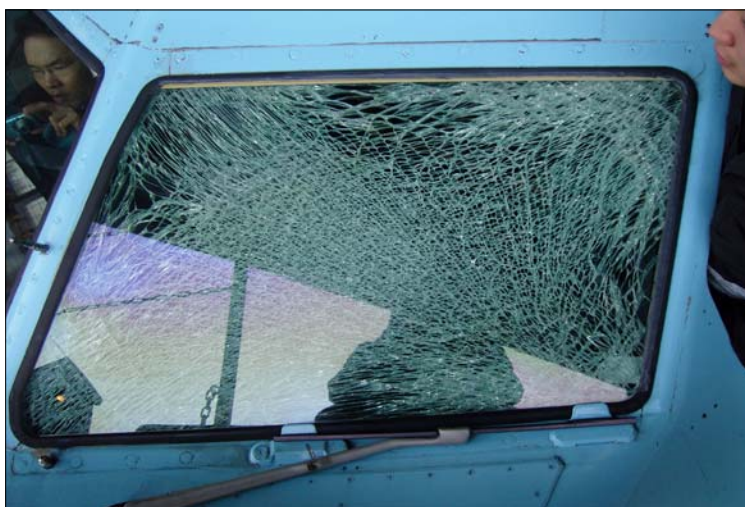
As shown in [Photo 2], there were serious cracks on the middle and inner plies of the L1 windshield, and the finely broken pieces of glasses were dropped on the floor of the cockpit.

[Photo 2] Damaged windshield (L1)

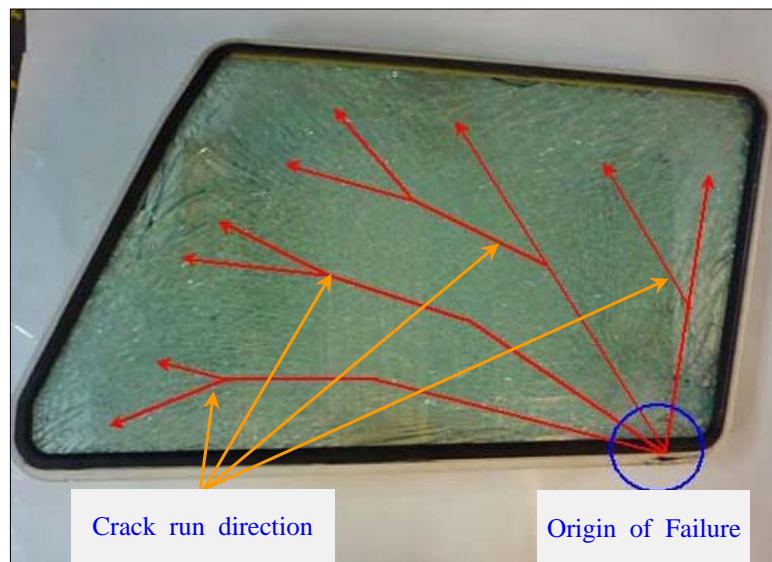
As shown in [Photo 3], the windshield crack ran from the inside bottom corner, and as shown in [Photo 4], the silicone pressure seal at the inside bottom corner was torn due to wear as it has been used for a long time, and it was found that there was electric arcing inside.

[Photo 3] windshield Crack pattern

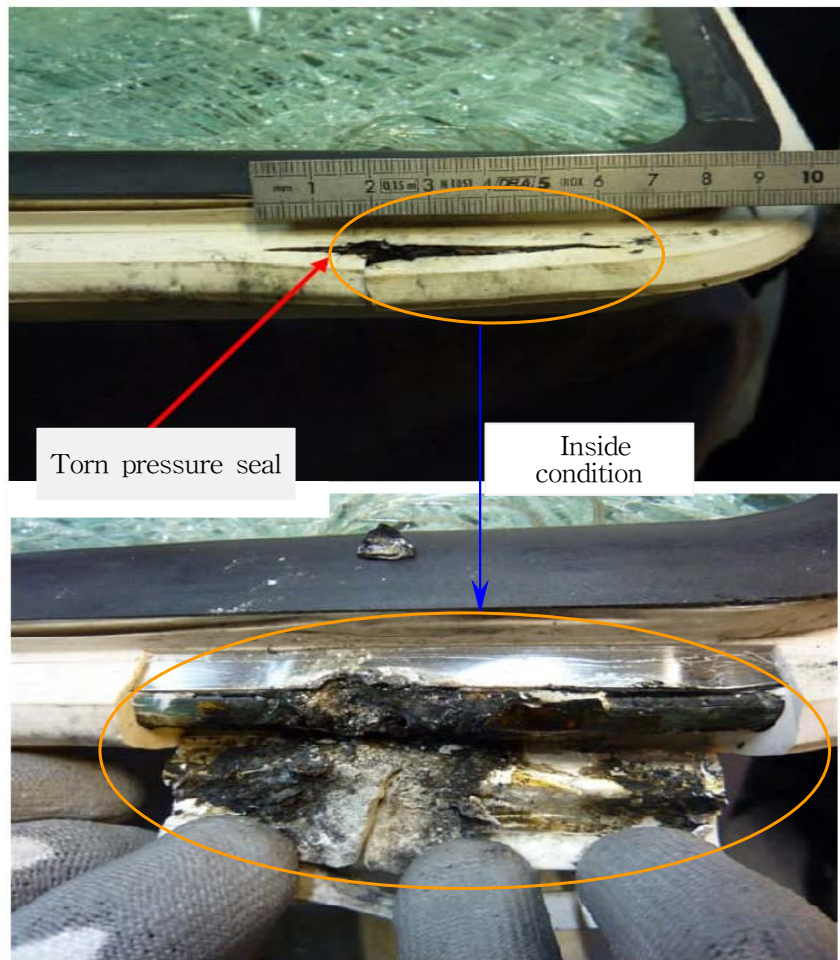
It was concluded that an arcing occurred due to double insulation failure²⁵⁾ between the braid wire and the metallic "Z" bar, and two structural plies have cracked due to a very high overheating in the vicinity of the lower braid wire of the heating system beneath the metallic "Z" bar.

[Photo 4] Location of the damaged silicone seal

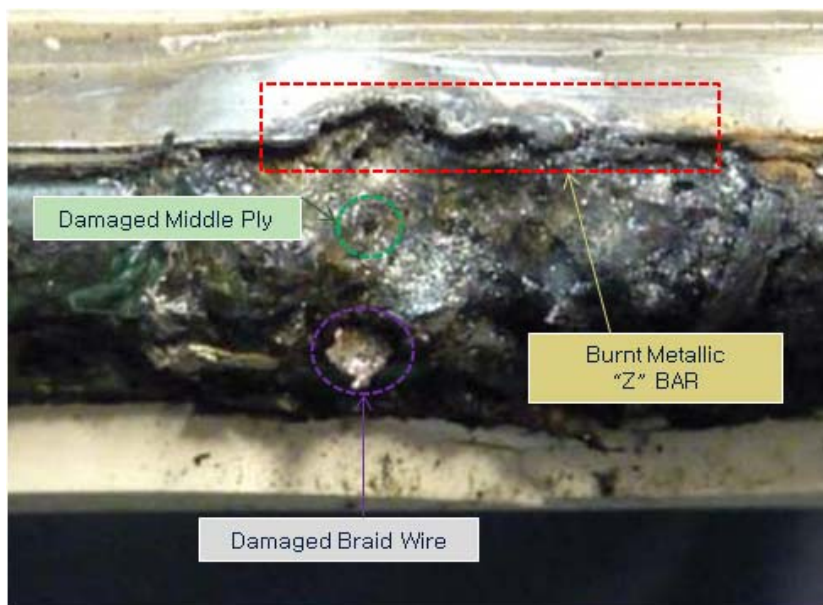
As shown in [Photo 5], the edge of the middle and inner structural plies has been strongly damaged (pieces of glass are missing) by a very high overheating, the metallic "Z" bar and the braid wire have been partially burnt in the vicinity of the overheating.

[Photo 5] Damaged part of the silicone seal

1. Provide operators with the information that 「If a windshield is used for a long period, the silicone pressure seal could be torn due to wear, an arcing could occur on the lower braid wire of the windshield heating system due to a double insulation failure, and eventually two structural plies of the windshield could crack due to a high overheating in the vicinity of the lower braid wire of the heating system.」 (AIR0908-1), and
2. In consideration of the point that it is not appropriate to fly with such a failure mode, take suitable measure(s) for the pre-mod windshields (SPSA340-2-4-1A) to be replaced with the windshields that such a problem has been resolved, as soon as practicable. (AIR0908-2)
