**Report No. ARAIB/AIR-1001**

# **AIRCRAFT SERIOUS INCIDENT REPORT**

**EMERGENCY USE OF OXYGEN BY THE FLIGHT CREW**

**A321-231, HL7730**

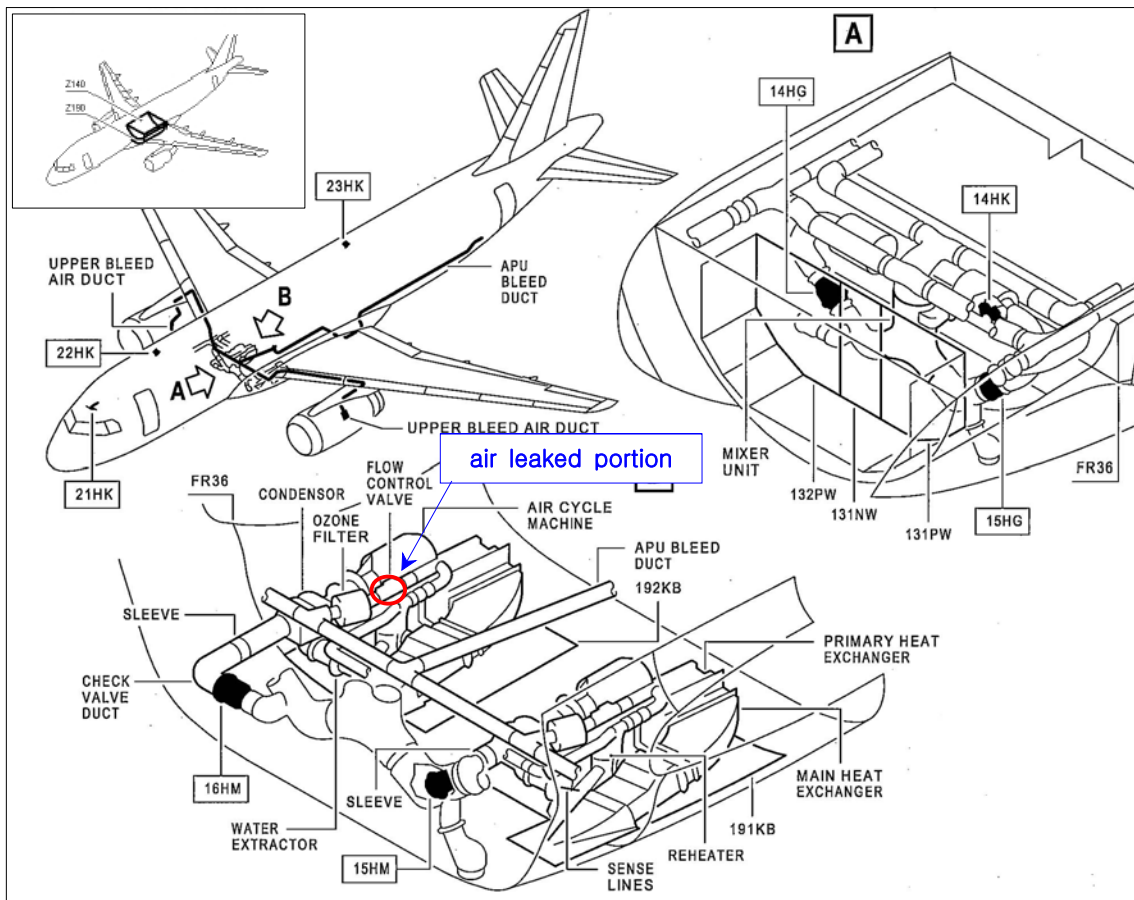
[Fig. 5] Portion where hot air leaked in the pack bay

As shown in [Fig. 5] and [Fig. 6], the left and right leak detection loops are located together in a pack bay made of one compartment. Because of this, if air leaked from either pack duct like this incident, depending on the direction, shape and flow of the air leakage, both leak detection loops could detect leak. But it was confirmed that the same case like this incident has never been reported to Airbus Company.

Because A320 series aircraft have both left and right air leak detection loops located in the pack bay made of one compartment, it is judged that if air leaked from the pack duct on either side, depending on the direction, shape and flow of the air leakage, the air leak detection loop on the other side could detect this.

Therefore, it is judged that in the HL7730, despite air leaked from the right pack valve, not only the right but also left air leak detection sensors detected this, so eventually both packs came to be in an inoperable situation.

1. It is required that the Airbus Industries, France, device a proper measure for improving the air leak detection system so that one of the bleed air leak detection loops does not detect the air leak of the other side pack duct like the case of this serious incident. (AIR1001-3)
2. Considering that the pack duct is located in a place to which access is somewhat difficult, it is required that Airbus Industries, France, specify it in the Maintenance Manual (36-22-00-790-051) that a proper tool, such as a specific tool or temperature sensor, etc, is to be used when checking on the pack air leak. (AIR1001-4)

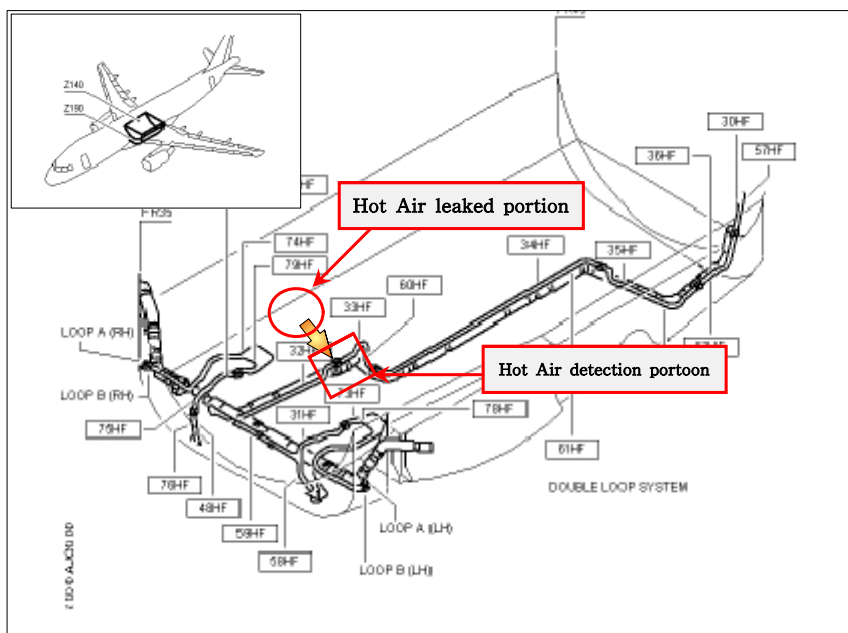
[Fig. 6] Air leak detection loop in the pack bay

In order to confirm whether the air leak detection loops of the left and right wings/fuselage are defective or not, the Asiana Airlines sent the measured values (See [Fig. 5] and [Table 1]) of impedance of these to Airbus Company, which confirmed there were no defect in the relevant air leak detection loops.

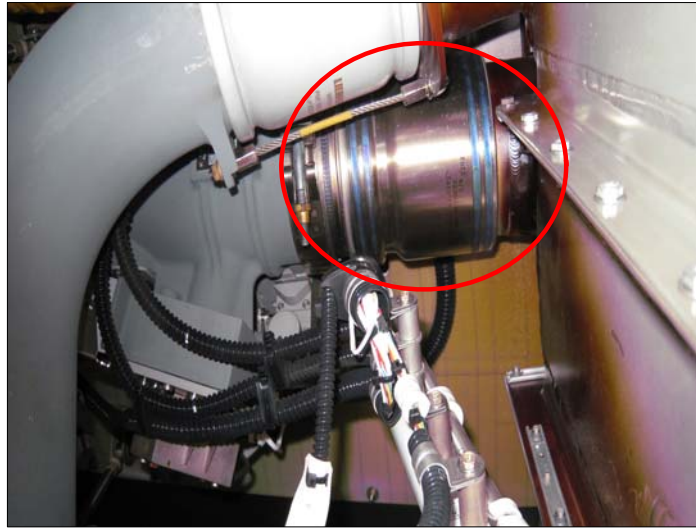
[Photo 1] Right pack valve duct

When the relevant parts were checked after landing, it was confirmed that hot air was actually leaking from the duct connecting the right pack valve and the primary heat exchanger as shown in [Photo 1].

If we put together the above data, actually hot air leaked through the damaged seal of right pack valve duct and the left air leak detection sensor detected this first, and then the right air leak detection sensor also detected this.

In the course of checking the defects after arriving at the Kansai International Airport, it was found that the seal of the right pack valve duct was pressed and torn, and this is judged that it was deformed as it had been used for a long period since installation as mentioned by Airbus Company in Service Bulletin (SB 21-1153).

1. It is required that the Asiana Airlines expedite to take action in accordance with the Service Bulletin (SB 21-1153) recommending to replace the existing seals with the new material seals. (AIR1001-1)

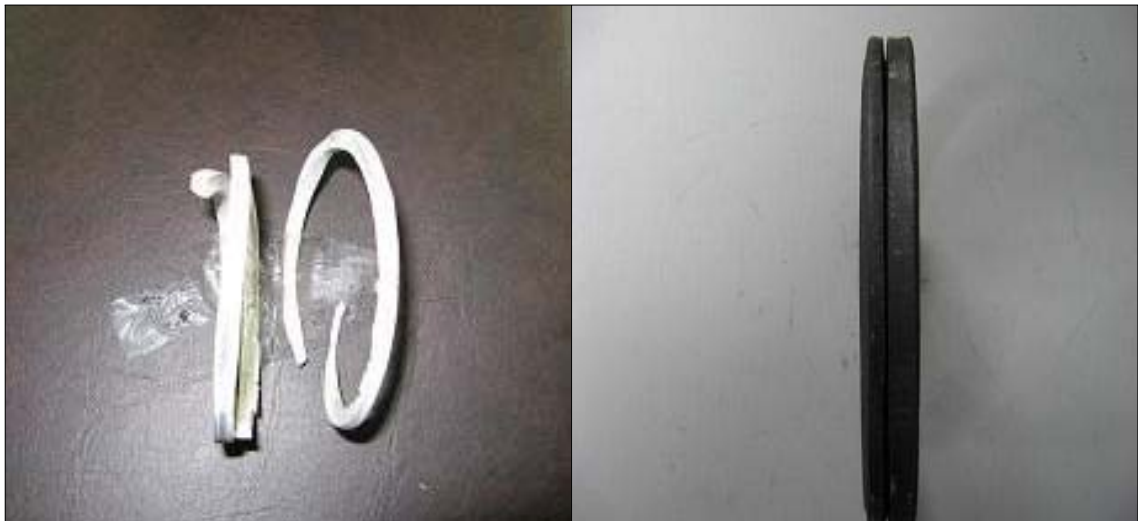
[Photo 2] Damaged Seal(Left)

The inside of this duct was checked to find that the seal of pack valve was pressed and torn as shown in [Photo 2]. But the air leak detection loops of the left and right wings/fuselage were good without any place pressed or torn.

Experience has shown that the present standard of pack seal, made of silicone, could lose their sealing qualities after some time in-service. This could lead to air leakages and subsequent equipment wear.
