# Aircraft Incident Report

One Engine Shutdown due to Overheat Warning  
Indication

CL-601, HL7577

Around 10:50, November 26, 2010

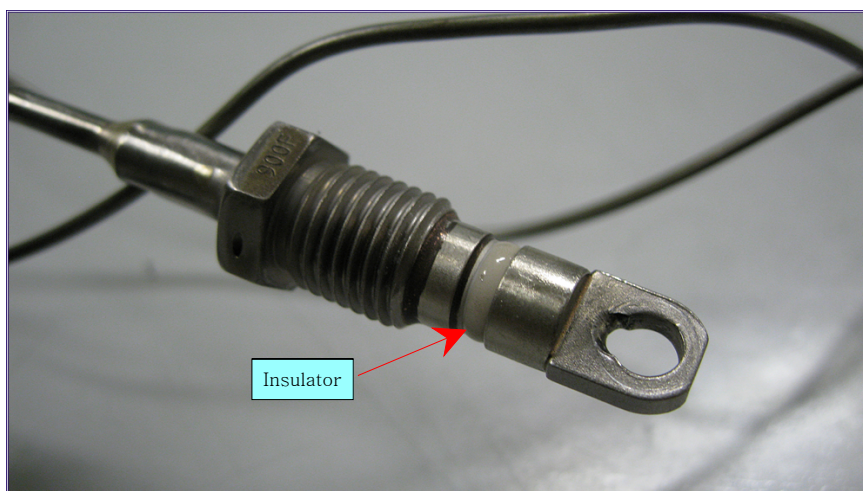
[Figure 1] Sensing Element Insulator

When actions<sup>10)</sup> taken in compliance with the Airworthiness Directive on November 25, 2010, a crack was found in the left engine's JET/PIPE sensing element insulator, and thus the sensing element was replaced. The insulator is a white part made of porcelain as shown in [Figure 1]. The sensing elements are not "repairable components" that can be repaired and recycled but "consumable parts."

When taking actions in compliance with the Airworthiness Directive on November 25, 2010, an aircraft mechanic found a crack in the left engine's JET/PIPE sensing element insulator and replaced a defective sensing element with a new one. On November 26 after the incident, the replaced sensing element was changed once again. The ARAIB sent the element removed to the manufacturer to carry out an inspection for the purpose of analyzing the cause.

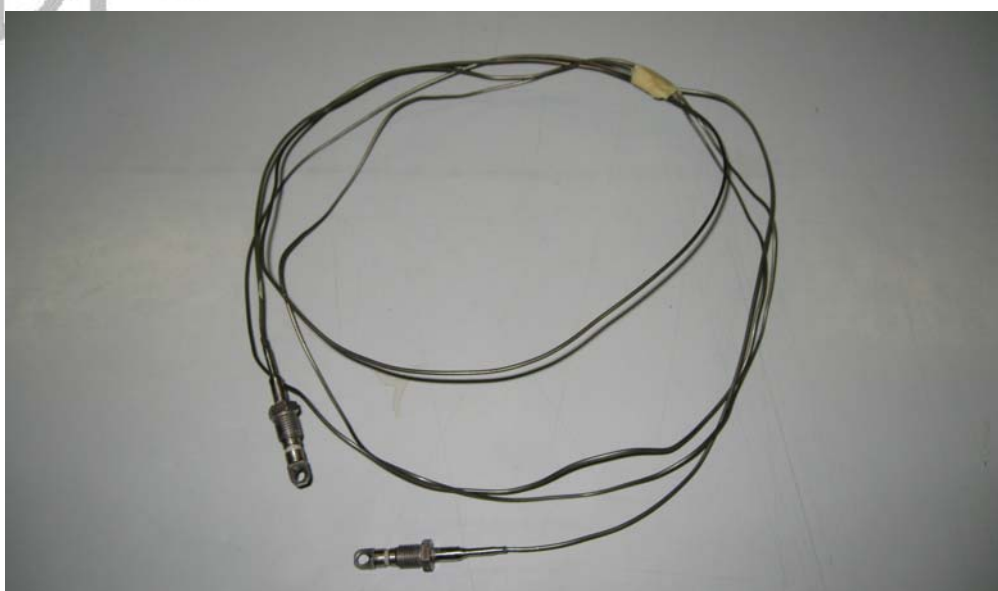
[Figure 2] JET/PIPE Sensing Element Removed

The part and serial numbers of the sensing element removed from HL7577 is 744-012047 and 103305, respectively.

The ARAIB entrusted the manufacturer with inspection of the defective sensing element. As a result, it verified that resistance values of the sensing element in the middle exceeded permitted limits.

The manufacturer conducted a resistance test on the sensing element, and the result of the resistance test by section showed that the resistance of some sections was higher than normal. Therefore, the manufacturer replaced it for free since it was still under warranty.

The cause of the malfunction was not verified whether it was a manufacturing fault or a mishandling fault, but the manufacturing fault is highly likely to have occurred in that the malfunction had occurred during the warranty period, and in that except for the resistance test by section, all the inspection results including visual inspection indicated no fault.

6. The resistance test on the removed sensing element by the manufacturer resulted in a fault indication that resistance values of the middle section were higher than normal, which caused the left engine's JET PIPE/PYLON OVHT light to come on.

1. Introduce a measure to enhance preventive maintenance, including a review of shortening the interval of a visual inspection of engine sensing elements (AIR1010-1).
2. Reconsider three Service Bulletins that were issued by the manufacturer to improve the fire detection system but not adopted by the company entrusted with maintenance, and then perform them unless special cause is shown (AIR1010-2).
