Aircraft Serious Incident Report

Runway Excursion during Landing Roll
Jade Cargo International Company Ltd., People's Republic of China
B747-400F
B2440
Incheon International Airport, Republic of Korea
16 April 2009

8 June 2010

Aviation and Railway Accident Investigation Board
Ministry of Land, Transport and Maritime Affairs
Republic of Korea

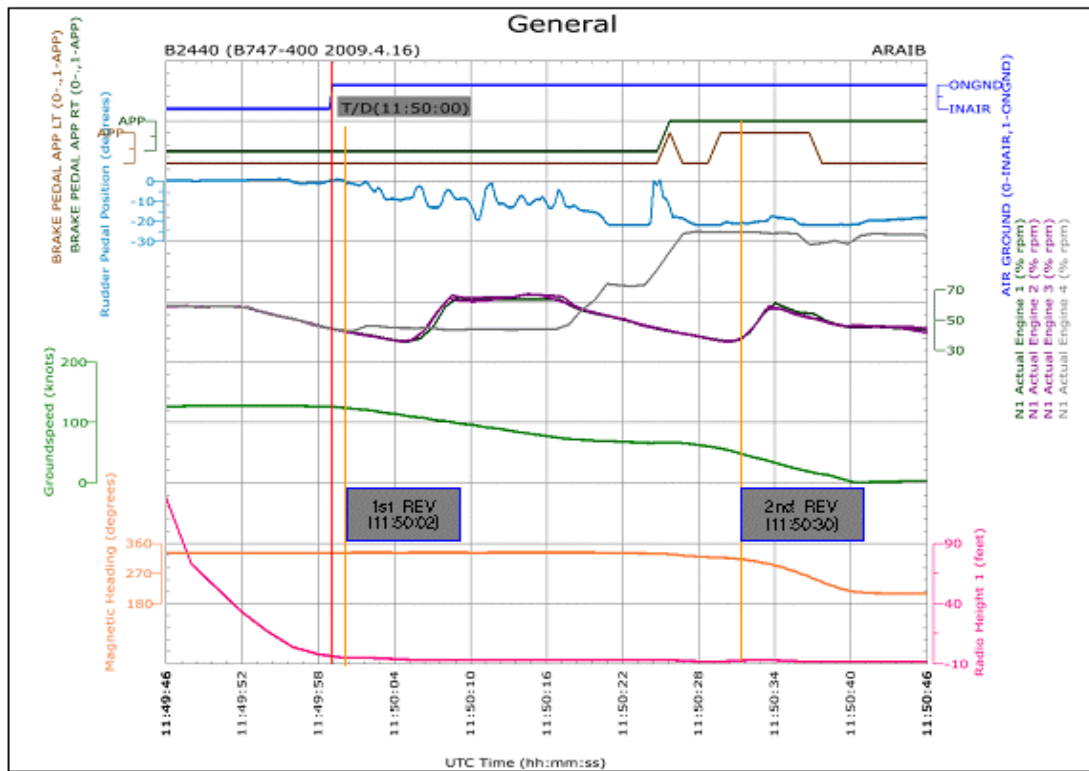
[Fig. 10] Major parameter data

Looking at the engine N1 in [Fig. 10], it shows the reverse thrusts of the No. 1, 2 and 3 engines were used 2 times, but the reverse thrust of the No. 4 engine was not used. And while the No. 4 forward thrust lever raised to the maximum thrust position, the reverse thrusts of the No. 1, 2 and 3 engines were used for the second time. Even when the aircraft stopped completely, the N1 of the No. 4 engine was indicating maximum thrust.

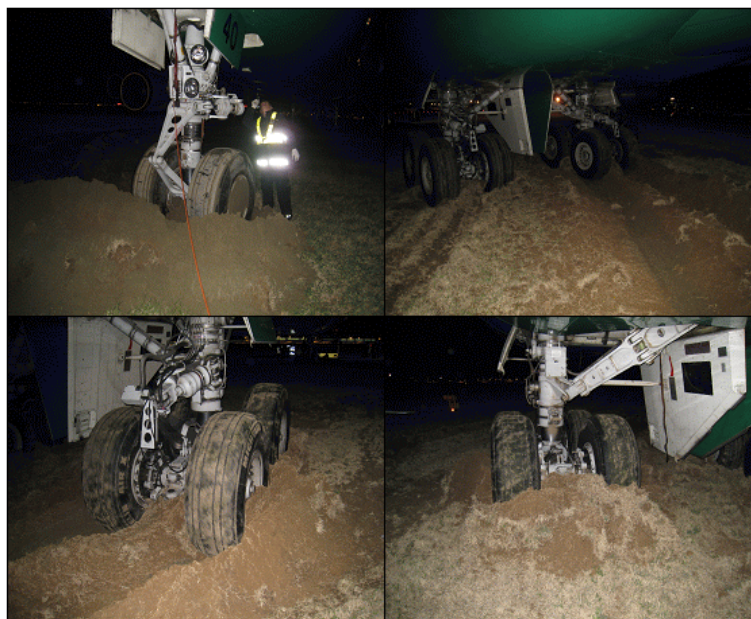
[Photo 4] After runway excursion

B2440 made excursion to the left of the runway hitting the 6,000 feet runway distance marker sign, and as shown in [photo 4], stopped near about 2,170 m from the runway 33R threshold.

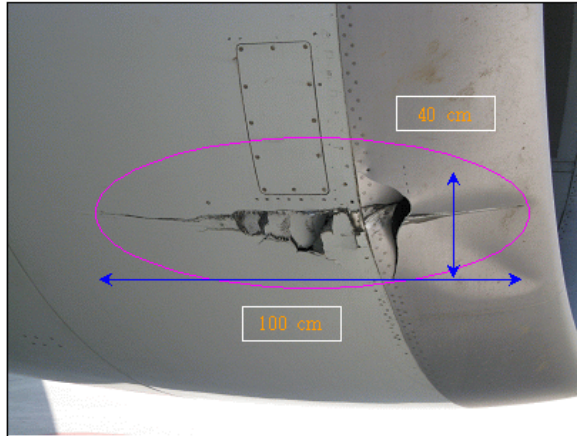
[Photo 5] Damaged No. 2 engine cowl

As shown in [Fig. 5], when the aircraft ran off the runway, the No. 2 engine cowl hit the runway distance marker sign to cause a damage of 100 x 40 cm to the engine cowl. All four engines ingested foreign objects (blades of grass and soil, etc), and two nose tires suffered minor cuts.

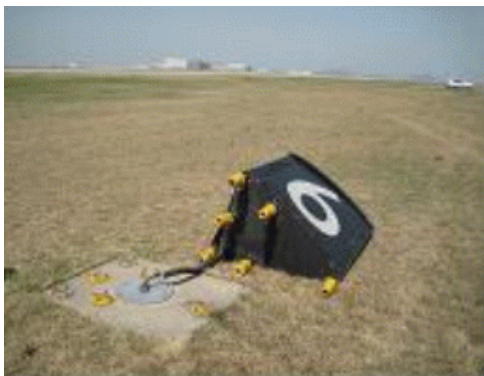
[Photo 6] Runway distance marker sign damaged

As B2440 ran off the runway, it hit one runway distance marker sign and one runway edge light to break as shown in [Photo 6] and [Photo 7], and as shown in [Photo 8] and [Photo 9], due to the tires and engine blast, the grass area was damaged and one stop sign was broken.

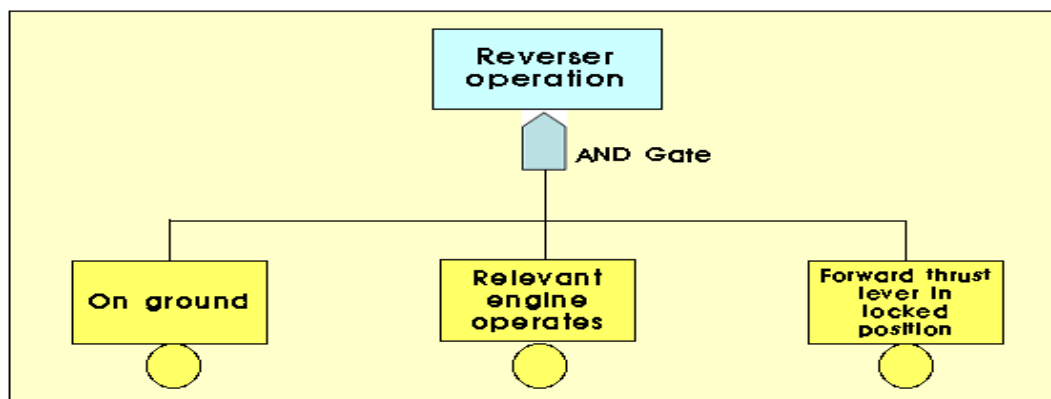
[Fig. 13] Reverser operation condition

As shown in [Fig. 13], the reverse thrust lever can be raised only when the aircraft is on the ground and when the relevant engine is operating and when the forward thrust lever is in the closed position. The forward thrust lever angle shall not be in the position exceeding 36.88° to raise the respective reverse thrust lever.

But because the angle of the No. 4 thrust lever moved from 35° to 43.8° when the reversers started to deploy, the No. 4 reverse thrust lever was not able to be raised. Therefore the statement of the captain that “I tried to raise the No. 4 reverse thrust lever several times but it was not able to be raised” is admitted.

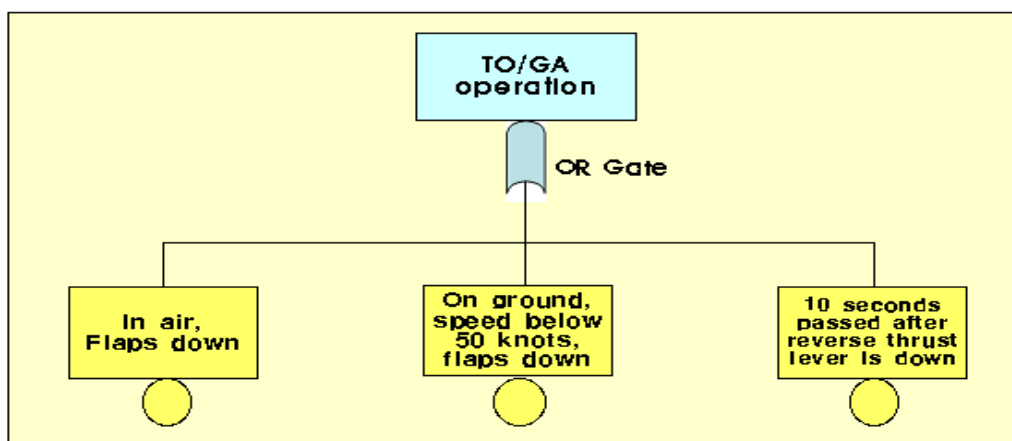
[Fig. 14] Conditions for TO/GA operation

As shown in [Fig. 14], the TO/GA switch operates⁴⁸⁾ when the aircraft is in the air and flaps are out of up position, or the speed is below 50 knots with the flaps down on the ground, or 10 seconds have passed after the reverse thrust lever is down.
