Report NO. ARAIB/AIR-F0801

# Aircraft Serious Incident Report

Runway excursion during landing

A340-300

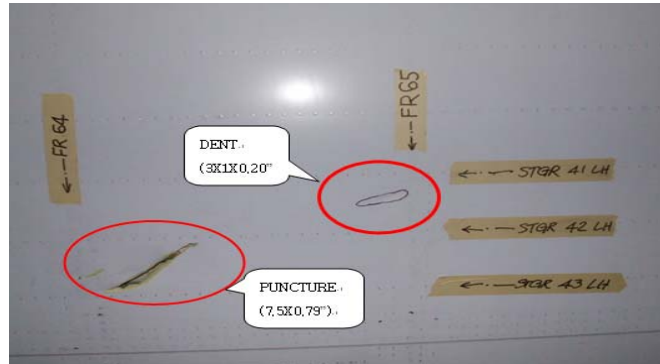
As shown in Photo 1 below, the lower left surface of aft fuselage (between stringer

number 42LH~43LH and frame number 64~65) was punctured (7.5 X 0.79") and the bottom left surface of aft fuselage (between stringer number 41LH~42LH, frame number 64~65) was dented (3 X 1 X 0.20").

[Photo 1] Damage to bottom left of aft fuselage

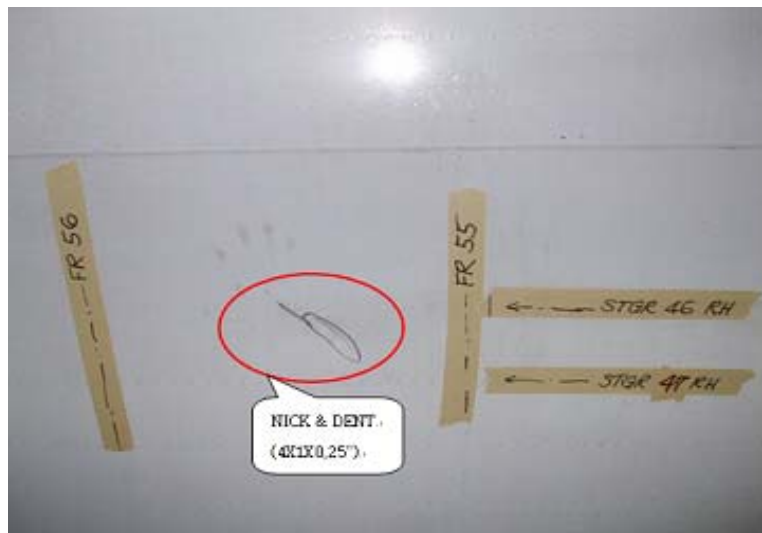
As shown in Photo 2 below, the bottom right surface of aft fuselage (between stringer number 41RH~42RH, frame number 64~65) was nicked and dented (4 X 1 X 0.25").

[Photo 2] Damage to lower right surface of aft fuselage

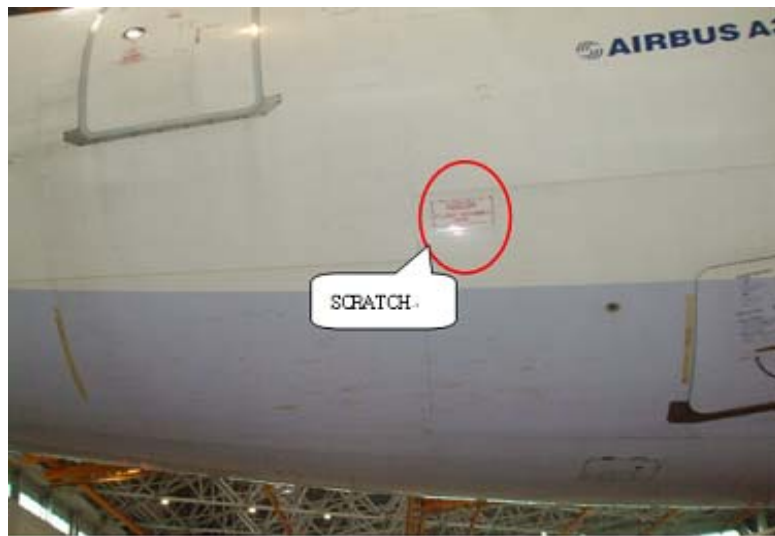
As shown in Photos 3-1 and 3-2 below, the lower right surface of aft fuselage and below the passenger door (stringer number 37RH~48RH, frame number 69~76) were

scratched in many places.

[Photo 3-1] Damage to lower right surface of fuselage in the rear

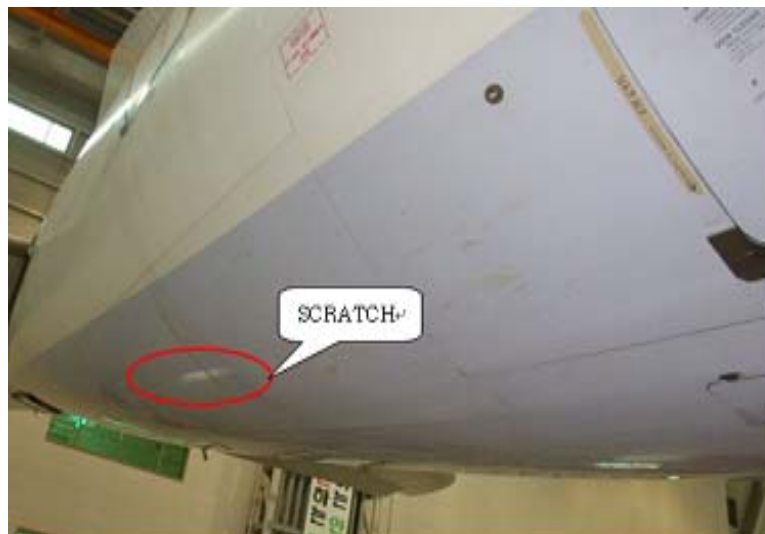
[Photo 3-2] Damage to lower right surface of aft fuselage

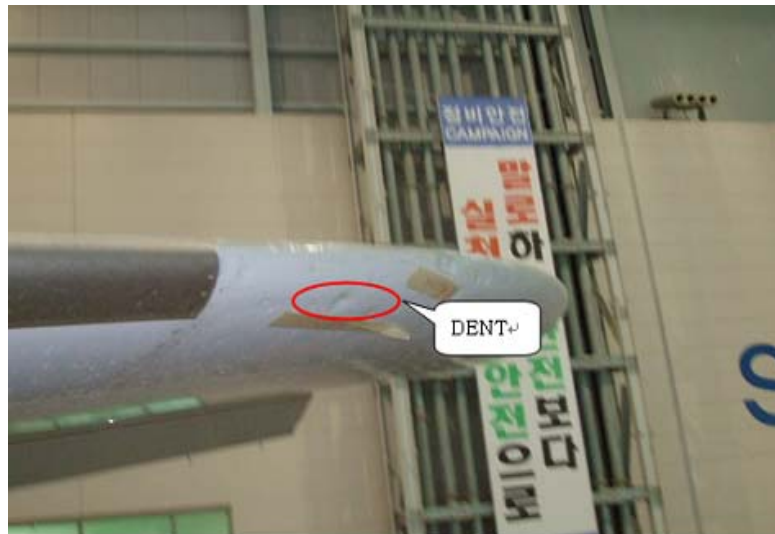
As shown in Photos 4 and 5 below, the left horizontal stabilizer tip portion was dented in many places and the front side was punctured.

[Photo 4] Damage to horizontal stabilizer 1

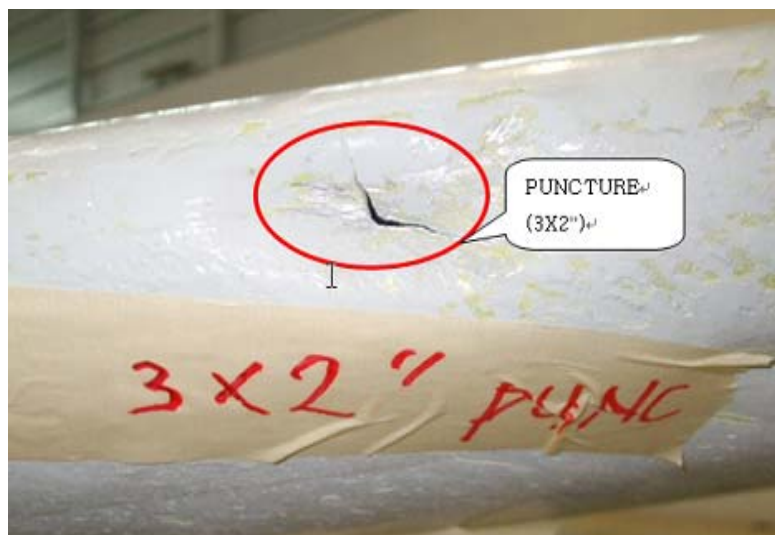
[Photo 5] Damage to horizontal stabilizer 2

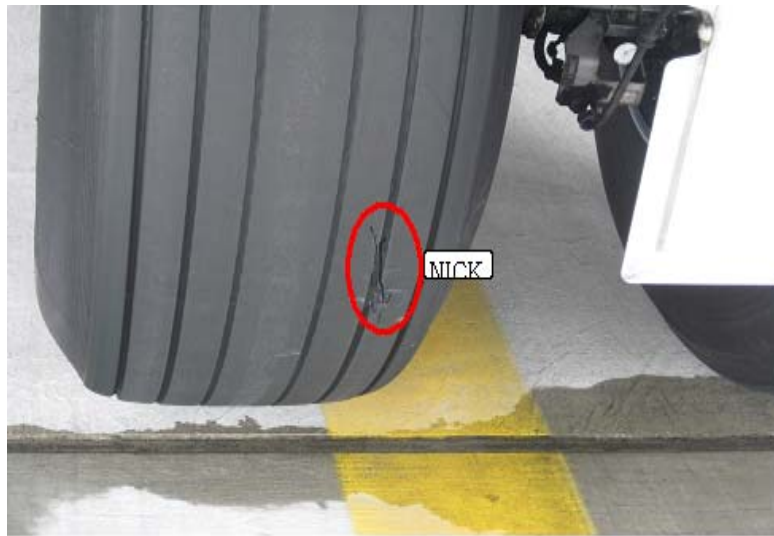
As shown in Photo 6 below, #1 tire of the left main landing gear was nicked.

[Photo 6] #1 tire nicked

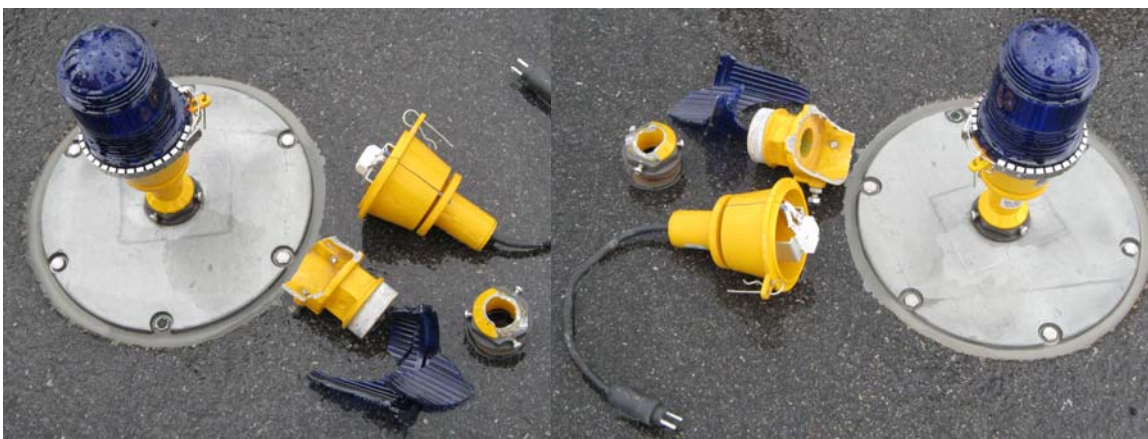
Two taxiway lights<sup>9)</sup> located on both sides of Taxiway "T", one taxiway guidance sign<sup>10)</sup>, and one "10/3" runway distance marker sign<sup>11)</sup> were broken by contact with the landing gear and airframe of Flight 160 as shown in Photo 7 and Photo 8.

[Photo 7] Taxiway lights damaged and restored to normal condition

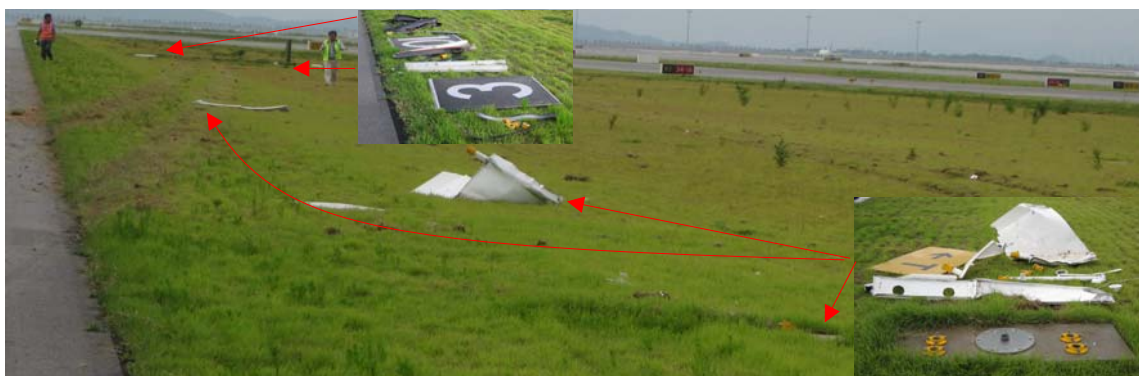
[Photo 8] Runway distance marker sign damaged

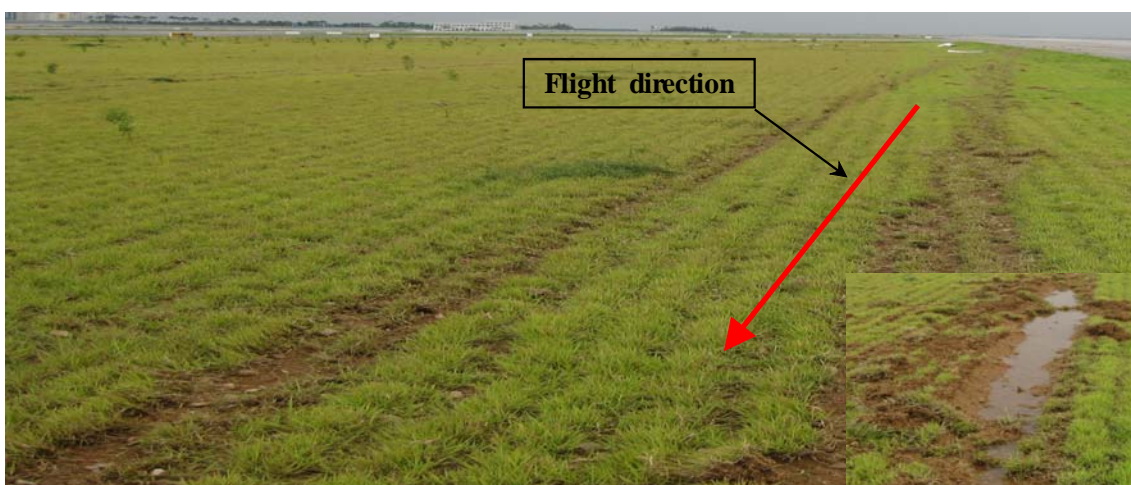
The landing strip between taxiways "T" and "N2" was damaged by the landing gear of Flight 160, about 400 meters long, 18 centimeters deep at most, and 80 centimeters wide at most as shown in Photo 9.

[Photo 9] Landing strip damaged

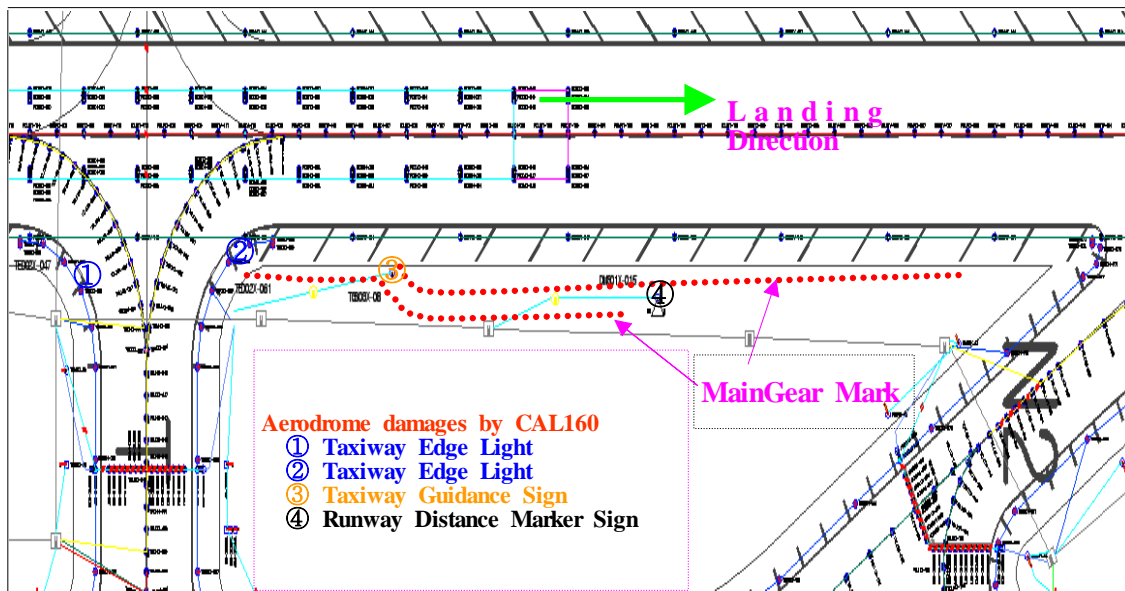
[Fig. 13] Situation map of runway excursion

According to the records of the ASDE (Airport Surface Detection Equipment) and the results of investigation of the trace, the circumstances of runway excursion as shown roughly in Figure 13.
