**Report No. ARAIB/AIR-0910**

# **Aircraft Serious Incident Report**

**Emergency Landing due to Engine Shut-down in Flight  
Asiana Airlines**

**B777-200, HL7500**

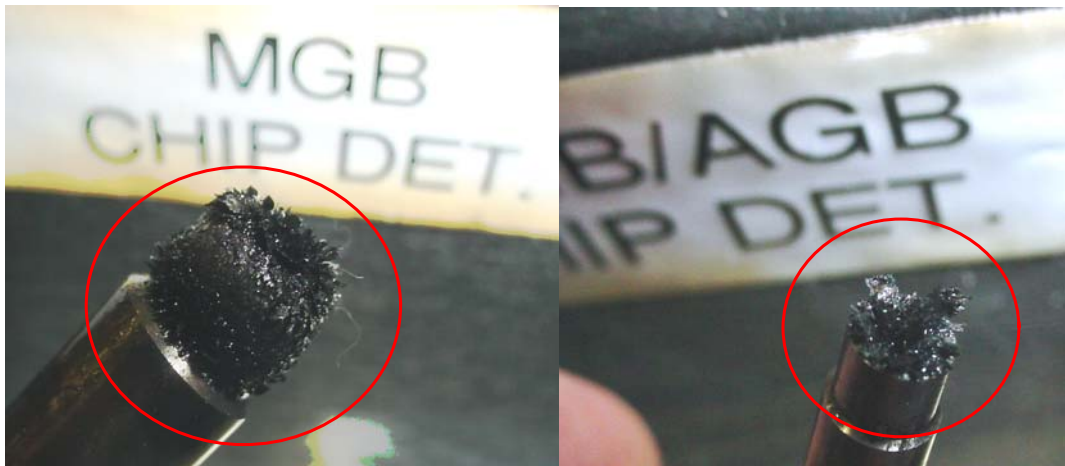
On-ground check showed no abnormalities at the inlet port and the exhaust port of the left engine and the fan blade, but a large quantity of metal chip was detected from the master and angle gearbox chips in the process of checking the magnetic chip detector (MCD) of the main gearbox.

The engine had no external damage, and the metal chip detector of engine gearbox was demounted to check and a large quantity of metal chip was found as shown in Photo 1.

[Photo 1] Metal chip found in the main gearbox and angle gearbox.

We consulted with Boeing Company for revision of the maintenance manual so that the master chip detector is checked every 150 hours according to the Service Bulletin (PW4G-112-79-29) and Maintenance Manual (AMM 79 -22 -00 -200 -802 -N00).

The metal contained in the oil system is to be stuck to the magnet portion of the master chip detector primarily, but if it is stuck together with oil of dark color an error can be made in reading it, so Boeing Company additionally specified in the maintenance manual on May 5, 2010 a technical method of removing the oil smeared to the chip by using alcohol or absorbing it into cloth.

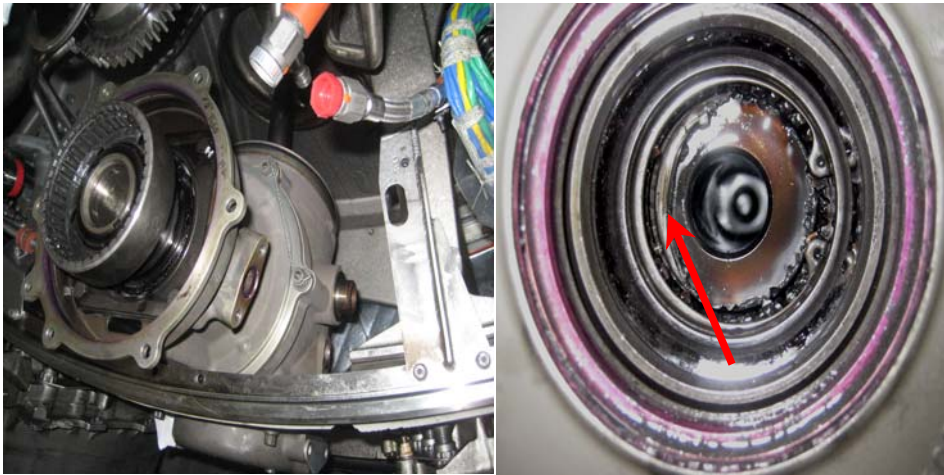
The external check on the gearboxes confirmed that the engine stopped in flight because the towershaft in the angle gearbox was separated to shut down the power of the main gearbox so that the engine accessories could not operate as shown in Photo 2.

[Photo 2] Damage to angle gearbox towershaft

The crumbling of the towershaft bottom splines in the engine angle gearbox caused the power to the main gearbox to shut off, which caused the accessory parts that drive the engine to lose their proper functions, so that the engine was shut down.

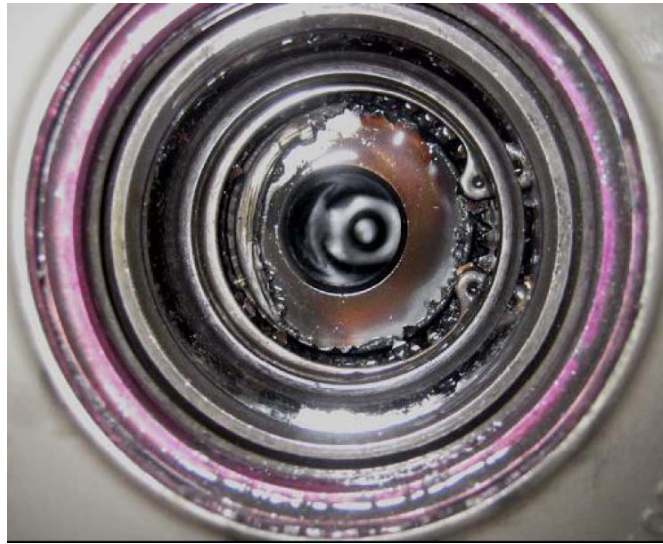
As shown in Photo 3, the towershaft bottom splines had severe rotational damage to make metal crumble.

[Photo 3] Damage to towershaft bottom splines

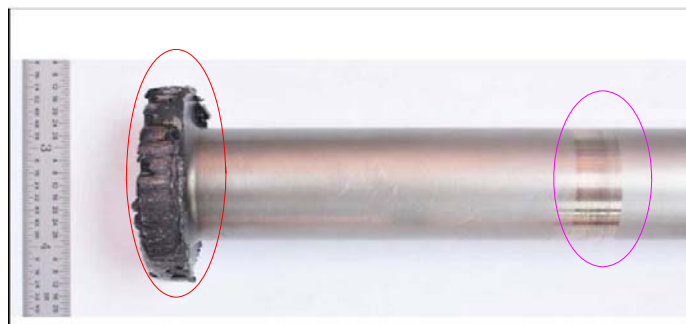
As shown in Photo 4 and Photo 5, the towershaft shank had rotational damage by contact with the loosened retaining nut of AB-1 bearing.

[Photo 4] Damage to towershaft

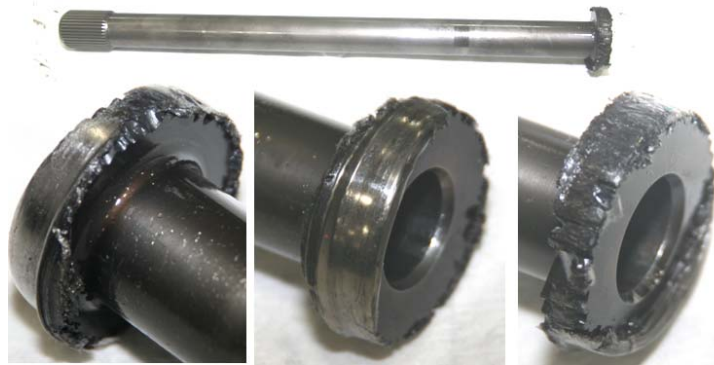
[Photo 5] Damage to towershaft splines

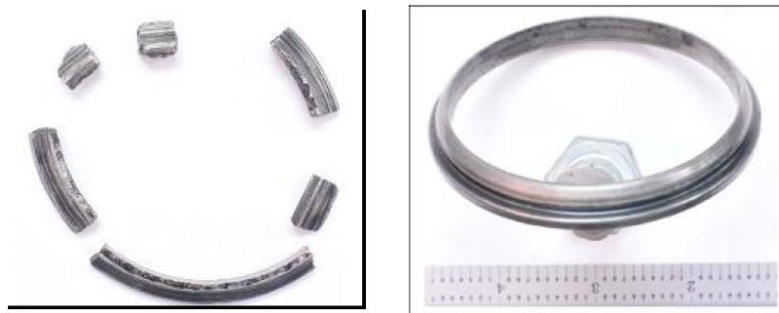
As shown in Photo 6, the AB-1 bearing bottom inner race was broken into six pieces, the top inner race was abraded by friction with the ball bearing.

[Photo 6] Damage to AB-1 bearing inner race

An excessive heat was produced by friction force generated by rotation as the retaining nut was loosened and the inner race and bearing cage were separated.

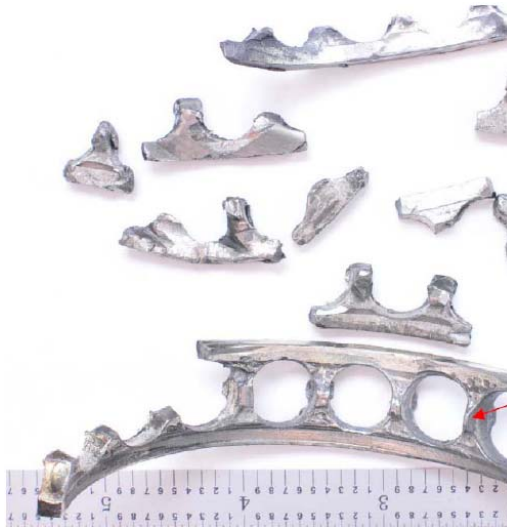
As shown in Photo 7, the cage was damaged to crumble, and part of it was fused with the ball bearing.

[Photo 7] Damage to ball bearing cage

The temperatures of both the bearing and cage reached almost the fusion point, so that two metals were fused, and irregular rotation continued in softened condition to make the size of bearing smaller.

The metal fragments of the damaged retaining lock washer damaged the bearing cage and the successive secondary damage is judged to have compounded the damage.

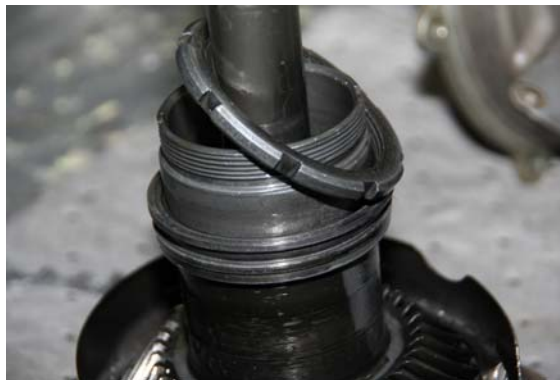
As shown in Photo 8 and Photo 9, the AB-1 ball bearing inner race retaining nut lock washer was damaged and separated, and the retaining nut was loosened from the screw thread of the angle gearbox bevel gear.

[Photo 8] Loosened AB-1 bearing inner race retaining nut

The AB-1 bearing retaining lock washer in the angle gearbox was damaged initially by a factor with unknowable cause, and it is judged that the metal fragments got jammed between bearing balls that were rotating at high velocity to cause resistance to loosen the retaining nut.

1. Add to the maintenance manual the contents about the method of using the angle gearbox retaining nut lock washer and the limit to the number of use. (AIR0910-1)
2. Revise maintenance manual to check the master chip detector periodically(every 150 hours) for the relevant engine angle gearbox. (AIR0910-2) - Already carried out.

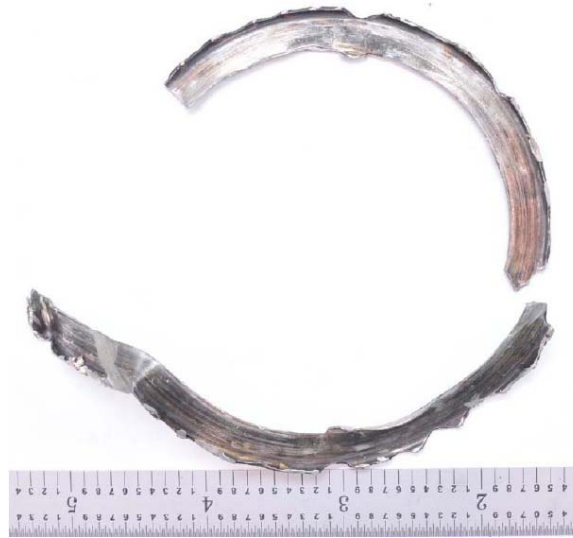
[Photo 9] Damaged retaining nut lock washer

The manufacturer reviewed the history of the bearing retaining lock washer (P/N:449185) to find no problems, but they decided to revise the future maintenance manual to limit the number of usage of lock washer and add a specific service method about the use of the tool.

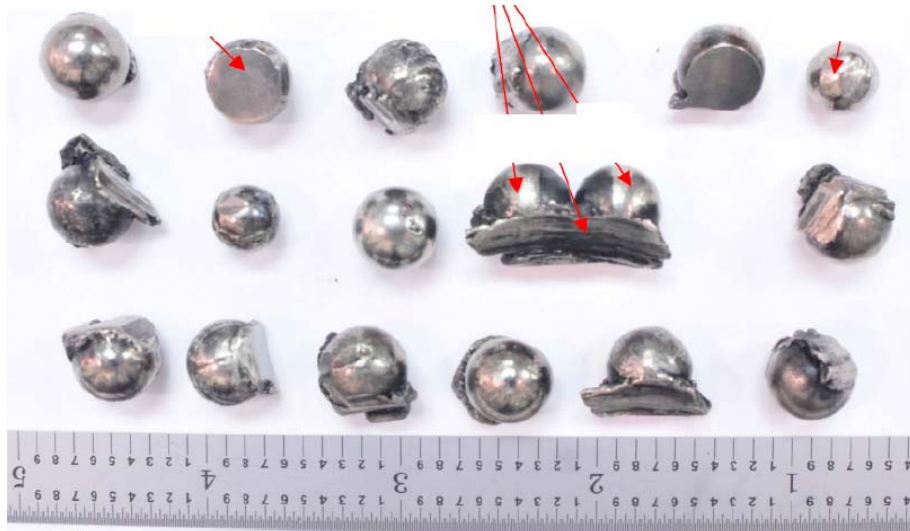
As shown in Photo 10, 18 AB-1 bearing balls in all were found with the damaged shape different each other. Especially two balls had its size reduced significantly smaller than other balls. Some of the balls were fused with the cage and bearing race metal.

[Photo 10] Damaged bearing balls

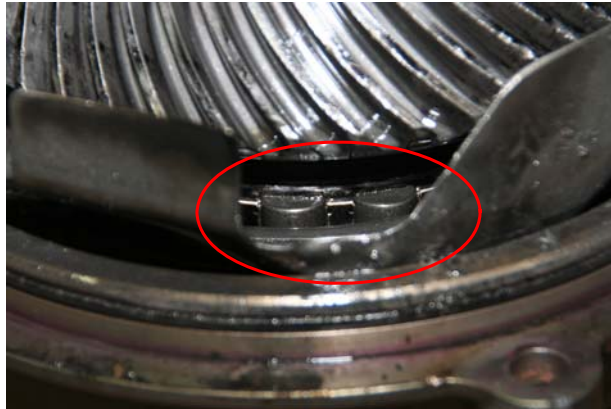
As shown in Photo 11, there was no damage to the AB-2 roller bearings, but there were scratches by AB-1 ball bearing wreckage on the surface of both ends of some bearings.

[Photo 11] AB-2 roller bearing

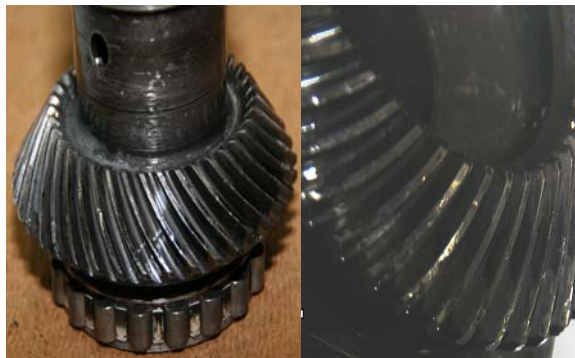
As shown in Photo 2, the angle gearbox bevel gear was nicked or pressed by metal.

[Photo 12] Damage to bevel gear
