AIRCRAFT SERIOUS INCIDENT REPORT

ENGINE IN-FLIGHT SHUTDOWN

B737-800, HL7786

3 SEPTEMBER 2010

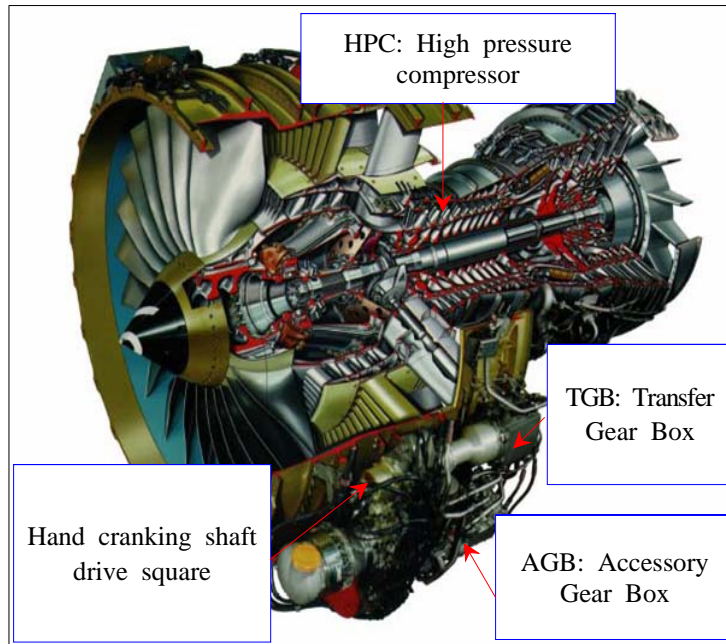
[Fig. 1] Illustration of CFM56-7 engine

As shown in [Fig. 1] and [Fig. 2], the No. 4 line of the accessory gear box of number 1 engine (hereinafter referred to as "AGB") was broken, and due to this the number 1 engine was shut down.

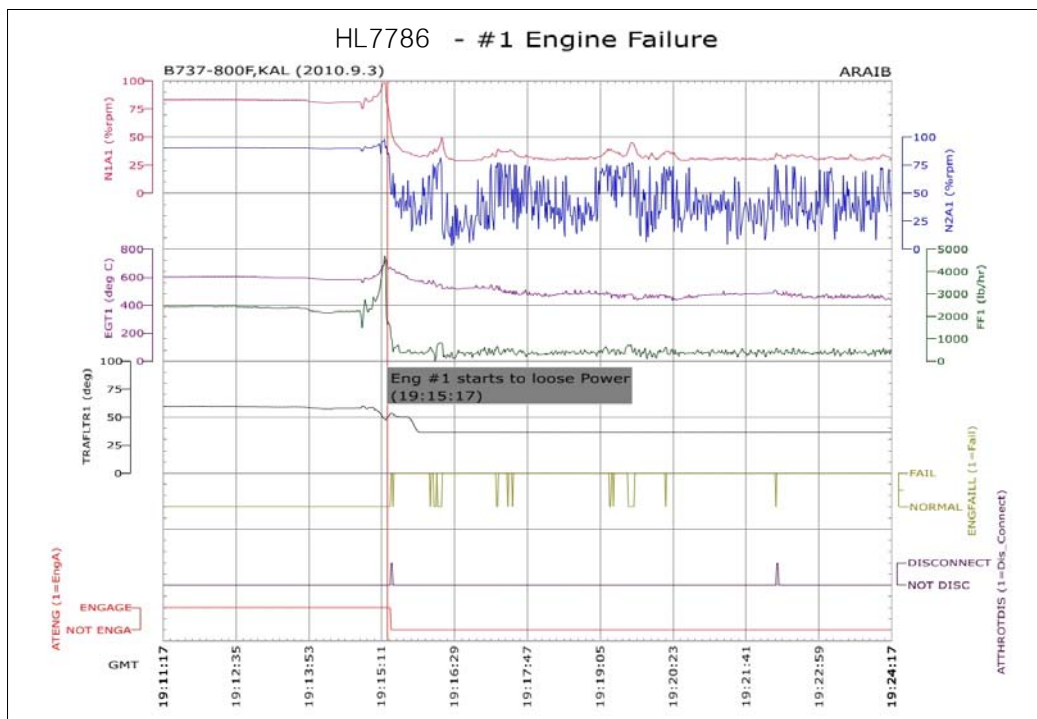
[Fig. 3] FDR major parameters

Referring to the major engine parameters in [Fig. 3] ~ [Fig. 6], we can see that the engine parameters started to fluctuate as engine abnormalities were indicated at 04:14:49, and N1 dropped abruptly from 04:15:17 and the "FAIL" message was displayed at 04:15:21 and the auto throttle was disconnected.

At 04:15:43 "WINDMILL" started and at 04:15:51 the thrust lever was reduced to the idle position, and at 04:24:43 fuel supply to engine was completely cut off.

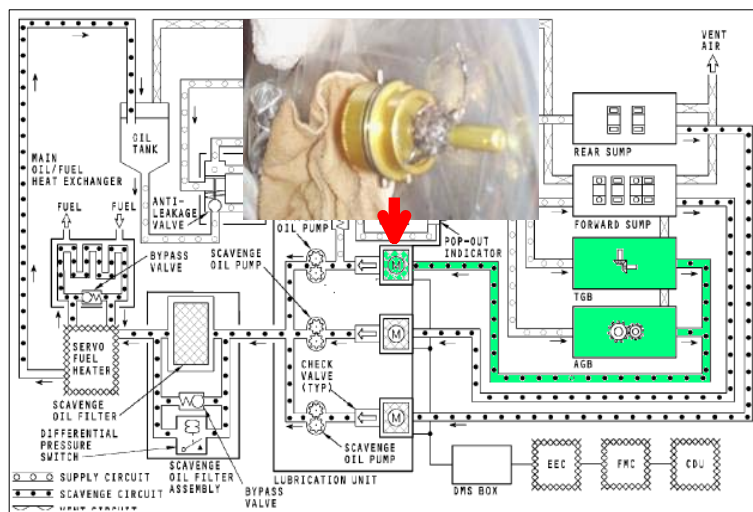
[Fig. 7] CF56-7B engine lubrication system diagram

In the inspection conducted after the emergency landing at Beijing Capital International Airport was completed, a large quantity of metal chips were discovered in the Magnetic Chip Detector (MCD) that detects metal chips coming out from the oil of the gear box as shown in [Fig. 7].

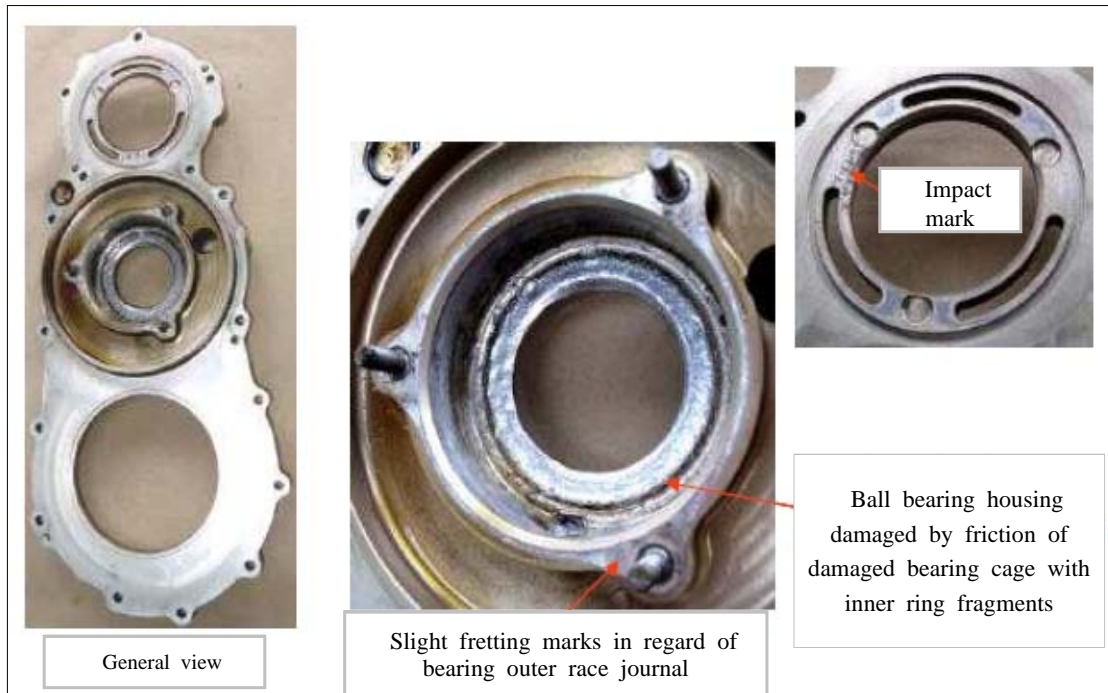
[Photo 2] Starter Pad view

As shown in [Photo 2], the cavity in regard of line 4 ball bearing housing was severely worn down by metallic impacts-rubs related to the fragmentation of both the cage and the inner ring. And line 4 ball bearing outer race journal superficially worn by fretting especially in front of the line securing lugs.

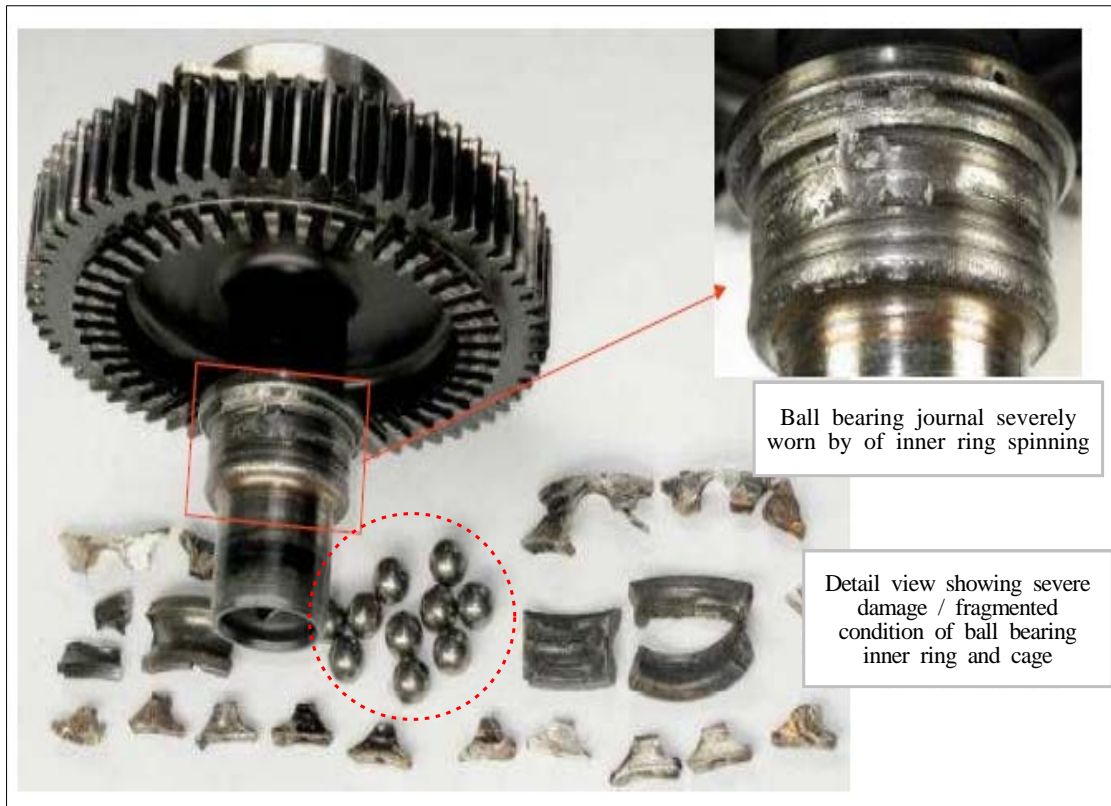
[Photo 3] Gear shaft of No. 4 line

As shown in [Photo 3], the ball bearing journal was worn down deeply by spinning of the inner ring prior to it separated in multiple fragments. The ball bearing was damaged severely and the inner ring and cage of ball bearing were broken into many pieces. The tooth active and non-active flanks severely worn / spalled due to gear shaft misalignment resulting from ball bearing damaging.

All 10 (ten) balls received exhibiting quite same superficial wear condition along with some isolated spalling craters. The residual diameters²³⁾ were 11.9 mm ~ 12.7 mm. However, heat discoloration which could be due to a lubrication was not found.

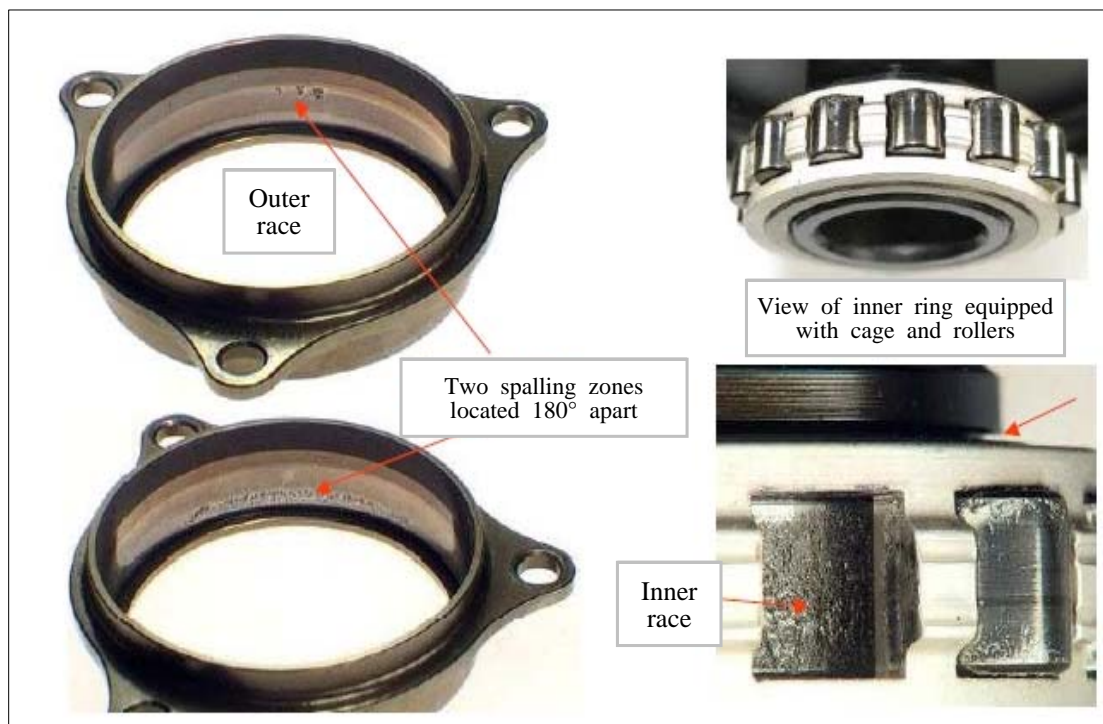
[Photo 4] Roller bearing

As shown in [Photo 4], the outer race way was affected by 2 spalling zones respectively located 180° apart with larger spalling sector close to retaining shoulder and the other one at roller track opposite end. The rollers also were affected by spalling craters mainly developed at each ends of the rolling land.

Inner raceway was exhibits 360° general spalling consistent with the amount of particles trapped on the MCD. Such bearing damaging was indicative of misalignment problem also related to the gear shaft offset resulting from ball bearing damaging.

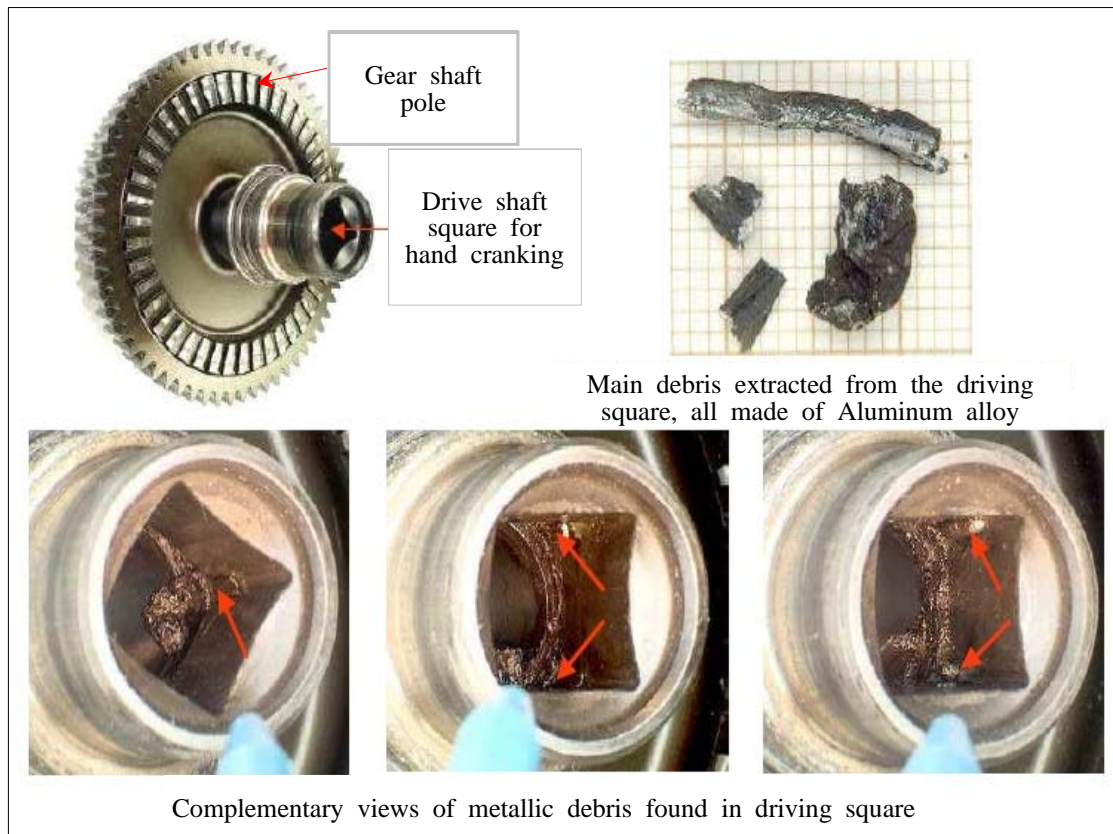
[Photo 5] Gear shaft square view

As shown in [Photo 5], Phonic wheel tooth tip also was worn by interference with N2 sensor as a consequence of gear shaft misalignment. Driving square cavity was contaminated by the metallic debris literally crushed at each square inner comers and all identified as made of aluminum alloy (AU2GN)²⁴.

By putting together the results of manufacturer's examination into the damaged parts, it was found that the metal debris were in the hand crank drive shaft square, and it is presumed that the brinelling marks were induced on the ball bearing outer race of accessory gear box (AGB) line 4 line because the inspector applied an axial load to accurately engage the tool for a borescope inspection.

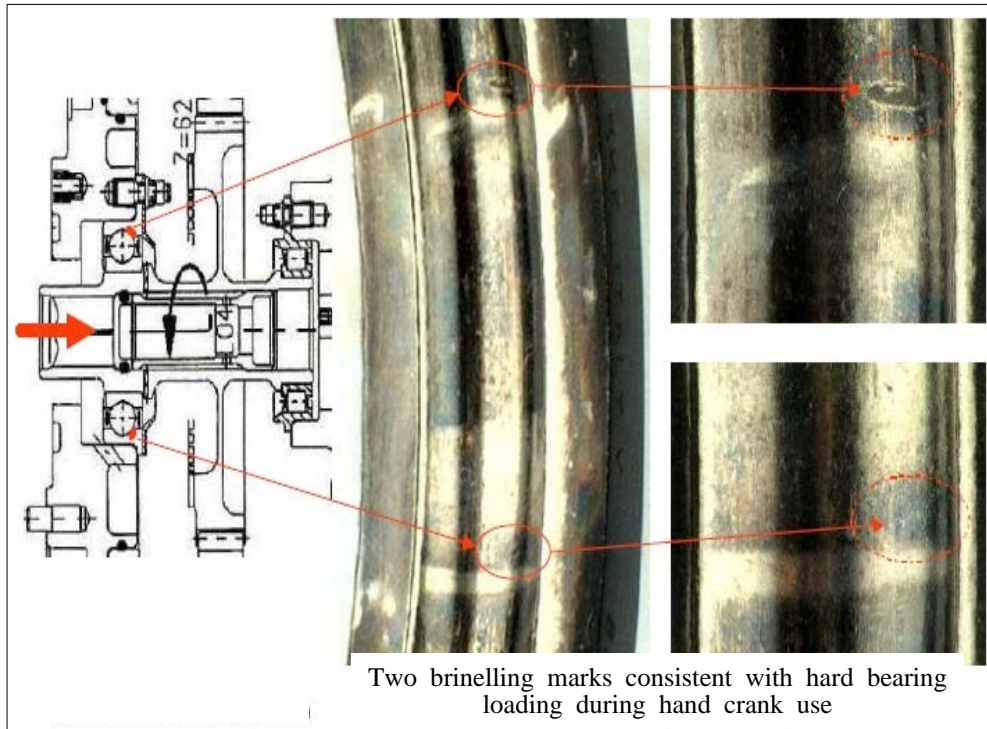
[Photo 6] Ball bearing outer race

of outer race way. The brinelling marks were induced by axial overload applied through the gear queue to force the inner wrench to enter the gear shaft square cavity.

The ball bearing was damaged severely by friction with the brinelling marks on the outer race while it was spinning at high speed, and by this damaged ball bearing, the inner ring and cage of ball bearing were broken into many pieces.
