# AIRCRAFT SERIOUS INCIDENT REPORT

**MULTI TIRE DISINTEGRATION DURING TAKEOFF ROLL**

**B747-300SF, N749SA**

**INCHEON INTERNATIONAL AIRPORT**

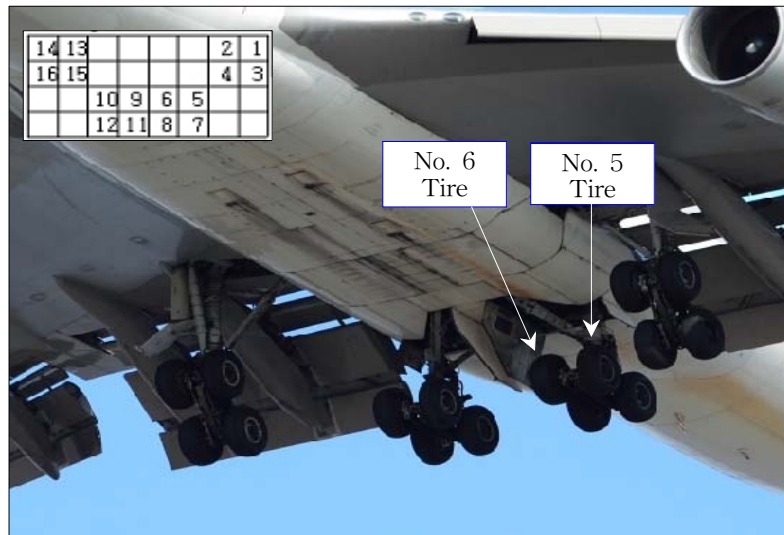
At about 23:22, when the airspeed passed about 150 knots during the takeoff roll, two of the left main body gear tires blew out and the flight crew felt the aircraft shaking up and down severely. The captain decided to reject the takeoff right away, and taking over the control, reduced the thrust levers to idle position at 159.6 knots, and slowed the airspeed by using maximum manual brake and reverse thrust.

[Fig. 2] positions of the damaged two tires

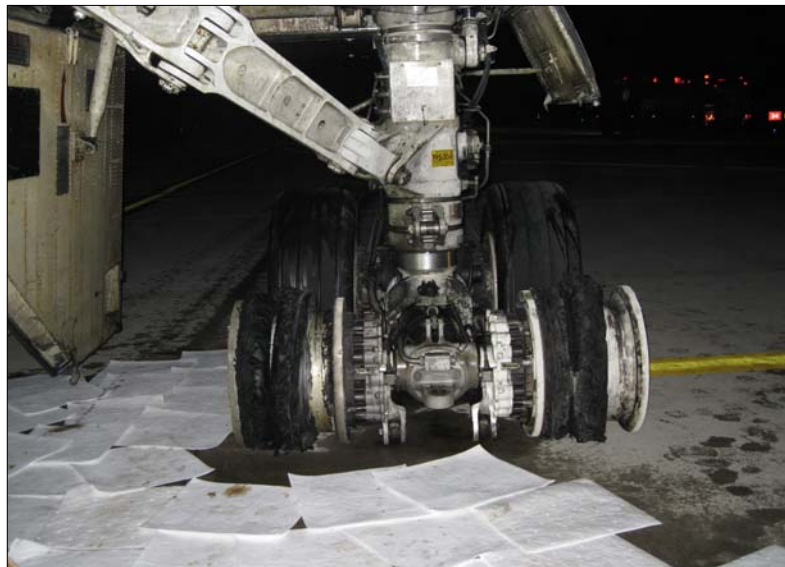
The Flight 720 Freighter had the forward two tires (number 5 and 6) of the left main body gear failed as shown in [Photo 1], and the left wheel well door was damaged by the collision with the damaged tire fragments, and number 1 hydraulic return line was cut out, and the number 5 and 6 wheels were abraded by friction with the runway. And the thermal Fuses of the wheels were activated so pressure leaked out from 12 tires.

[Photo 1] Damaged number 5 and 6 tires

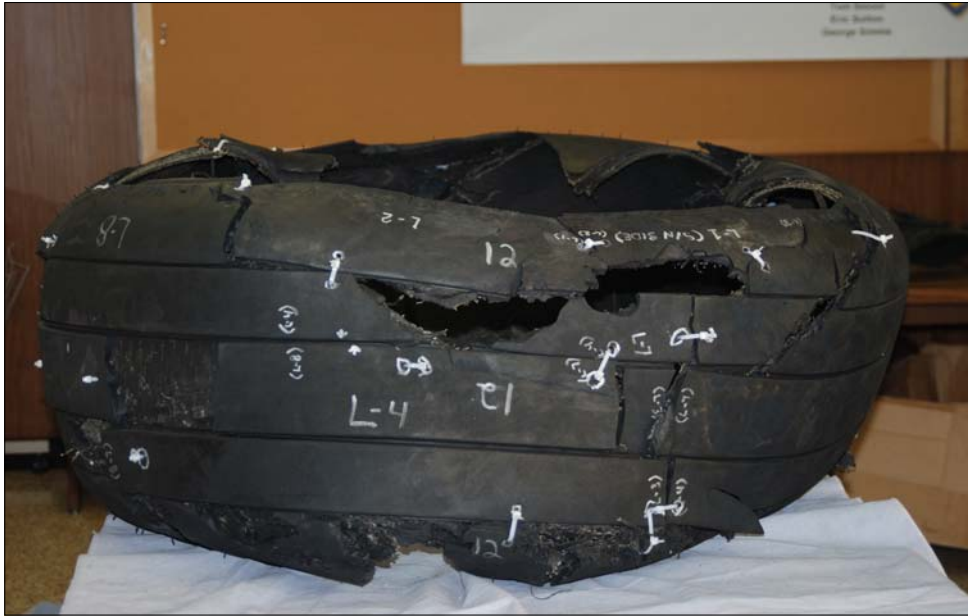
[Photo 2] Reconstructed number 5 tire

- No tire manufacturing defects were found nor traces of FOD.
  - The conditions of the casing and tread package suggested that the casing rupture occurred while the tire was pressurized.
  - Nearly the whole beads remained on the wheel, and the beads remaining on the inboard were worn out much more seriously than those on the outboard or the number 6.
  - The color of rubber had blue tinting and the nylon fibers were stiff. There was no rubber reversion.
- Number 6 tire
- As shown in [Photo 3], a quantity of fragments sufficient enough for reconstruction of the number 6 tire was not collected except for about 75% of tread.
  - The size of fragment of the number 6 tire was much smaller than that of the number 5 tire, and the edge was lengthened like a string or ripped.

- The tire beads were separated from the casing and remained attached to the wheel assembly, and both beads had severe mechanical damage and heat damage.
- The casing broke apart into many pieces, and most of the casing pieces had severe mechanical and heat damage.

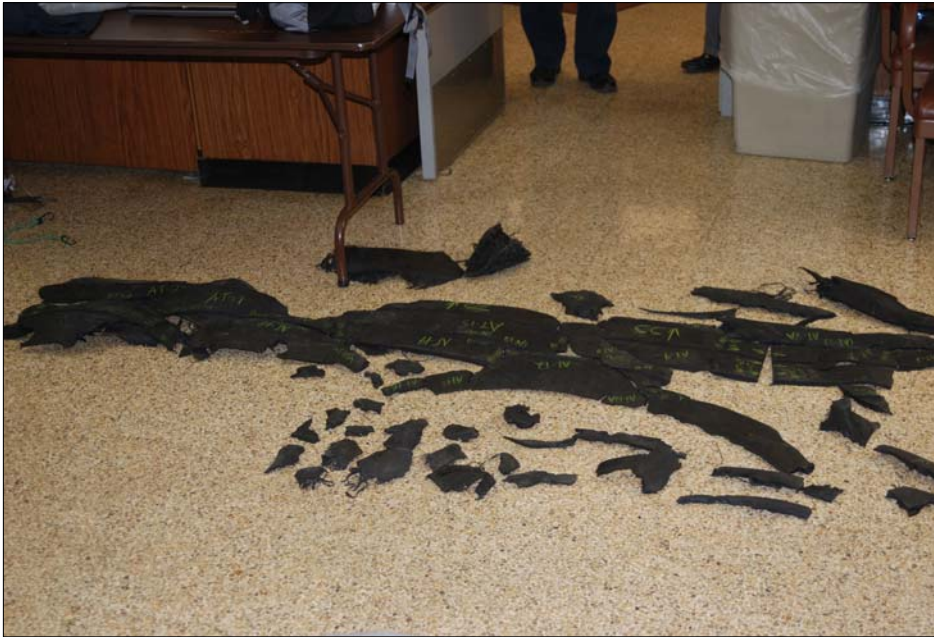
[Photo 3] Number 6 tire fragments

- There was head damage to the shoulder, casing and tread pieces as evidenced by a blue color. But It was weaker than that of the number 5 tire.
- The tread was separated primarily from the top of ply, casing materials remained attached on many liner pieces. The collected portions of the shoulder and inner liner had wrinkles on the inside of both shoulders.
- There were no signs that the tire was broken away from the wheel or had the pressure lost by FOD.

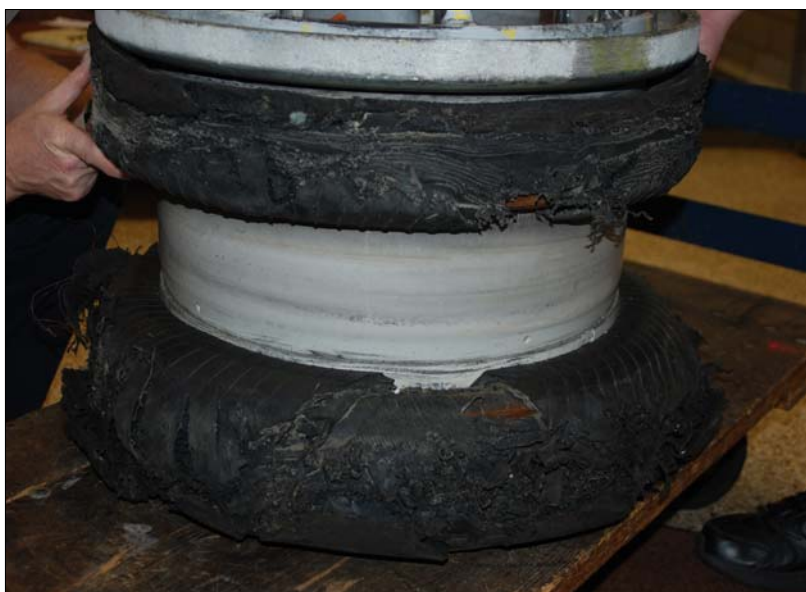
- As shown in [Photo 4], the inboard and outboard bead areas were still attached

to the wheels. The remaining beads had extensive mechanical and heat damage.

[Photo 4] Number 5 wheel

- The half rim of wheel had extensive abrasion damage due to contact with the concrete runway surface after the main portion of the tire casing was broken away from the wheel assembly.
- Air leak tests were conducted on the thermal fuses and inflation valves by air test block and soapy water solution to find no air leaks from any part.
- Tests were not conducted on the overpressure relief plug because the test equipment owned by Goodyear at the time was not adequate for the tests. Subsequently tests were conducted in the Boeing Company, but no malfunction was found.

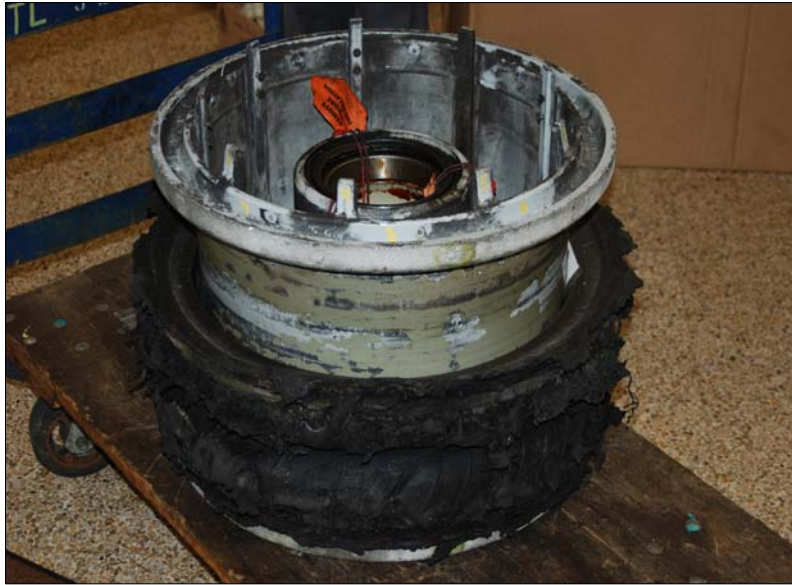
- As shown in [Photo 5], the inboard and outboard tire bead areas were still attached to the wheels. The remaining tire beads had extensive mechanical and heat damage.

[Photo 5] Number 6 wheel

- The wheel half rim had extensive abrasion damage due to contact with the concrete runway surface after the main portion of the tire casing departed the wheel assembly.
- Air leak tests were conducted on the thermal fuses, inflation valves and overpressure relief plugs using air test block and soapy water solution to find no air leaks from any part.
- The inflation valve stem was installed but was found to be barely tighter than hand tight.
