Aircraft Accident Report

In-Flight Turbulence Encounter

Korean Air

A330-300, HL7710

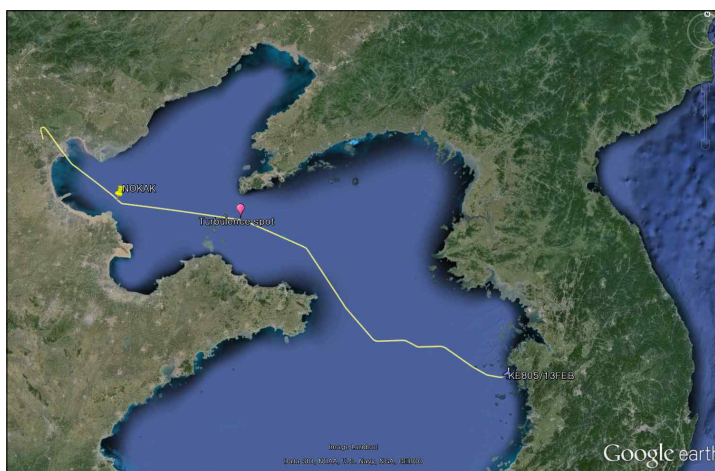
[Figure 1] Point of Turbulence Encounter

Dalian ATC instructed HL7710 to fly direct to NOKAK²⁾, then to CG³⁾ about 11:46. HL7710 encountered light to moderate turbulence near abeam of MAKNO at 23,600 ft at 11:47:16. After hitting turbulence, the captain immediately turned on the fasten seatbelt sign chime twice.

The captain reduced the engine thrust, following the first officer's advice that speed was increasing. At 11:47:38, HL7710 requested Dalian ATC to allow its descent and was cleared. At 11:49:00, HL7710 reached 21,650 ft at which the atmosphere got stable. Passengers were not injured by turbulence, but two flight attendants were seriously injured. HL7710 landed at Tianjin Airport at 12:34:09.

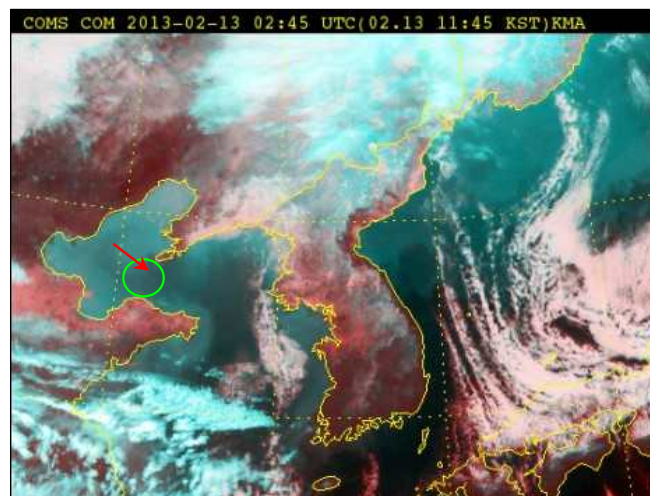
[Figure 2] Satellite Image at 11:45

The Korea Meteorological Administration (KMA)'s weather satellite image taken on 13 February 2013, at 11:45, showed that, as shown in [Figure 2], the haze was present at the point where HL7710 encountered turbulence (arrow), but that cumulonimbus clouds²³⁾ and clouds with precipitation were not present.

According to the KMA's satellite image of the area (in the vicinity of 38° 33' 6.12" N, 121° 15' 17.3" E) where HL7710 was cruising on 13 February 2013, about 11:45, there were no clouds. The pilot stated that "when turbulence

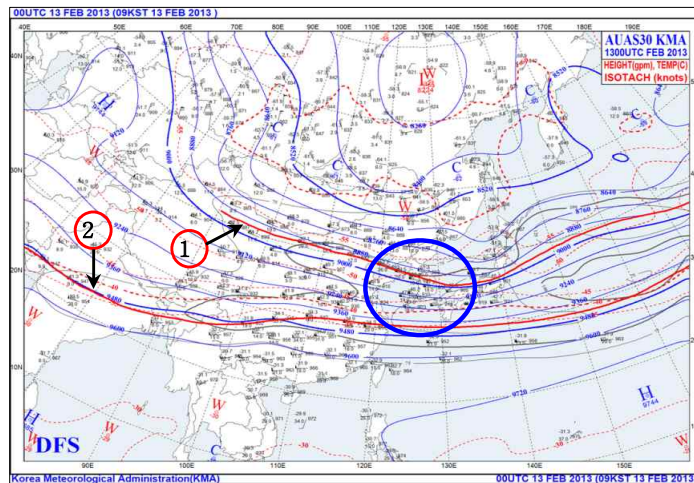
[Figure 3] Upper-Level Weather Chart Produced by the KMA

The KMA produces an upper-level weather chart²⁴⁾ based on the weather observed at the ground level every 12 hours. The chart in [Figure 3] below, which was valid from 09:00, 13 February 2013, indicated two strong jet streams depicted as two red solid lines, ① and ②. One jet stream, ①, was extended from the Chinese continent to the Yellow Sea to central Korean Peninsula to Japan, and the other one, ②, was extended in the same manner south of ①.

was encountered, there was some haze". In addition, according to an upper-level weather chart valid at 09:00, 13 February 2013, a strong jet stream was extended from the Chinese continent to central Korean Peninsula at about 8.8 km above sea level, and the area likely to encounter turbulence was predicted in the vicinity of the jet stream.

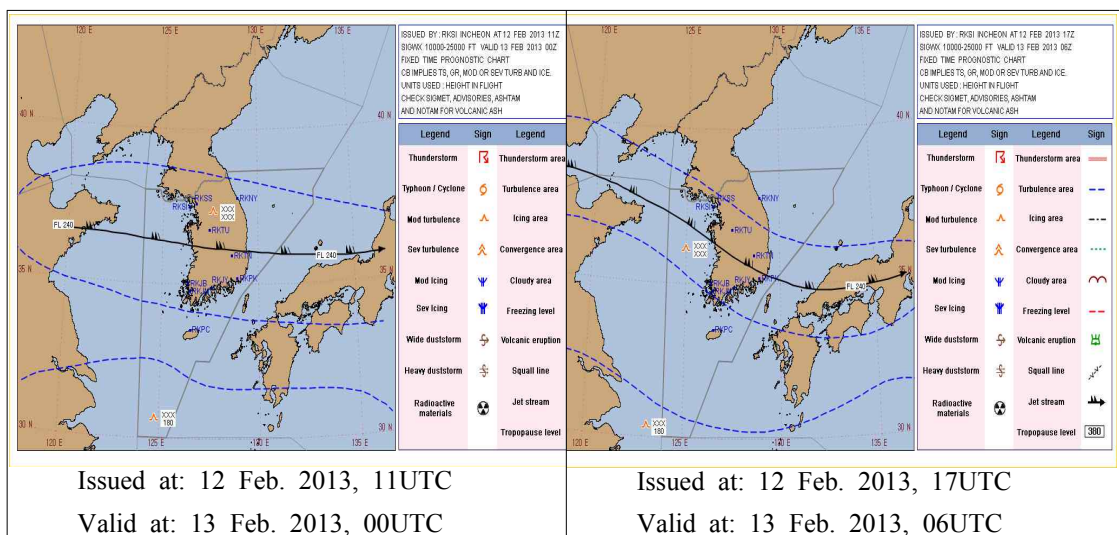
[Figure 4] Prediction of Mid-Level Jet Stream and Turbulence

The mid-level (10,000 ft - 25,000 ft) prognostic chart valid at 09:00, 13 February 2013 and issued by the Korea Aviation Meteorological Agency²⁵⁾ (KAMA) at 20:00, 12 February 2013 forecast that, as shown at the left of [Figure 4], a jet stream²⁶⁾ would blow at 110 kts at 24,000 ft, and that moderate turbulence would be likely to occur in a blue dotted portion of an area. The prognostic chart valid at 15:00, 13 February 2013 and issued at 02:00, 13 February 2013 is shown at the right of [Figure 4].

The KAMA's mid-level prognostic chart valid at 09:00, 13 February 2013, forecast that a jet stream would be present at 100 kts at 24,000 ft south of the central Korea. The agency also predicted the area likely to encounter moderate turbulence. In addition, the forecast chart issued at 03:00, 13 February 2013, and produced by KAMA's GDAPS predicted the weather 9 hours later, showing a contour line (about 28,000 ft), temperature and wind speed (streamlines more than and less than 50 kts) at 300 hPa. According to this chart, a jet stream blowing from the Chinese continent to the Korean Peninsula travelled at 110 - 140 kts.

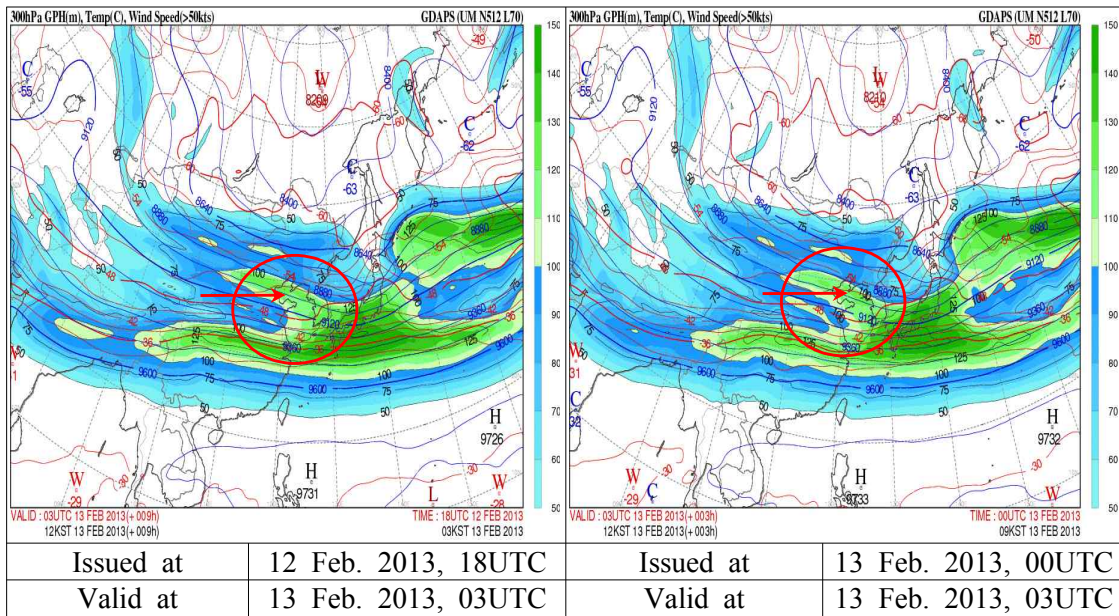
[Figure 5] Forecast Chart Produced by the GDAPS

As shown in [Figure 5], the forecast chart produced by KAMA's global data assimilation and prediction system (GDAPS) depicts a contour line (about 28,000 ft), temperature, and wind speed (more than 50 kts) at 300 hPa.

The left chart of [Figure 5] was issued at 03:00, 13 February 2013, forecasting the weather 9 hours later. Green and blue areas in the chart depict a strong jet stream at more than 100 kts and at less than 100 kts, respectively. The darker green the color, the faster the wind speed. The lighter blue the color, the slower the wind speed, and the chart shows winds at more than minimum 50 kts.

The right chart of [Figure 5] was issued at 09:00, 13 February 2013, forecasting the weather 3 hours later. Both charts cover the area from the Chinese continent to the Yellow Sea to the Korean Peninsula to Japan.

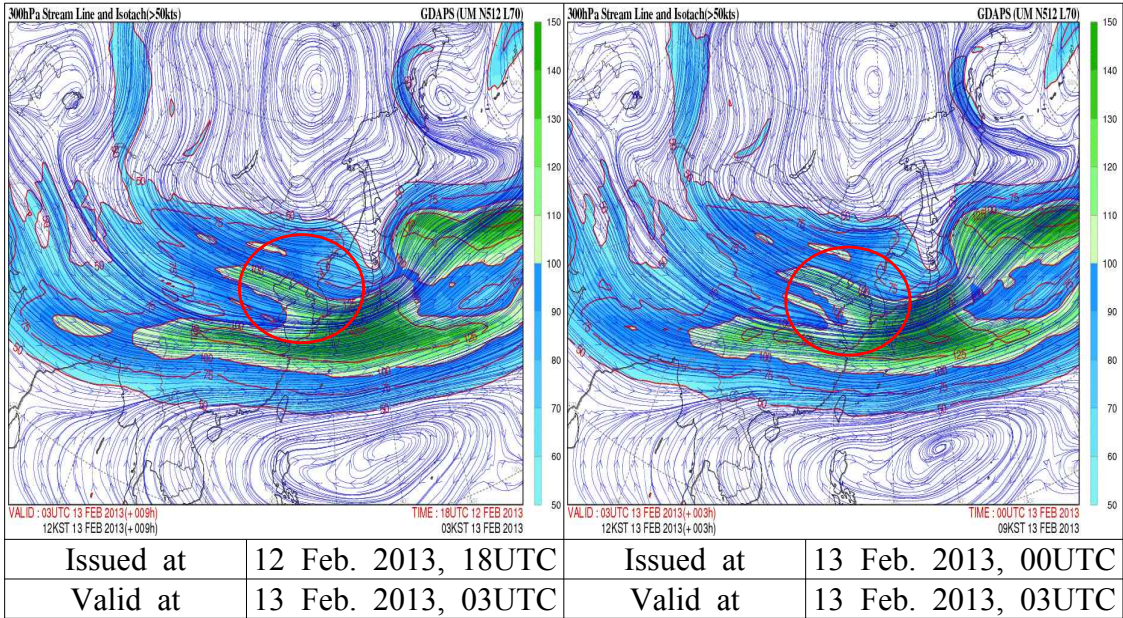
[Figure 6] Forecast Chart Produced by the GDAPS

As shown in [Figure 6], the forecast chart produced by KAMA's GDAPS depicts streamlines (about 28,000 ft) and wind speed (more than 50 kts) at 300 hPa.

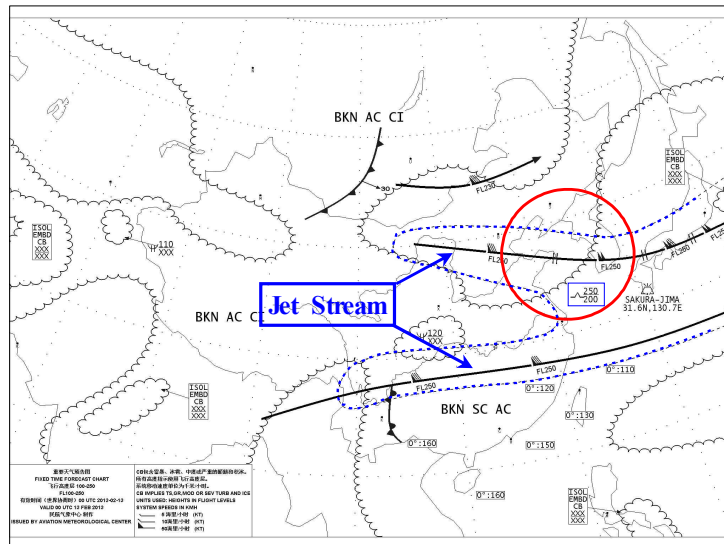
[Figure 7] SIGMET Chart Produced by the CMC

As shown in [Figure 7], the SIGMET chart issued by the China Meteorological Center (CMC) at 09:00, 13 February 2013 showed that two strong jet streams were extended from the Chinese continent to the southwest of the Korean Peninsular to Japan at 10,000 - 25,000 ft at 90 - 100 kts, and that moderate turbulence was likely to occur at 20,000 - 25,000 ft in a blue dotted line.

The CMC's SIGMET chart valid at 09:00, 13 February 2013, predicted that a jet stream was extended from the Chinese continent to the Yellow Sea to the south of the Korean Peninsula to Japan at 90 - 100 kts at 25,000 ft, and that moderate turbulence was likely to occur at 20,000 - 25,000 ft where a jet stream existed.

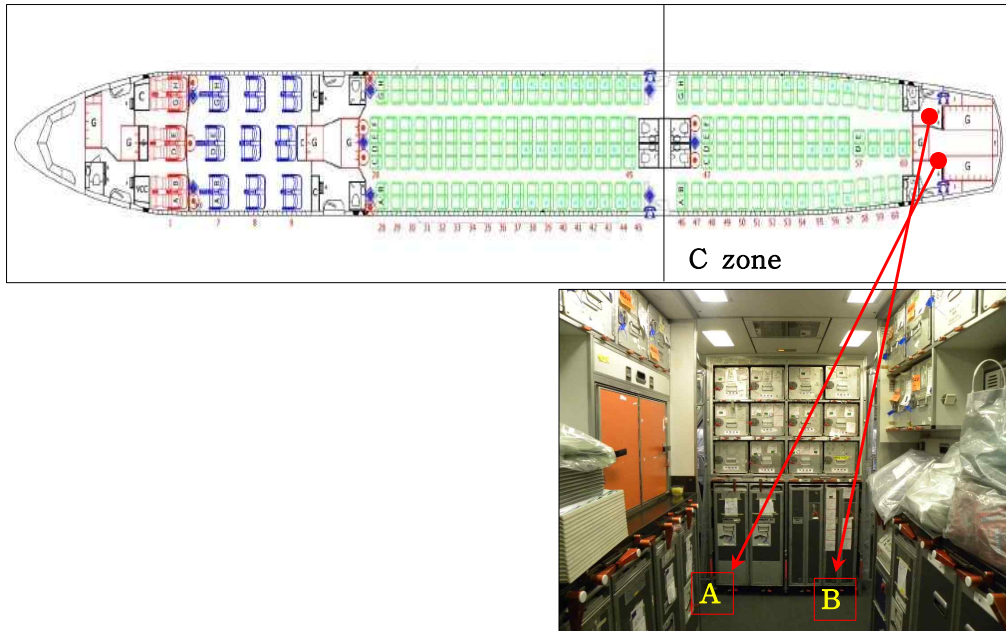
[Figure 8] Locations of the Injured Flight Attendants

The aircraft suddenly shook when the purser organized the collected meal trays at the entrance of the aft galley in the "C" zone, and the "fasten seatbelt sign" came "on". When a turbulence announcement was made, the chime was heard. When a worse turbulence was encountered, she was thrown upward about 10 cm and back down, having her left ankle sprained at the spot "A" in [Figure 8]. The flight attendant next to her was thrown upward and deposited on the floor at the spot "B", hurting her back.

During a turbulence encounter, four of ten flight attendants were in the "C" zone galley and at the entrance of the galley. Three carts were placed respectively at L4 jump seat, R4 jump seat, and the galley, and in the "B" zone galley, other flight attendants were preparing duty free sales carts.
