Aircraft Serious Incident Report

Landing on Runway Used by Another Aircraft

B737-800, HL8292

Runway 24R, Cheongju Int'l Airport

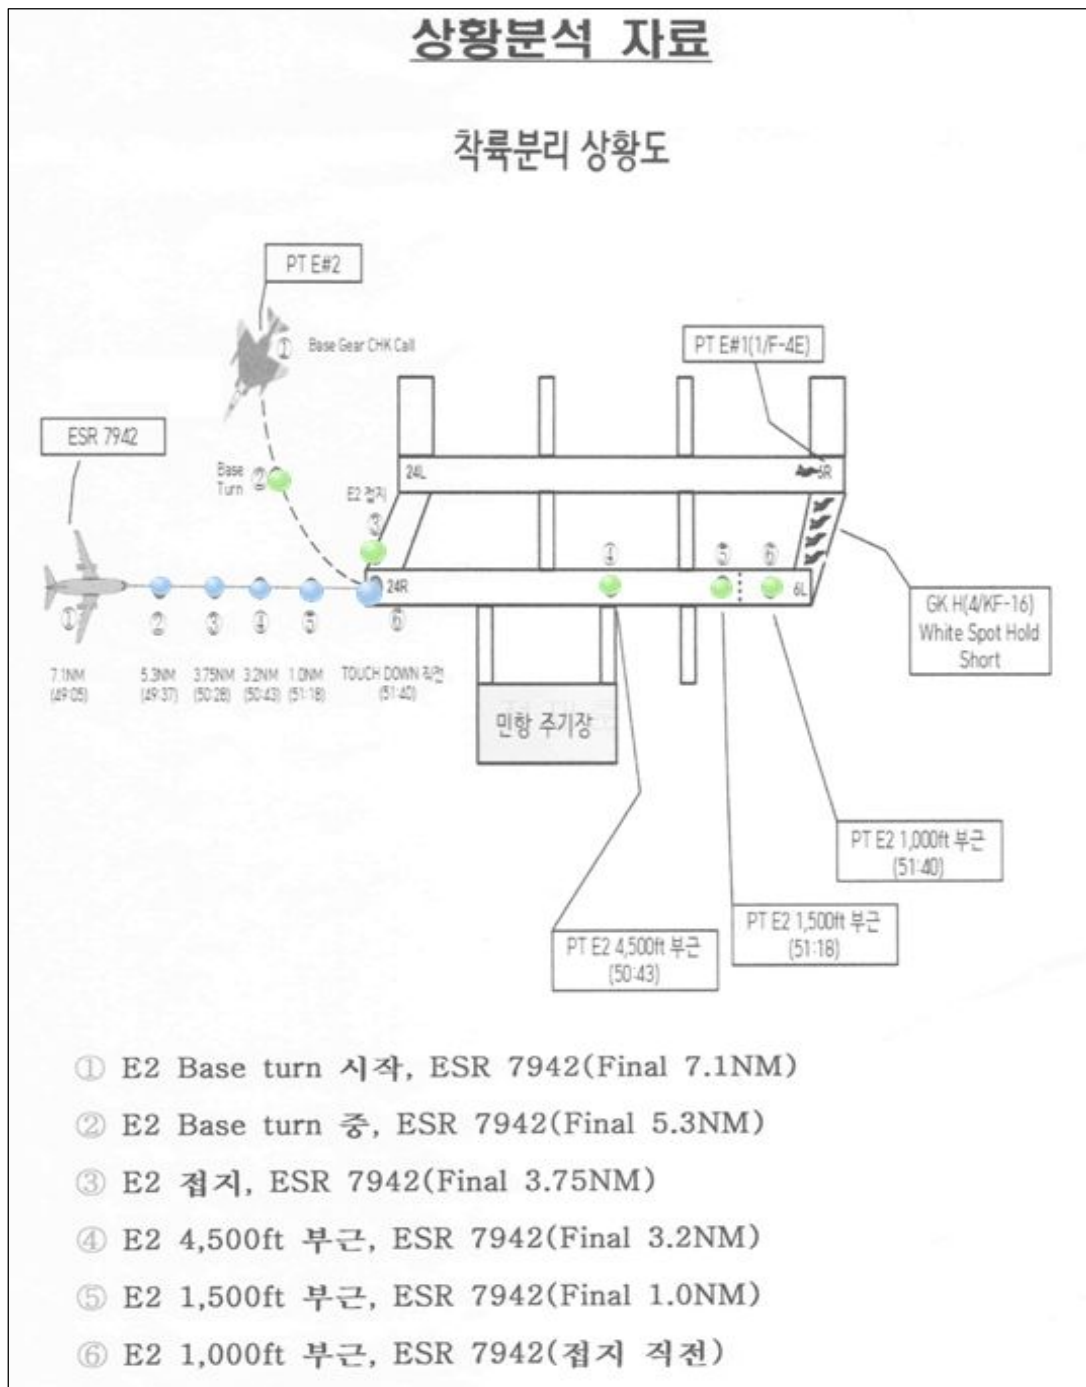
[Figure 2] Analysis of the Event

At 15:48:55, HL8292 reported to CJJ GCA, "Runway in sight", and CJJ GCA advised HL8292, "Traffic two fighter on downwind. You are number three. Contact Tower 118.7." About 15:49:07, the Cheongju Control Tower (hereafter referred to as the "Cheongju Tower") cleared the second fighter jet on the downwind leg for landing at runway 24R.

At 15:49:20, HL8292 informed the Cheongju Tower that it was established on an ILS runway 24R. At 15:49:37, the Cheongju Tower instructed HL8292, "Traffic one F-4 turning base to final, wind 360 at 3, cleared to land runway 24R." At 15:49:40, the captain responded, "Cleared to land 24R and traffic in sight."

At 15:51:18, the Cheongju Tower instructed the fighter jet which had landed earlier, "Taxi without delay due to behind airliner traffic," and at 15:51:40, again advised, "Say again taxi without delay."

fighter jet on the same runway and attempted to stop abruptly, but came within about 3,000 ft (1,000 m) of it. HL8292 reported to the Cheongju Tower that it had stopped because there had been a traffic in front of it and, after the fighter jet vacated runway 24R, turned 180° at the end of runway 24R and taxied to the aircraft stand for civil aviation.

When HL8292, using the VFH, communicated with CJJ GCA and the Cheongju Tower to approach and land at Cheongju Airport, no problems with any communications equipment were reported. The fighter jet used the UHF. The major content of the ATC/pilot communications¹⁹⁾ and the analysis of the event are shown in [Table 2] and [Figure 2], respectively.
