AIRCRAFT ACCIDENT REPORT

CRASH WHILE MOVING FOR AIRLIFT OPERATIONS

B214B-1, HL9131

OCTOBER 19, 2011

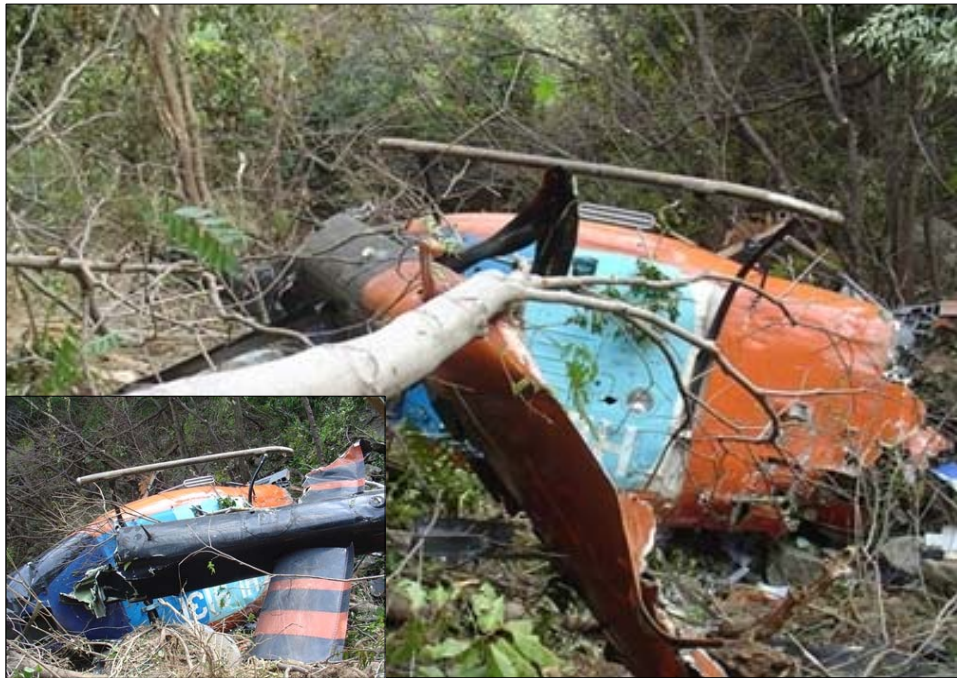
[Figure 2] Aircraft at the Crash Point and its Surroundings

As shown in [Figure 2], HL9131 was destroyed by the crash impact.

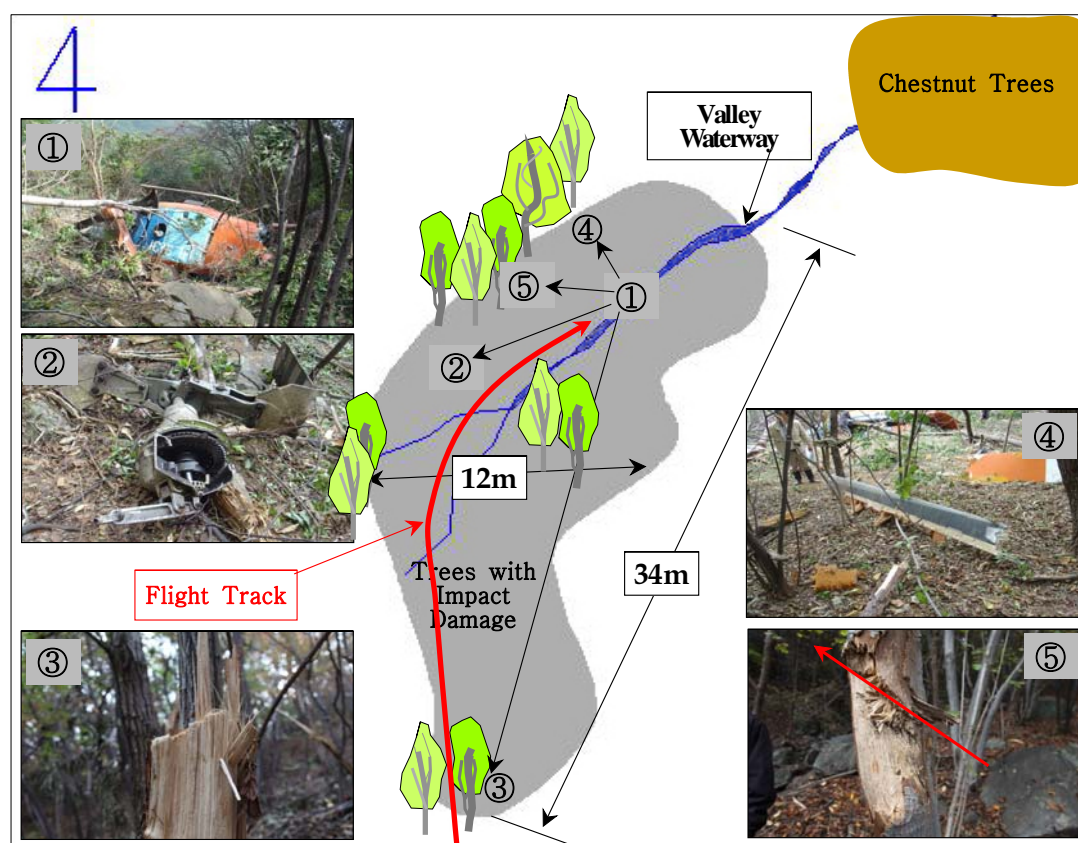
[Figure 4] Wreckage Distribution Chart

As shown in [Figure 4], the tree 23 cm in diameter in ⑤ sustained impact damage by the main rotor blades, about 1 m from the ground at approximately a 45-degree angle, and around the tree there were about 30 big and small trees severed or fallen by the main rotor blades and tail boom. The wreckage distribution chart of HL9131 is shown in [Figure 4].

During the crash sequence, both main rotor blades contacted trees, resulting in multiple fractures of the composite material of the trailing edge, which was scattered around along the entry track. The leading edge of the blades was severed during the final crash sequence, resulting in one resting beside the fuselage and the other in ④ location as shown in [Figure 4].

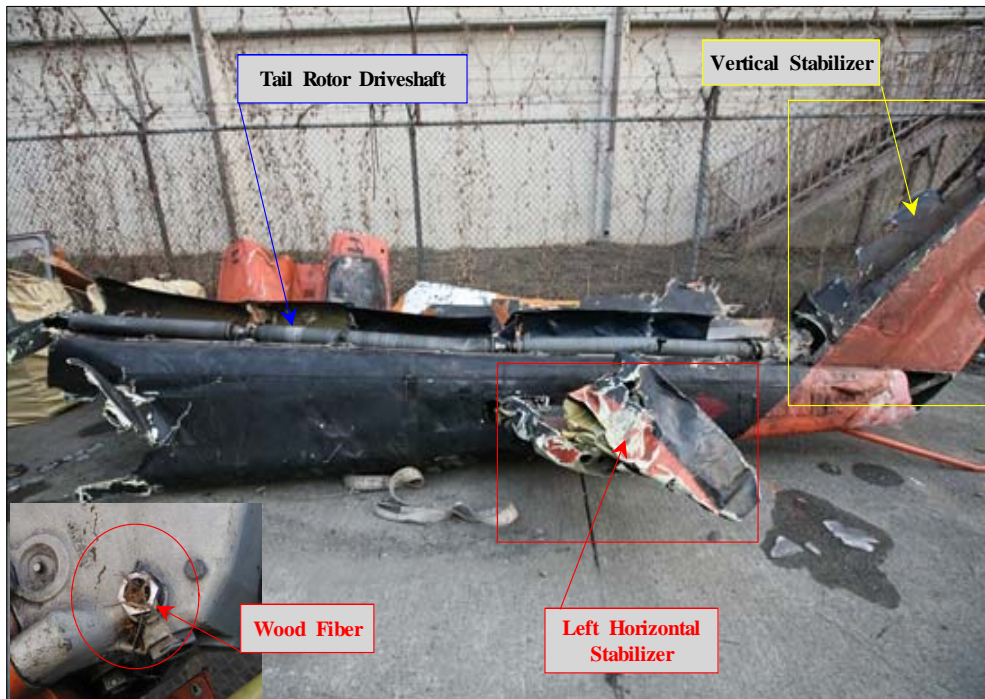
[Figure 5] Left Side of the Fractured Tail Boom

As shown in [Figure 5], the tail boom was fractured and separated at the portion connected to the forward fuselage. The left side of the separated tail boom was substantially damaged, whereas the right side of it sustained relatively minor damage. Wood fiber was jammed in the damaged portion of the tail boom.

As shown in [Figure 5], the tail rotor driveshaft cowling sustained crushing damage by an external force from left to right. The cowling was punctured at two points as it made contact with the inner rotating driveshaft fractured, resulting in rotational wear.

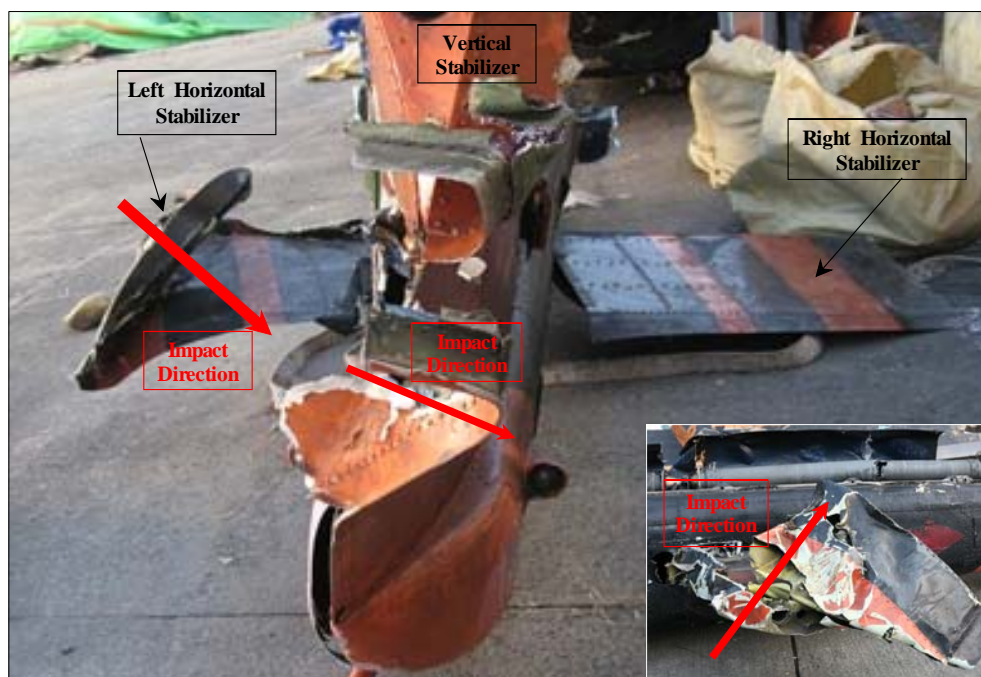
[Figure 6] Damage to Left/Right Horizontal Stabilizer and Vertical Stabilizer

As shown in [Figure 6], the left horizontal stabilizer was damaged by an external force from bottom left forward to upper right backward. The right horizontal stabilizer was intact without external damage. The bottom portion of

the vertical stabilizer was damaged by an external force from left to right based on the nose.

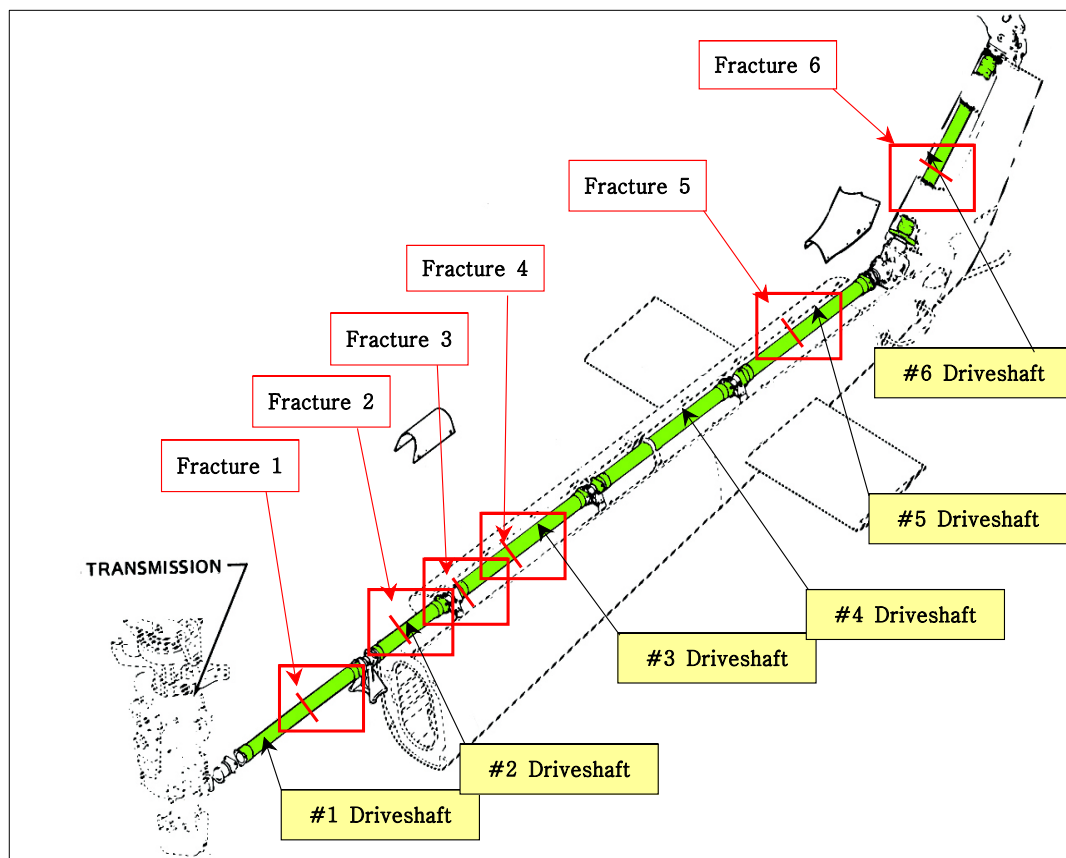
[Figure 7] Tail Rotor Driveshaft Fractures and Their Locations

As shown in [Figure 7], the tail rotor driveshaft displayed separation at six different locations⁴¹⁾ as a result of strong rotational resistance in the direction of the tail rotor. One location displayed counterclockwise twisting⁴²⁾.

Also, there was circumferential scoring throughout the driveshaft, and the fracture surfaces⁴³⁾ of the #1 driveshaft in both directions of the gearbox and the tail rotor showed the inner diameter of the driveshaft expanded outwards due to the impact and wear.

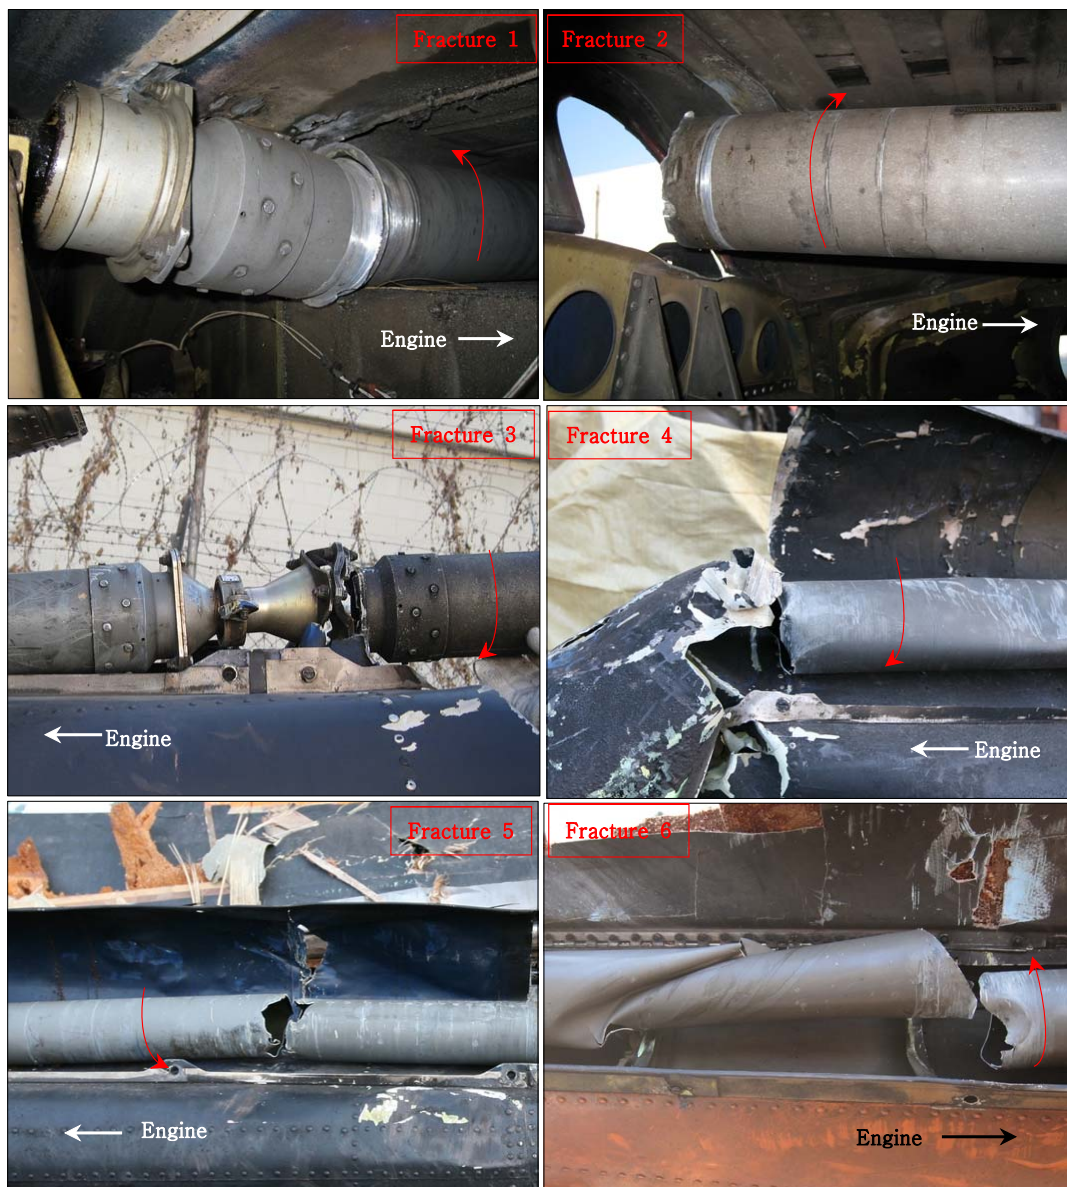
[Figure 8] Fracture Surfaces of the Tail Rotor Driveshaft

42) Fracture #6 in [Figure 8].

43) Fracture #1 in [Figure 8].

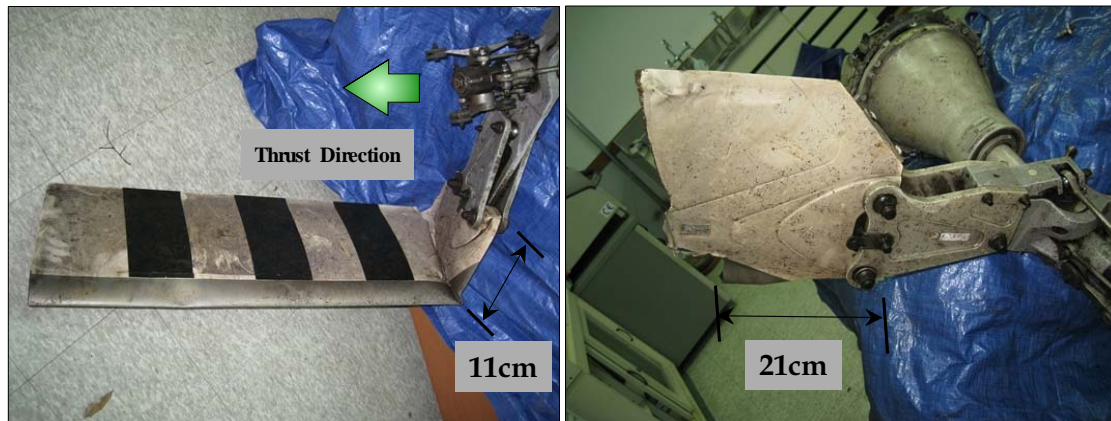
[Figure 9] Tail Rotor Blades Damaged

As shown in [Figure 9], one of the two tail rotor blades was fractured 21 cm from the installation bolt in the rotational direction. The other tail rotor blade was bent 11 cm from the installation bolt, at approximately 90 degrees in the thrust direction.

The surface of the tail rotor blade displayed no severe rotational damage, such as dents or scratches caused by striking a hard object like a tree at the crash point.

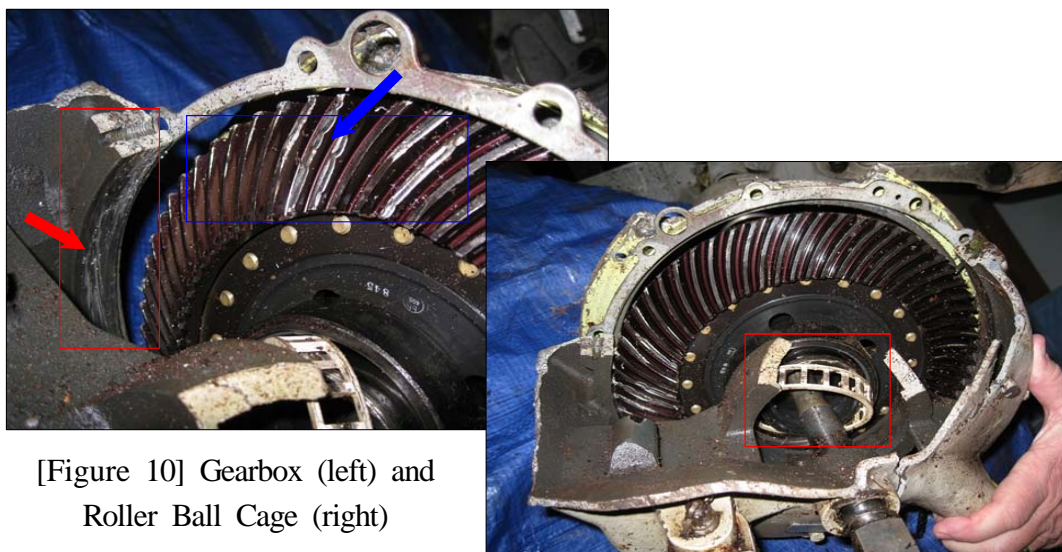
[Figure 10] Gearbox (left) and Roller Ball Cage (right)

As shown in [Figure 10], the 90° gearbox sustained damage as the tail rotor blades experienced instantaneous strong rotational resistance. On the inside surface of the gearbox there was circumferential damage by the gears rub. The roller ball cage did not display any heat distress.

The gear in the 90° gearbox sustained damage by instantaneous impact, and the portions around the gearbox displayed no heat distress⁷²⁾ by resistance. The driveshaft between 42° gearbox and 90° gearbox was twisted by strong resistance to rotation in the tail rotor direction.

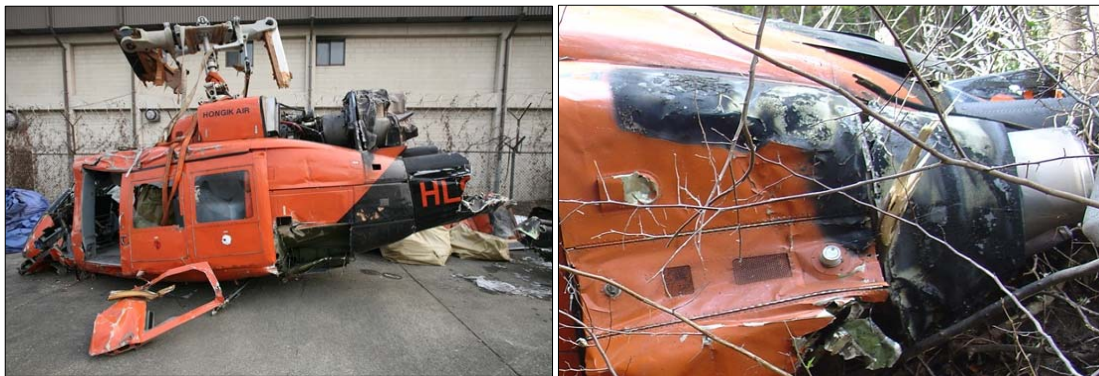
[Figure 11] Left Side of the Fuselage (left) and the Engine Cowling (right)

The left side of the fuselage was severely dented, bent, and fractured as it contacted trees and rocks during the crash sequence. The paint on the engine cowling burned black due to the engine exhaust gas⁴⁴⁾ shortly after the crash.

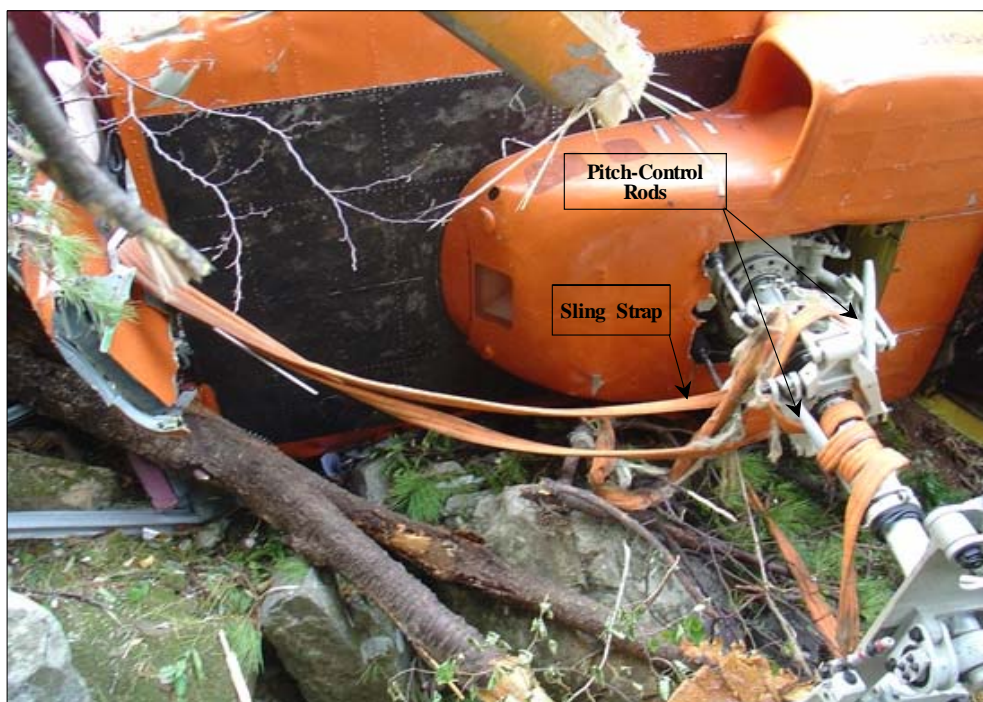
[Figure 12] Sling Strap Wrapped Around the Mast and the Fractured Pitch-control Tubes

At the time of the accident, the sling strap⁴⁵⁾ was attached to the belly hook of the HL9131 aircraft for airlift operations. As shown in [Figure 12], the on-site investigation revealed that the sling strap wrapped around the mast counterclockwise six times. One of the two pitch-control rods fractured was wrapped by the sling strap, whereas the other was not.

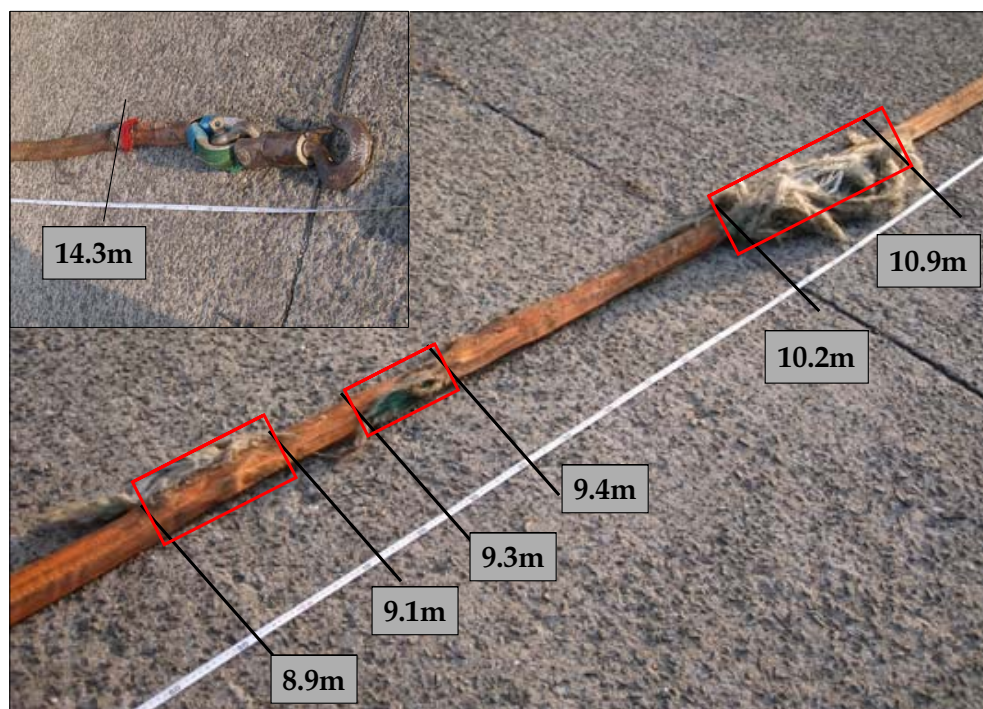
[Figure 13] Damage Locations of the Sling Strap

As shown in [Figure 13], the fiber of the sling strap was damaged by an external force in three locations, which were 8.9~9.1 m, 9.3~9.4 m, and 10.2~10.9 m from the belly hook.

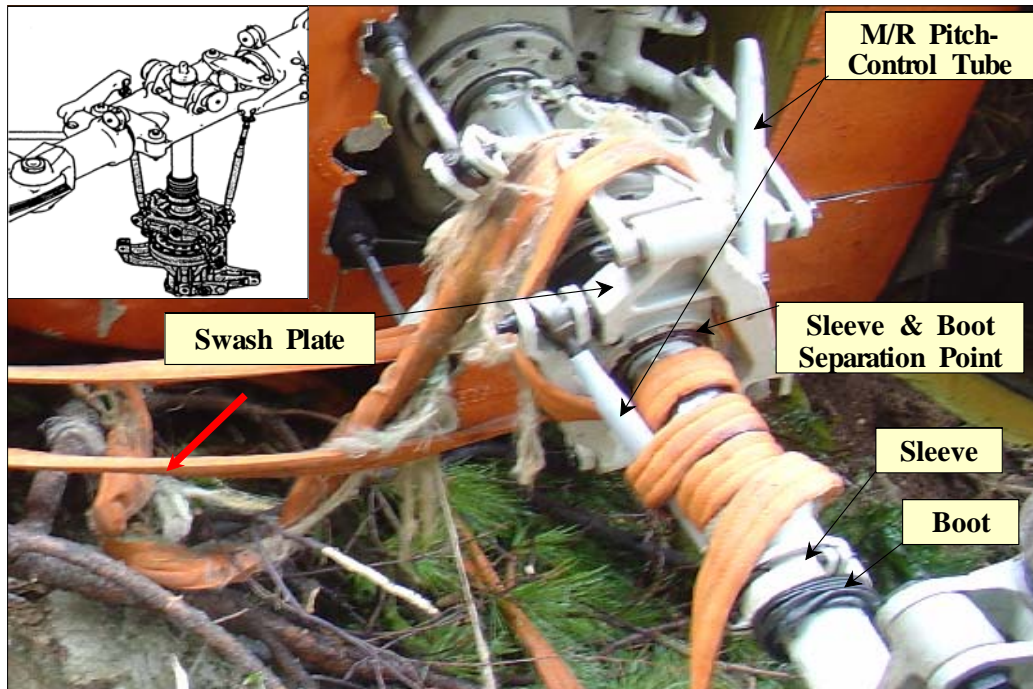
[Figure 14] Sling Strap Wrapping around the Mast and the Surrounding Wreckage Damaged

As shown in [Figure 14], the sling strap wrapped around⁷¹⁾ one of the two fractured pitch-control tubes. If the pitch-control tubes were fractured by the sling strap during flight, the sling strap should have wrapped around both pitch-control tubes or the pitch-control tubes should have bent towards the mast, however, evidence indicating both was not found.

Also, the sling strap should have covered the sleeve and boot, or the sleeve and boot should not have been pushed upwards since the sling strap had wrapped around them before they got fractured and separated.

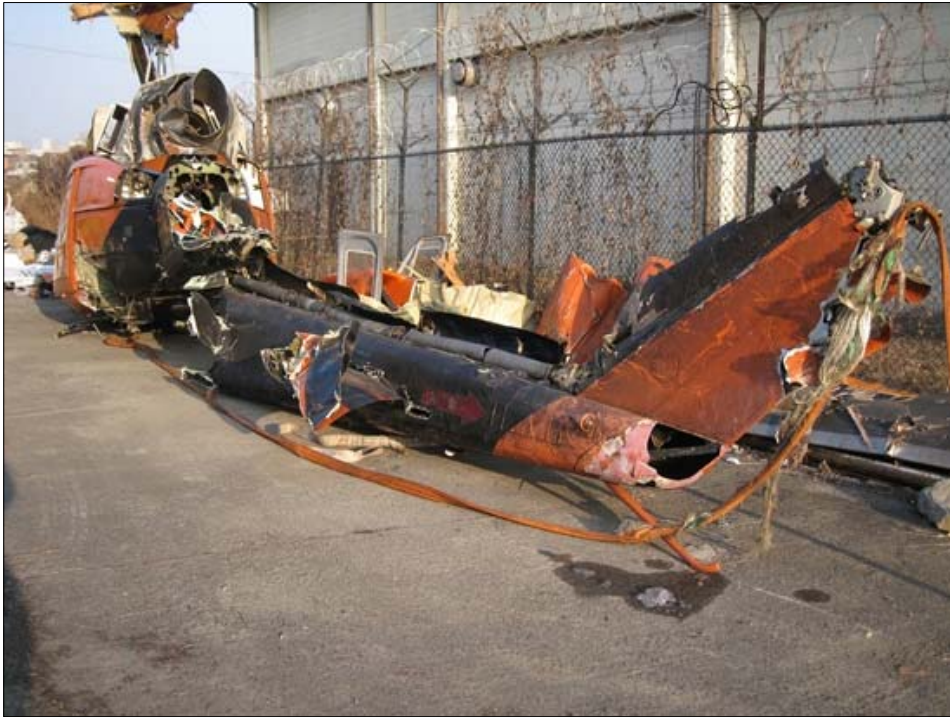
[Figure 15] Comparison of the Damaged Location of the Sling Strap with the Location of the Tail Rotor

As shown in [Figure 15], it was confirmed that the damaged portion of the sling strap is exactly consistent with the location of the tail rotor, and the captain stated that failure occurred after he heard a sudden loud "bang" while descending at a rate of approximately 500 ft/m at 70 kts and 1,200 ft before the accident.

Accordingly, the ARAIB assumed based on these facts that when HL9131 decelerated and descended after flying over the ridge right before the crash point, the sling strap got closer⁷³⁾ to the tail rotor, then struck it, thereby resulting in damage to the sling strap, separation of the tail rotor blade, fractures of the tail rotor driveshaft, and impact damage to the 90° gearbox.

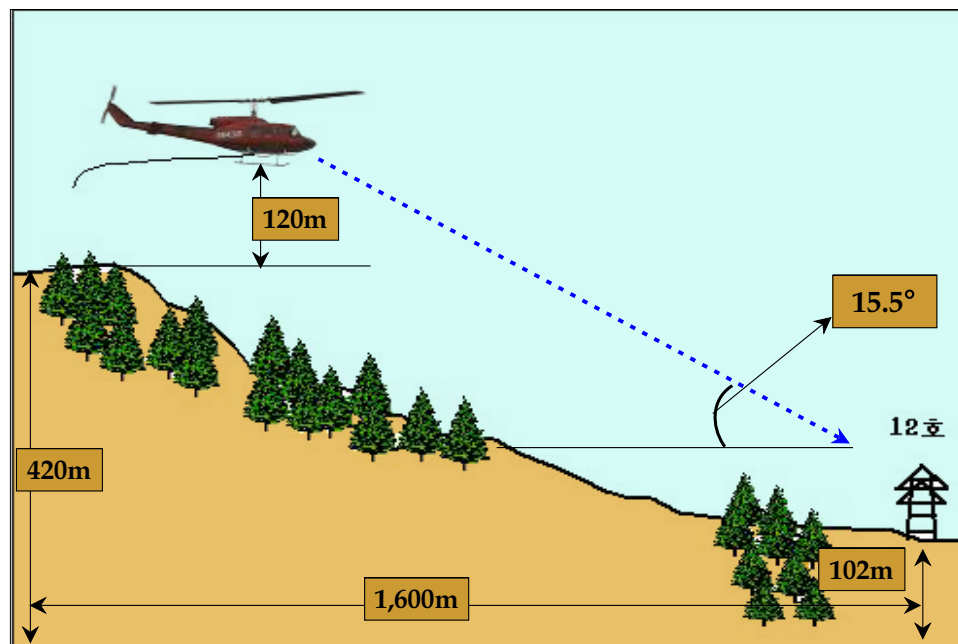
[Figure 16] Topography between the Descending Point and the Power-line Tower #12 and the Estimated Approach Angle

As the descending point was located 1.6 km from the power-line tower, HL9131 approached at an angle of approximately 15.5 degrees as shown in [Figure 16], which is slightly deeper than the rotorcraft's normal approach angle, 8 - 12 degrees.

Against this backdrop, to hover and land on the destination, the captain had to decelerate more greatly than normal. Furthermore, if the captain recognized the distance to the destination as 800 - 900 m, which means shorter than real, he was highly likely to decelerate much more greatly.

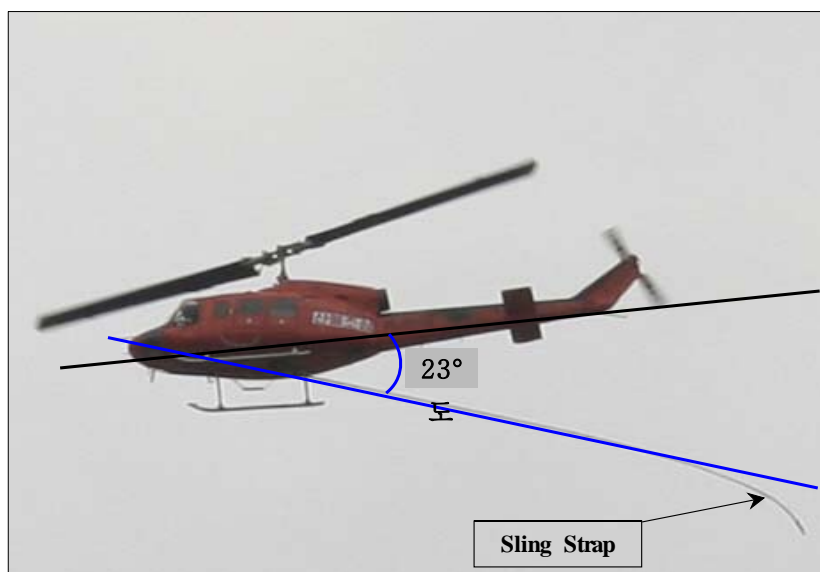
[Figure 17] Angle between the Sling Strap and the Fuselage during Level Forward Flight

As shown in [Figure 17], if the aircraft has a level flight with the sling strap attached at a speed of 70 kts, the angle between the fuselage and the sling strap is about 23 degrees. The angle between the sling strap and the aircraft fuselage per speed is shown in [Table 3].

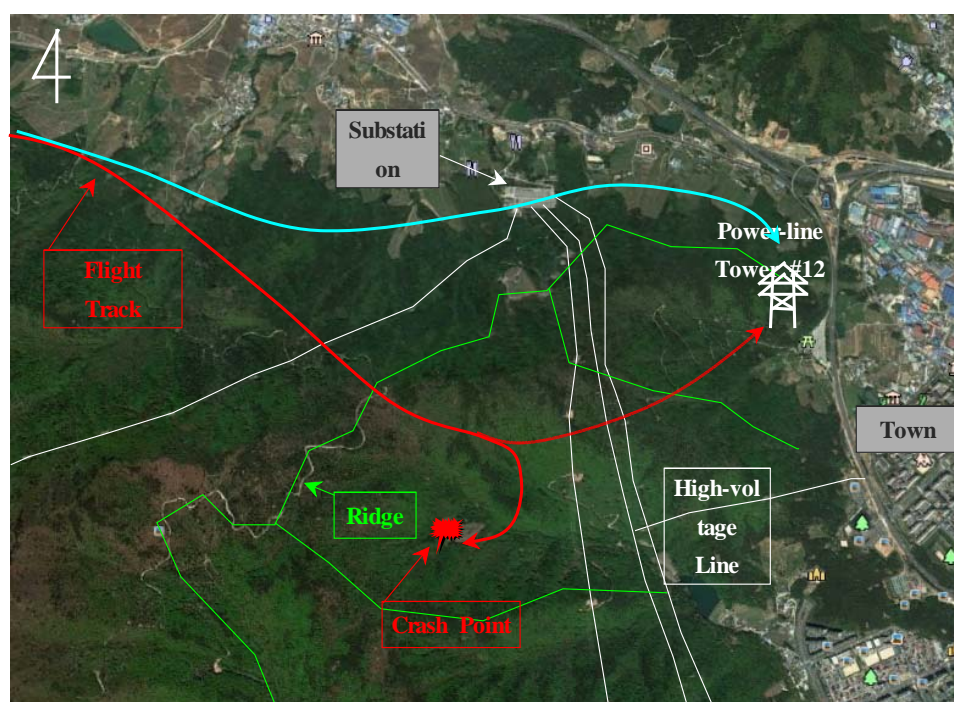
[Figure 16] Crash Point and the Surrounding Obstacles

Yet, the aircraft already entered the valley after flying over the ridge, and moreover, on the periphery of the aircraft, there were high-voltage lines ahead and a town beyond them as shown in [Figure 16]. Thus, the captain determined that circular or straight flights were impossible.

Subsequently, while approaching the point he considered relatively flat in his vicinity, HL9131 crashed into the valley.

Therefore, the captain should have planned the flight route⁷⁶⁾ on which there were more flat areas with fewer obstacles so that he could have performed emergency procedures in case of aircraft failure. In reality, there was a better flight route⁷⁷⁾ beyond the ridge north of the route he had taken.
