# AIRCRAFT ACCIDENT REPORT

CRASH INTO A OBSTACLE DURING A DESCENT FOR LANDING  
LG ELECTRONICS

S-76C<sup>++</sup>, HL9294

16 NOVEMBER 2013

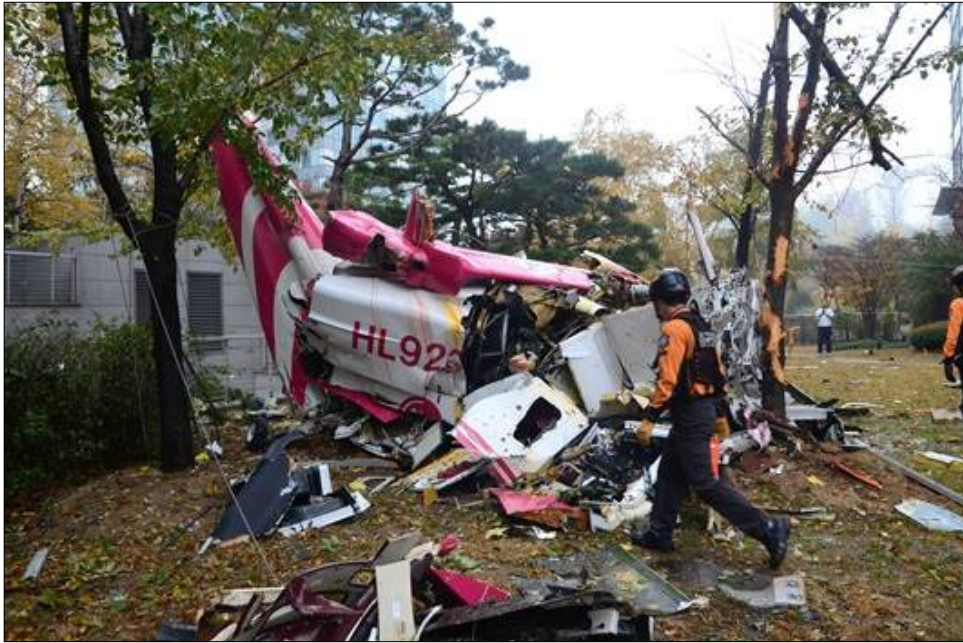
[Figure 2] Wreckage of the Event Aircraft

As shown in [Figure 2], HL9294 was destroyed by the crash impact. HL9294 was insured against hull damage,<sup>20)</sup> crew and passenger injury,<sup>21)</sup> and bodily injury and property damage,<sup>22)</sup> effective<sup>23)</sup> at the time of the accident.

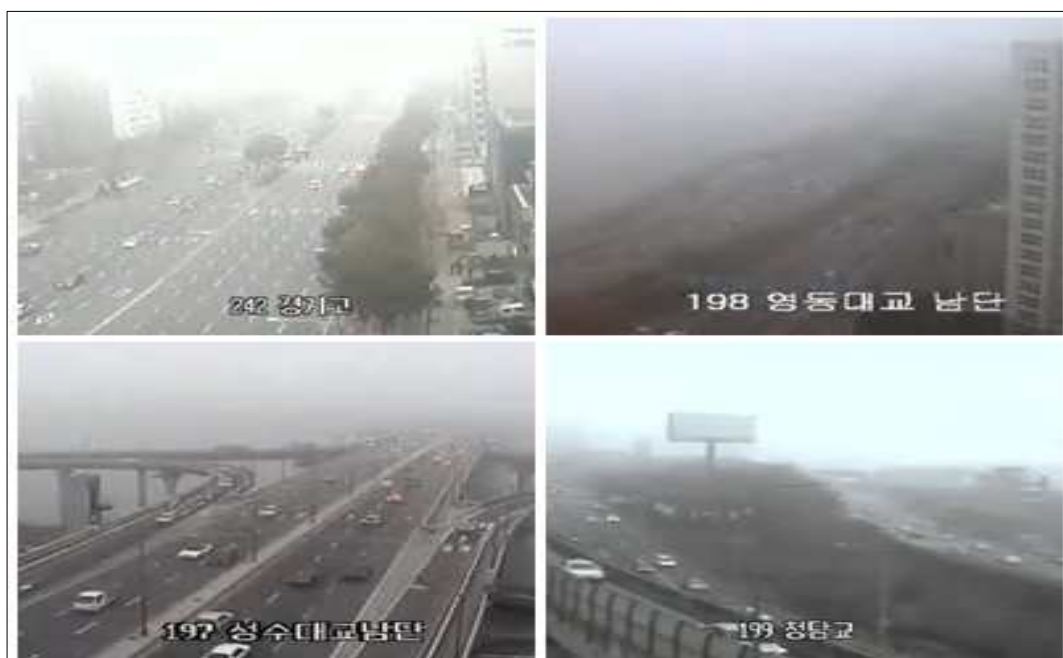
[Figure 3] CCTV Images of Olympic Expressway about 08:30 on the Event Day

※ CCTV Height (about 30 m), Visibility (about 100 - 200 m)

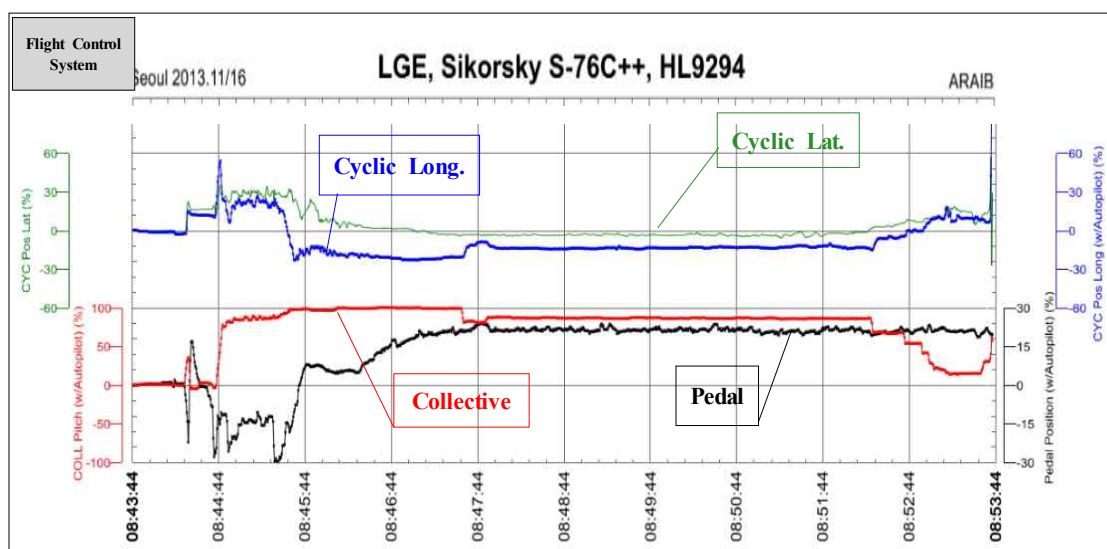
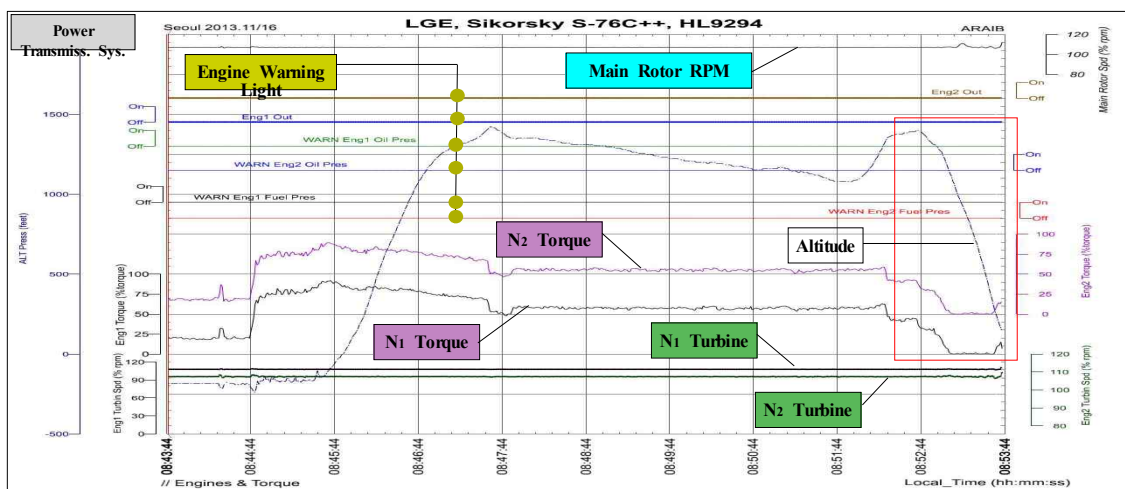
[Figure 7] FDR Parameters

As shown in [Figure 7], on the flight leg before the accident, HL9294's engine turbine RPM (green box) and main rotor RPM (light blue box) were maintained normal, and engine N1 and N2 torques (pink box) decreased (red box) due to power decrease caused by altitude drop. No engine-related warning lights<sup>71)</sup> were illuminated.

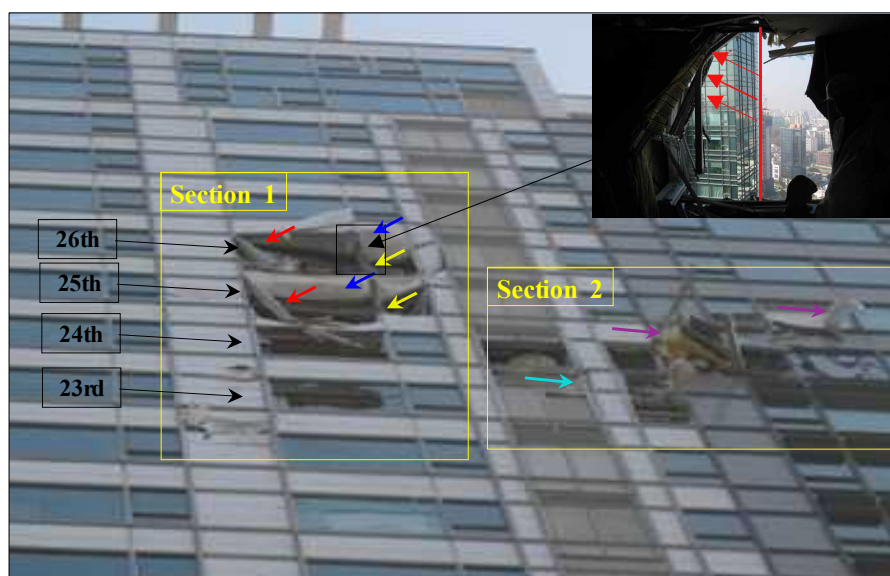
[Figure 10] Condominium Building Damage

The area damaged by a direct impact with HL9294 mainly contained the 23rd, 24th, 25th and 26th floors on the north side of building 102, and it is divided into two sections as shown in [Figure 10]. Apart from this area, other damages to the building were caused either by fragments of the main rotor blades generated by the initial impact or by fuselage debris scattered during the crash into the ground.

As shown in [Figure 10], the lower part of the window frames (red arrow) in Section 1 was bent from left to right and fractured, and centerline window frames (yellow arrow) were bent from bottom left to upper right. Exterior panels (blue arrow) on the 25th and 26th floors were compressed and bent upwards from the bottom.

In Section 2, mainly exterior panels or window frames (light blue arrow) were torn out from left to right, and some window frames (purple arrow) sustained damage when pushed to the right.

Judging from the damage to the condominium building, the left side of the climbing aircraft initially crashed into Section 1, then, as its tail boom was rotated by inertial force, the aircraft impacted Section 2 for the second time.

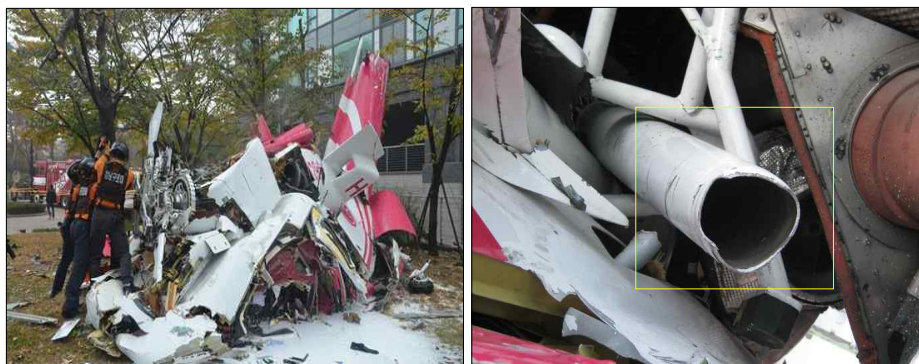
[Figure 11] Compressed Fuselage and Damaged Tail Rotor Driveshaft

As the main fuselage fell to the ground, right down from Section 2 shown in [Figure 10], the upper and lower sections of the main fuselage were crushed in, and the gearbox with its middle portion broken was separated from its assembled position and placed on top of the cockpit along with the hub. Please, refer to [Figure 11].

The tail boom was fractured at the junction with the main fuselage and the horizontal stabilizer. The tail rotor driveshaft was fractured by a strong rotational overload, and damage from rotation (scratches) was found around its fracture surface.
