ARAIB/AIR1002

AIRCRAFT INCIDENT REPORT

HELICOPTER DAMAGE FOUND AFTER EMERGENCY LANDING
HELIKOREA CO. LTD.

KA-32A, HL9406

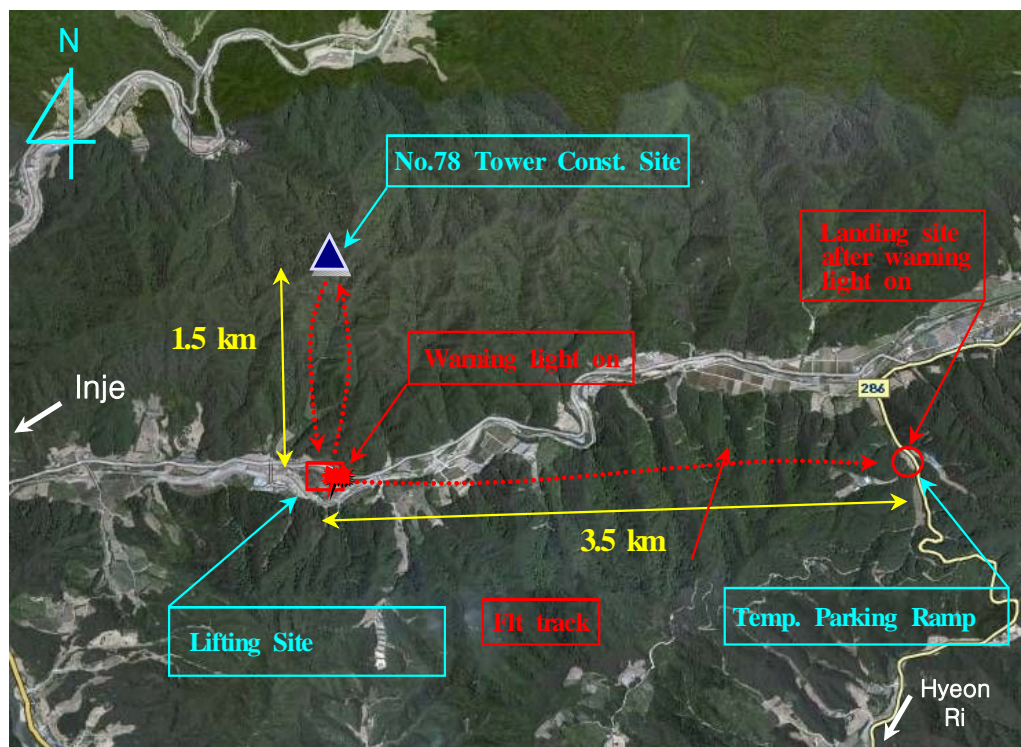
[Photo 1] HL9406 Mission Area and Flight Route

The flight mission of the HL9406 aircraft on the day of the incident was to airlift ready-mixed concrete from the lifting site³⁾ to the construction site of the high-voltage power line tower No.78. Refer to [Photo 1].

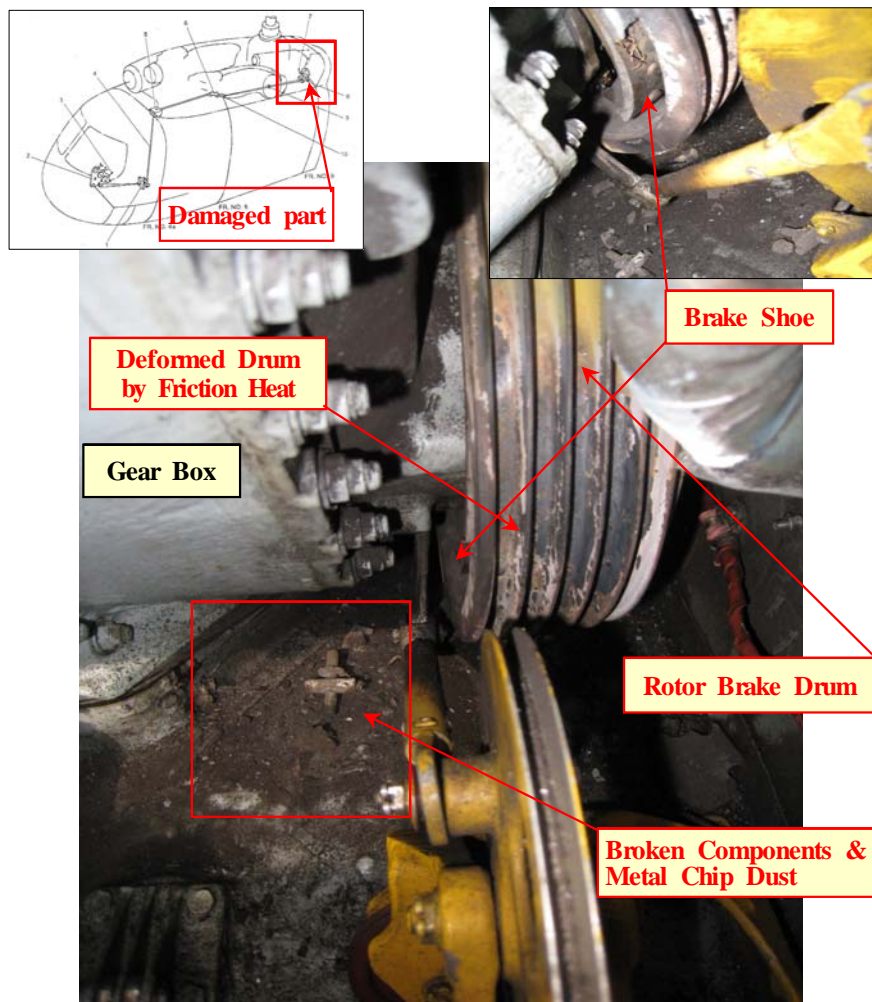
[Photo 2] Heat Damaged Rotor Brake & Separated Surrounding Components

The damage found after the HL9406 aircraft landed in the temporary parking ramp was (1) metal chips exceeding the permitted limits detected in 3 main gear box chip detectors; (2) the rotor brake drum deformed by friction heat; and (3) the brake shoe, the mounting bracket, and related components destroyed and separated.

Also, there was a gap found exceeding the permitted limits in the oil cooling fan drive shaft, along with scratch marks made by rotation found in the inner wall of the bracket and the brake drum. Refer to [Photo 2 & 3].

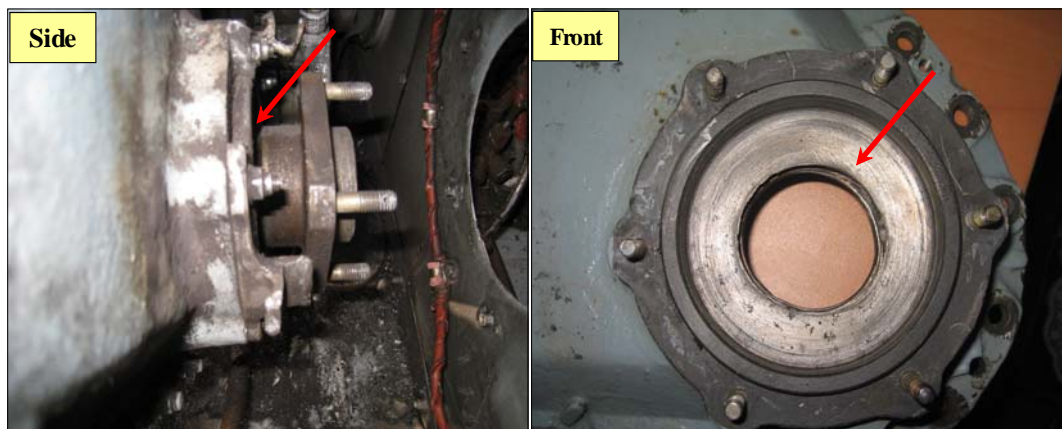
[Photo 4] Damaged Part of Main Gear Box Roller Bearing

In addition, when the cooling fan drive shaft and the rotor brake system were removed for inspection, as shown in [Photo 4], the abrasion and damage (red

arrows) in the main gear box roller bearing were verified.

7. The damage in the gear box roller bearing (75-4 2206B1) resulted from its parts' deterioration caused by the fatigue flaking under a normal oil intake.

8. The fatigue flaking of the bearing parts was caused by the bearing assembly's operation under the influence of considerable off-design vibro-dynamic axial and radial load from the fan drive shaft direction, and this load was caused by the destruction of Main Rotor brake parts.

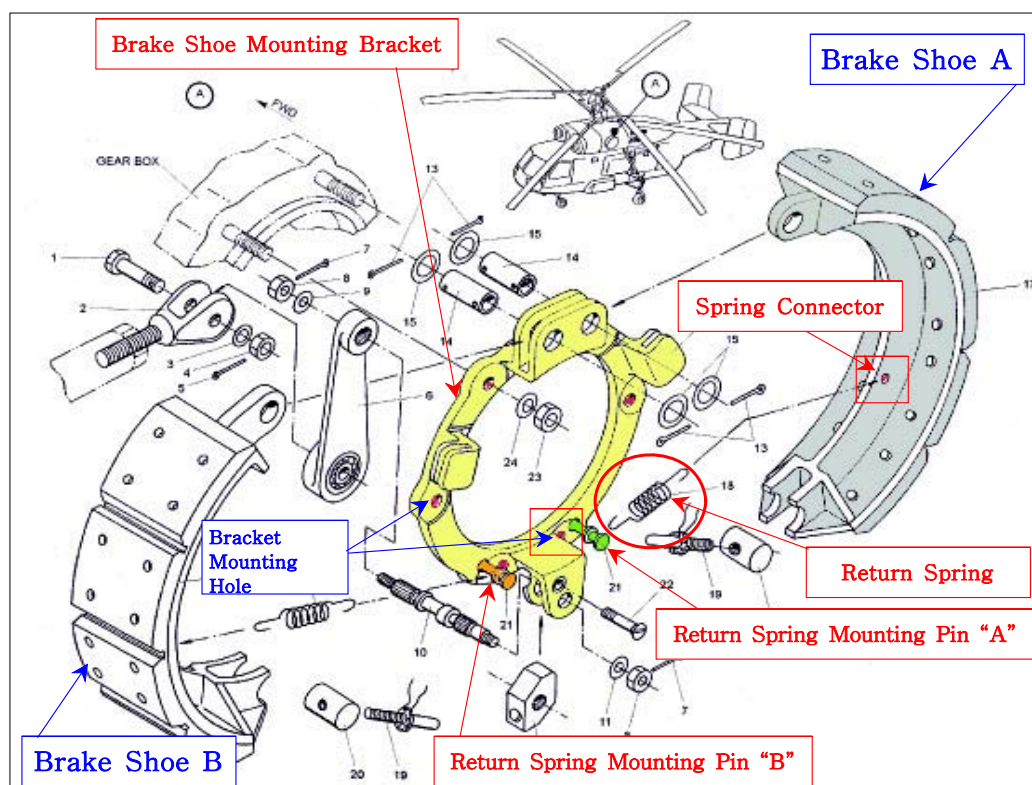
[Fig. 1] Disassemble Drawing of Brake Shoe

As shown in [Fig. 1], the return spring (red circle) jointed with the rotor brake 「brake shoe A」 was separated during flight, thus resulting in the imbalance in the 「brake shoe A」, and this imbalance caused the 「brake shoe A」 to contact the drum abnormally, thus resulting in the vibro-dynamic load in the system.

The Main Rotor brake was damaged due to a sudden growth of vibro-dynamic load in the system caused by the imbalance in the 「brake shoe A」, and this imbalance was caused when the 「brake shoe A」's return spring was uncoupled from the bracket mounting pin.

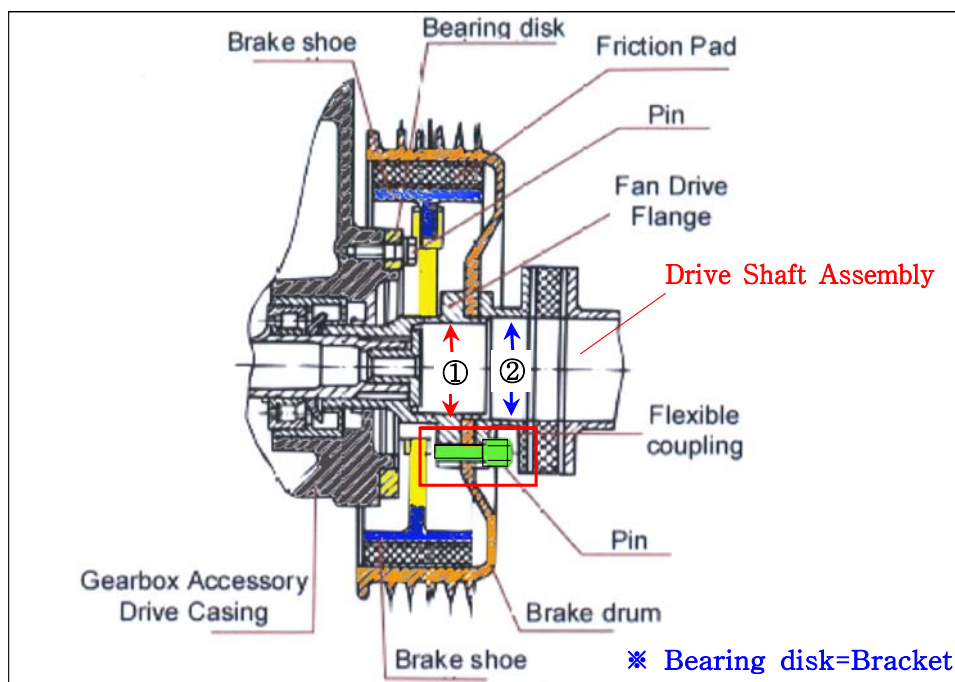
[Fig. 2] Rotor Brake System and Drive Shaft Assembly

As shown in [Fig. 2], this vibro-dynamic load was suddenly grown since the gap was generated between the fan drive flange (red arrow ①) and the flexible coupling (blue arrow ②) due to a failure to tight the bolt (red square) in accordance with the Technical Specification requirements when the drive shaft assembly was installed.

Contributing to the incident were (1) the failure to tighten a bolt in accordance with the Technical Specification requirements when combining the fan drive flange with the flexible coupling; and (2) the failure to meet the Technical Specification requirements when jointing the brake shoe return spring pin (5.00.1540.0015.000) with the bracket (5.00.1540.0011.000) mounting hole, \varnothing 6mm in diameter - the actual gap was 0.05mm, whereas the max. gap permitted is 0.017mm.

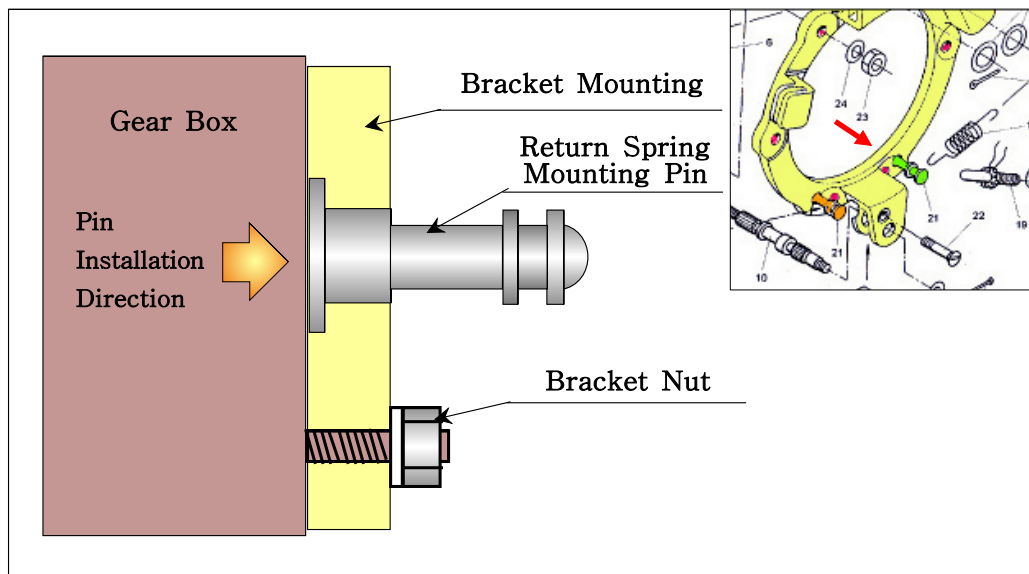
[Fig. 3] Structure Drawing of Coupled Return Spring Mounting Pin

When the return spring mounting pin is coupled to the bracket, as shown in [Fig. 3], the pin is inserted from the gear box direction, then the mounting nut is tightened, thus it is structured that the pin cannot uncouple unless it is broken or the bracket is deformed.

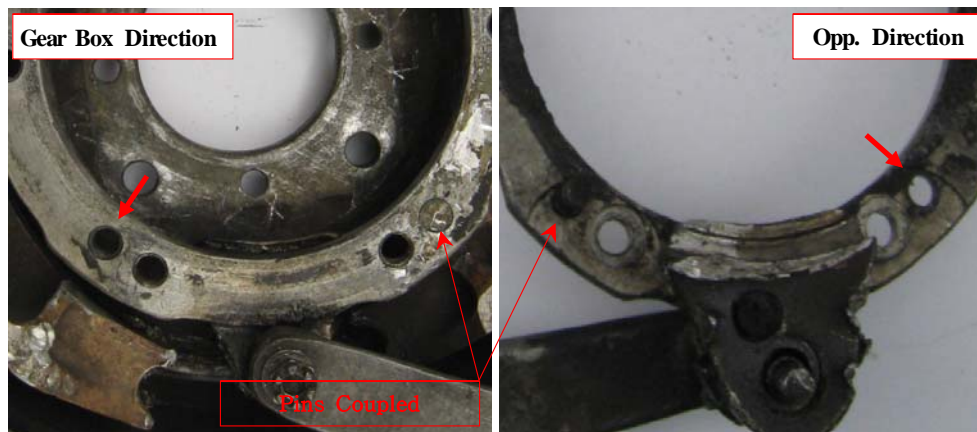
[Photo 5] Connector Hole of Return Spring Mounting Pin

Nevertheless, according to the result of damaged bracket inspection, the hole with the mounting pin decoupled (red arrow) shows no sign of expansion or deformation as shown in [Photo 5]. Therefore, there is no possibility that the return spring mounting pin "A" was separated by the deformation of the bracket.

As verified in the Korea-Russia joint investigation, the gap (0.05mm) when coupling the mounting pin was not wide enough to make the return spring fell off. Therefore, it is highly unlikely that the return spring "A" was separated only by the gap.

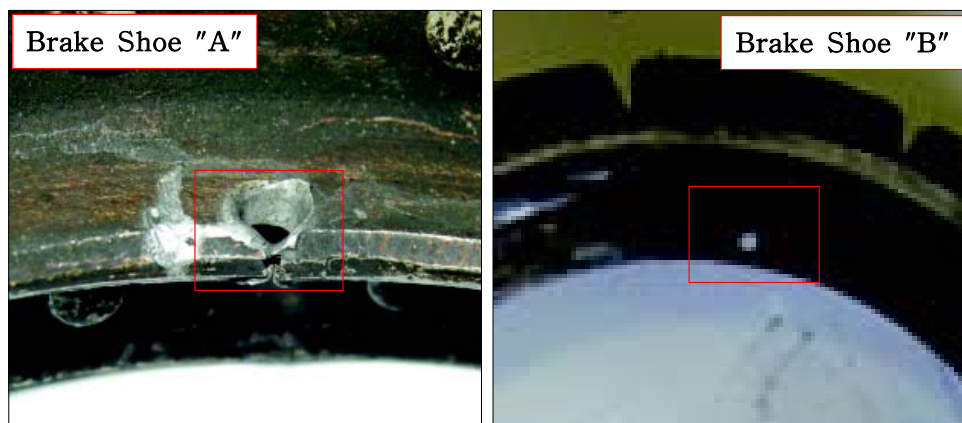
[Photo 6] Damage in Return Spring Connector of Brake Shoe

As shown in [Photo 6], the return spring connector of the brake shoe "B" almost maintains the original shape, whereas the connector of the brake shoe "A" is more expanded by abrasion and severely damaged than "B".

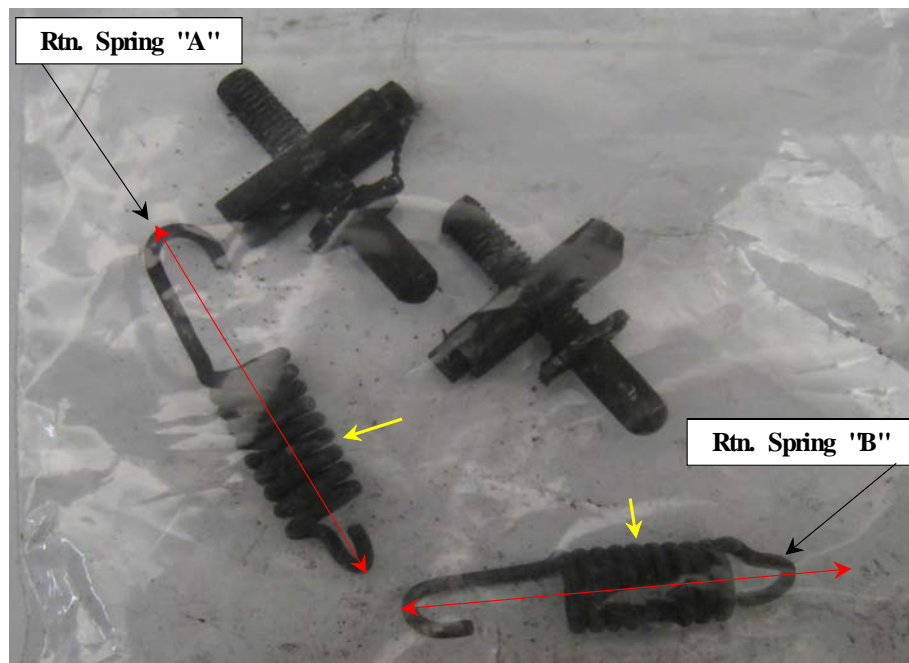
[Photo 7] Deformation of Return Spring

When compared the length of the return springs "A" and "B" using same length arrows, as shown in [Photo 7], the length of the spring "A" is extended, and the gaps between the spring rings of the spring "A" are bigger.

On the basis of the aforementioned facts, therefore, it is assumed that the gap between the mounting pin and the bracket hole along with the weakening of the return spring elasticity resulted in the vibro-dynamic load, thus separating the return spring from its original installation position.
