# Aircraft Accident Report

**Tail Strike During Landing**

**Asiana Airlines Flight 340**

**A321-200, HL7730**

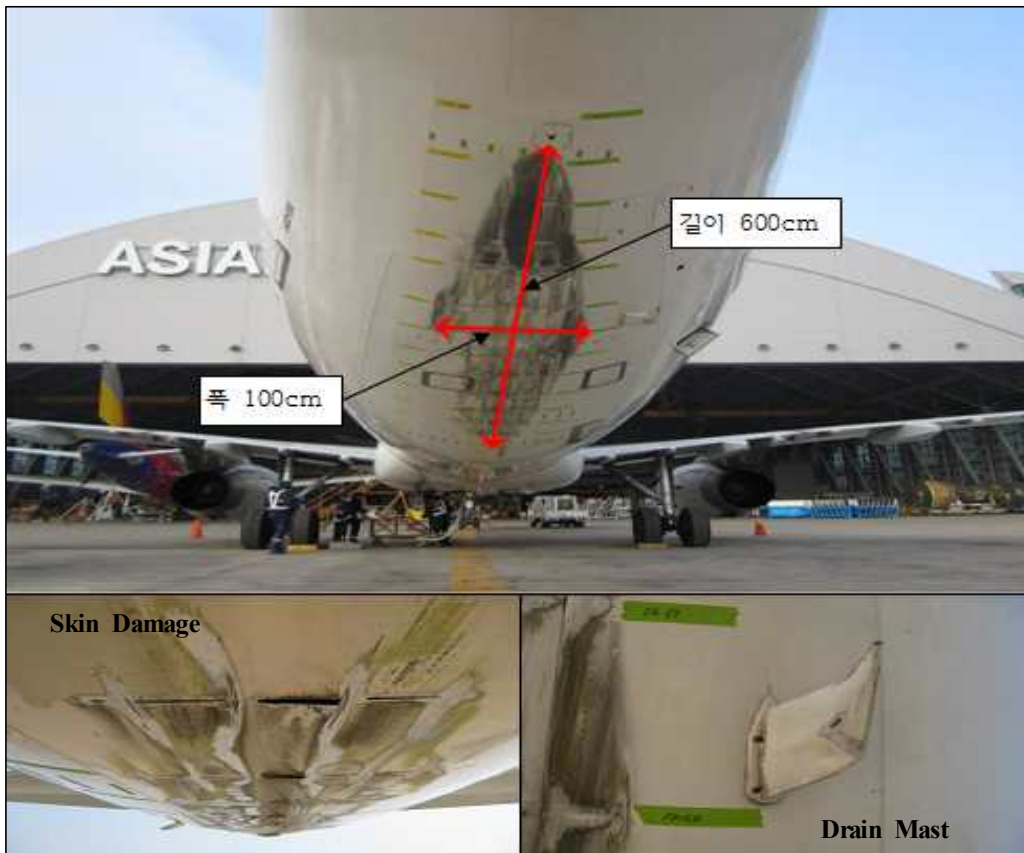
[Figure 1] Damage on the Exterior Surface of the Rear Fuselage

As shown in [Figure 1], as the belly of the rear fuselage contacted the ground during landing, it sustained abrasion damage 100 cm wide and 600 cm long, including wear-through. The drain mast was bent to the side.

As shown in [Figure 4], major repair or replacement of the affected components were performed with technical support of the manufacturer's AOG team for about three months and completed on 12 August 2013. The cost of repairs was about 3.7 billion won (\$ 3.37 million) including personnel expenses.

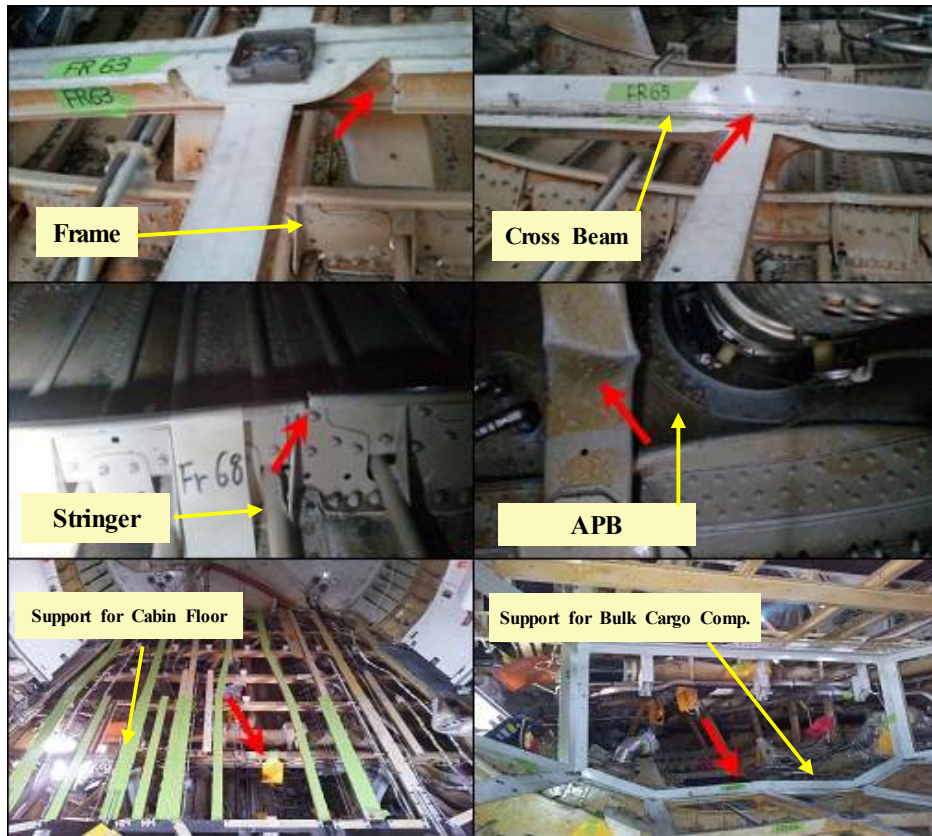
[Figure 2] Damage to the Interior of the Airplane

[Figure 2] shows damage to the interior fuselage. Out of frames, major structure of the fuselage, 11 of them from No. 62 to 72 were cracked or deformed. Also, nine stringers<sup>7)</sup> in the same location, from STGR39LH to STGR41RH, were damaged.

CGO floor cross beam at FR62, FR63, and FR64 was damaged, and PAX floor cross beam at FR65 and FR70 was fractured.

The supports for the water tank and the waste water tank were damaged.

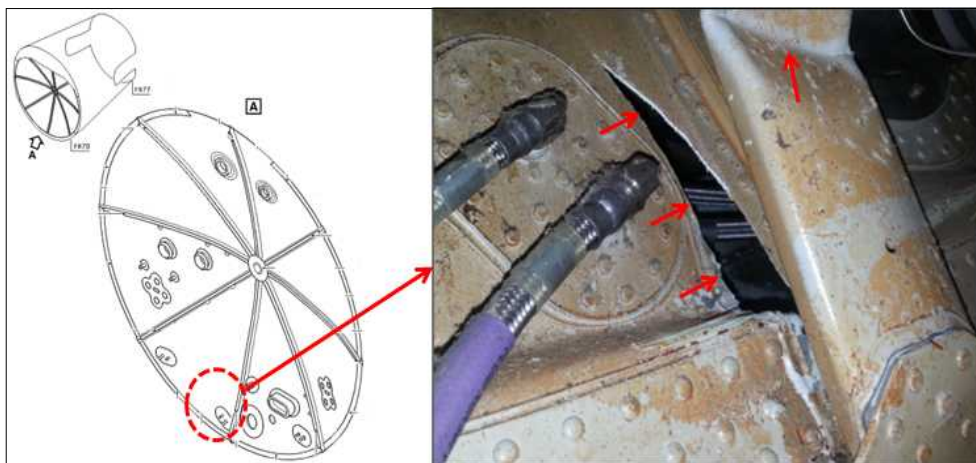
[Figure 3] Damage to the Dished Segment

As shown in [Figure 3], part of the dished segment was deformed or torn at the 6 o'clock position of the aft pressure bulkhead (APB).

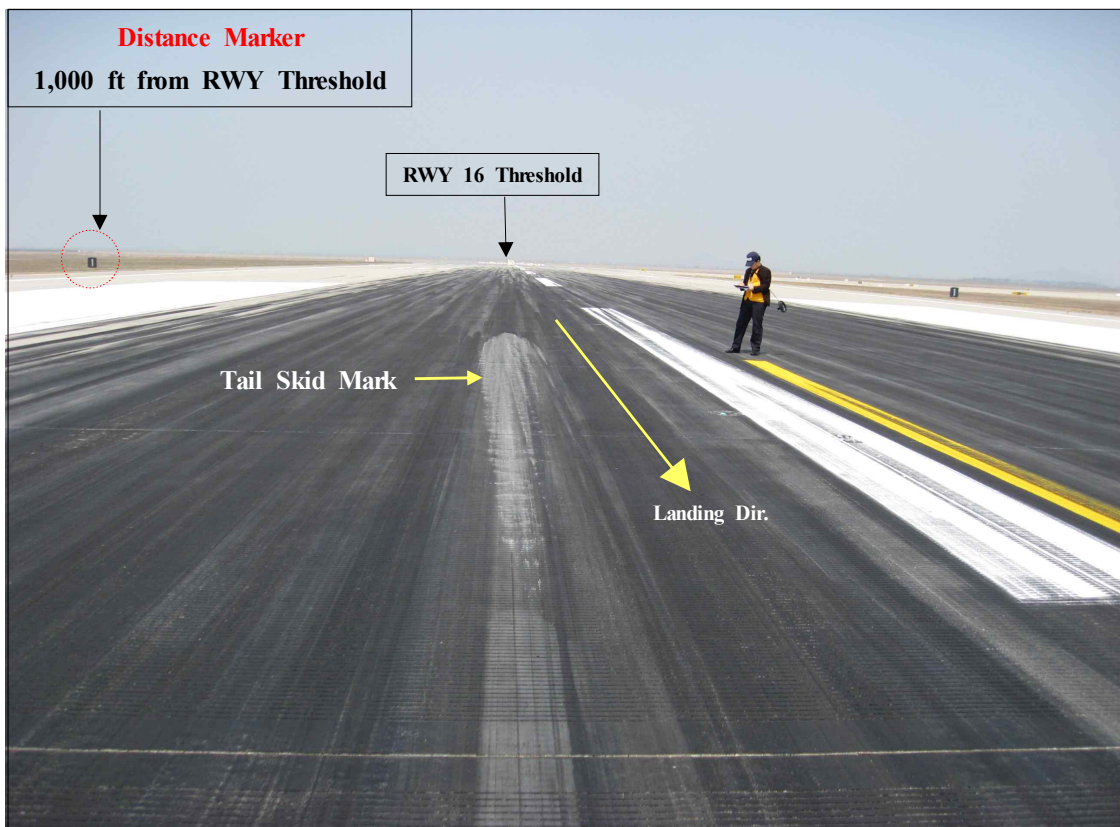
[Figure 7] Tail Skid Mark on Runway

Runway 16's tail skid mark left by HL7730 during landing is shown in [Figure 7]. The mark began about 491 meters from the runway threshold, about 2.2 meters<sup>24)</sup> to the right of the runway centerline, as shown in [Table 2].

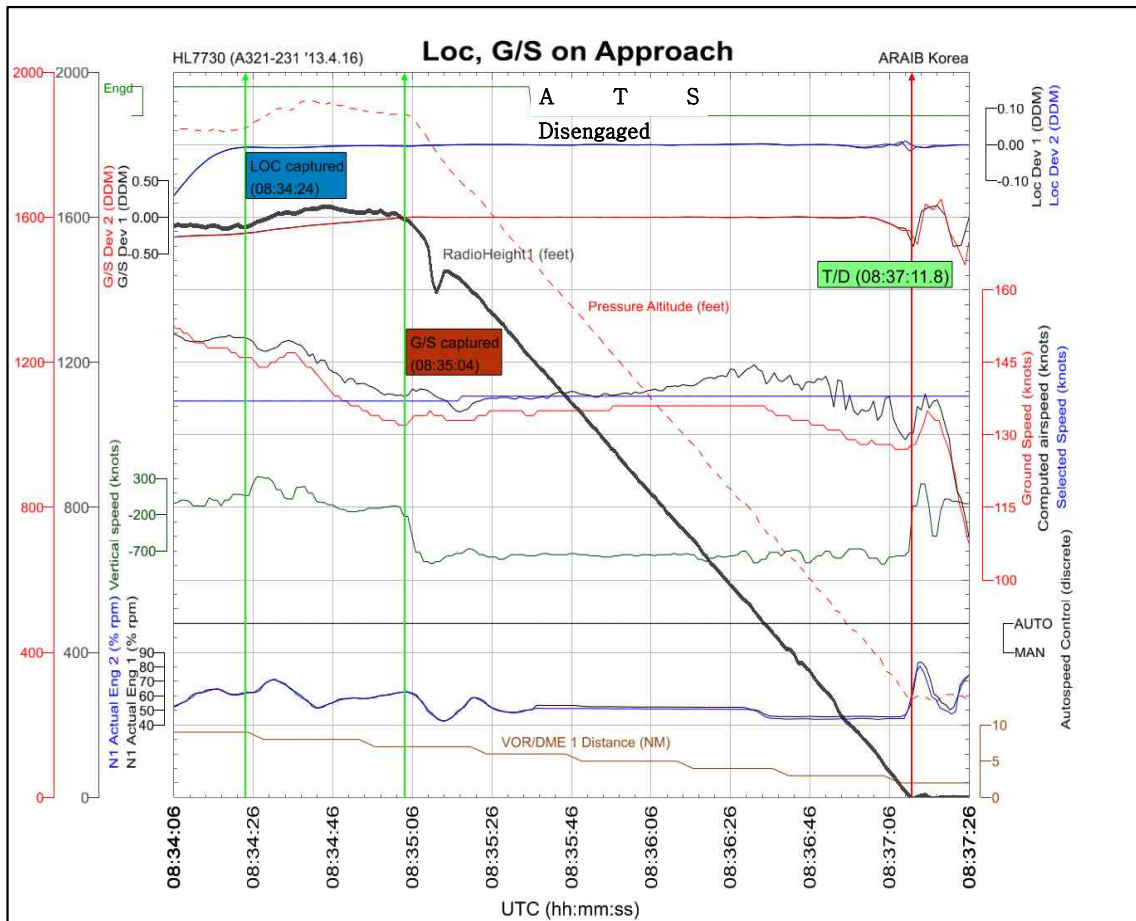
[Figure 9] Major Parameters During ILS Approach and Touchdown

Major flight parameters recorded between HL7730's approach to runway 16 using the ILS approach and touchdown are shown in [Figure 9].

According to the FDR data, HL7730's pitch attitude was 6.7°, 9.8°, and 10.9° on initial touchdown, in the air after bouncing, and on second touchdown, respectively, which indicates that its pitch attitude on second touchdown exceeded 9.7°, an A321 airplane's pitch attitude limitation with the main gear oleo position fully compressed, and that the PF failed to establish the proper pitch attitude at second touchdown after bouncing.

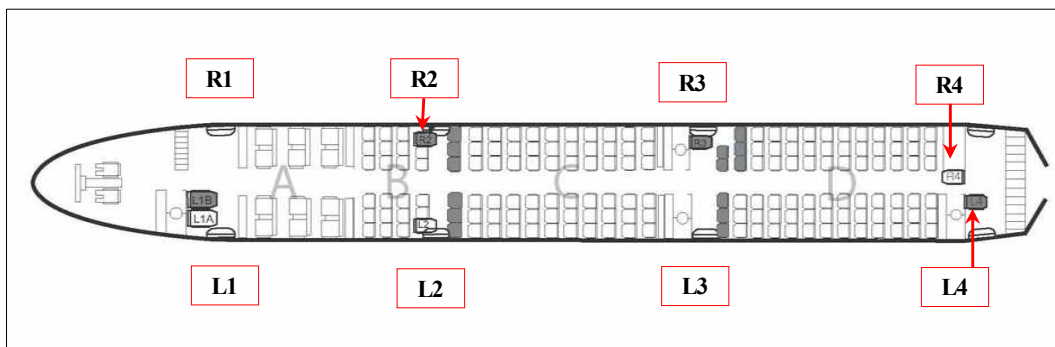
[Figure 10] Locations of Injured Flight Attendants

attendants in jumpseats R2, R4, and L4 sustained injuries<sup>25)</sup> as shown in [Figure 10]."

Flight attendant R4 stated, "I felt like the airplane smashed into the ground with a sudden bang. At the time, two oxygen masks dropped from the ceiling, and the handset for the interphone system fell out of the stowage cradle."
