Ultralight Vehicle Accident Report

Unmanned Rotorcraft Collision with Pilot

Osu Agricultural Cooperative

RMAX L17, S7044

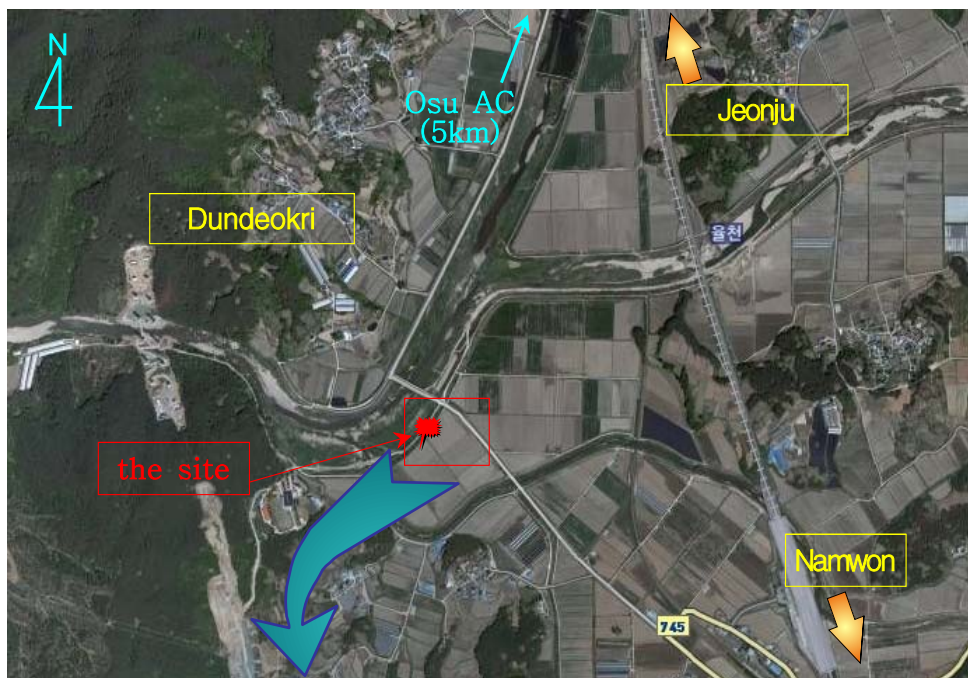
Photo 1. Location of accident

After having lunch at a restaurant nearby, the aerial spray team and the paddy owner arrived at the aerial spray work site shown in [Photo 1]

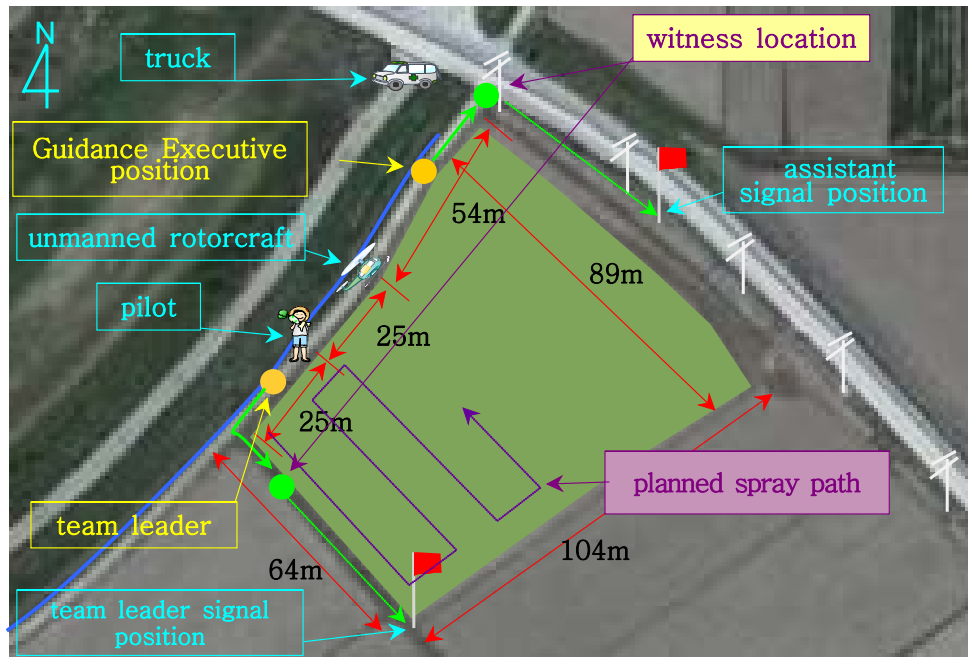
Photo 2. Aerial spray site

for the afternoon aerial spray. According to the statements of witnesses, the aerial spray team made preparations until aerial spray work, such as identification of obstacles in the area scheduled for the afternoon aerial spray, dilution of agricultural pesticide, work briefing and visual check of S7044, and the aerial spray work was planned to be conducted by flying to the left and right from southwest to northeast as shown in [Photo 2].

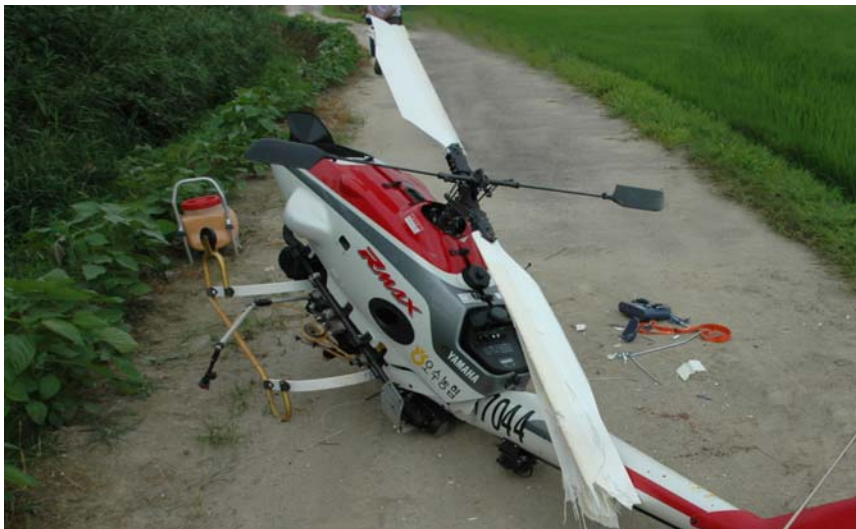
Photo 3. Main rotor damaged

The middle portion of the main rotor blades were broken by ground impact as shown in [Photo 3]. But the balancing stick and the pitch control stick of the hub portion were not damaged.

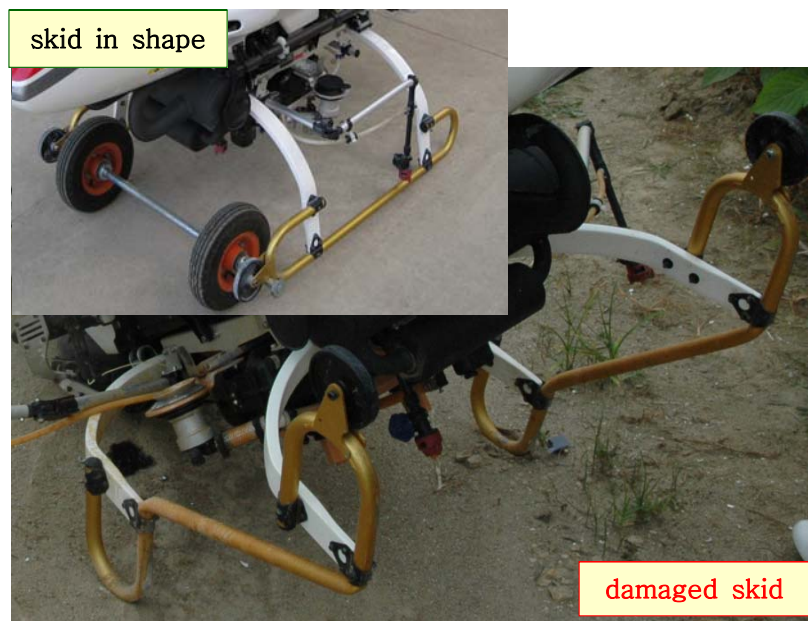
Photo 4. Skid damaged

The skid of the S7044 was bent and damaged by ground impact as shown in [Photo 4].

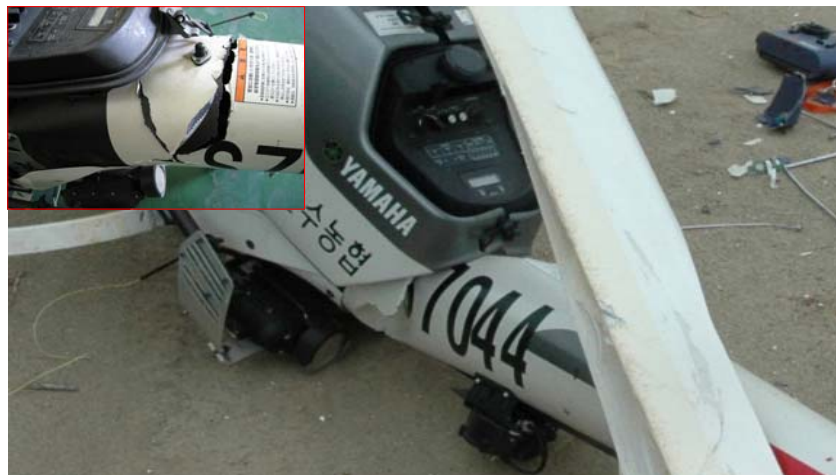
Photo 5. Tail boom damaged

The tail boom was broken at the joint of the forward fuselage and aft fuselage by ground impact as shown in [Photo 5].

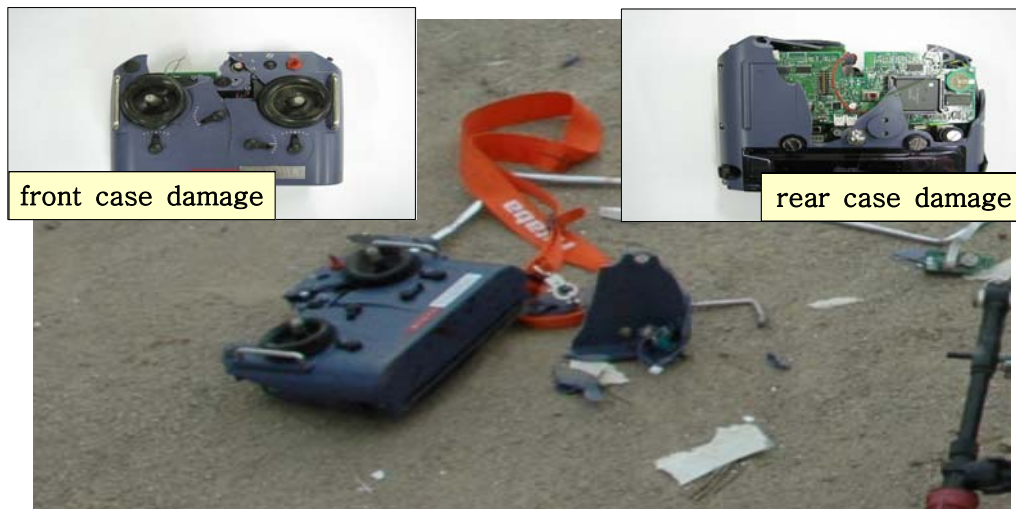
Photo 6. damaged radio control box found at the site

The front and rear case of the radio control box were broken as shown in the [Photo 6], and the inside circuit board was partially damaged due to the collision with rotor blades.

- a. The radio control box had the left portion of the outer case broken by the collision with main rotor blades.
- b. Damage to the circuit board was caused by a strong contact with the metal switch shaft inside.

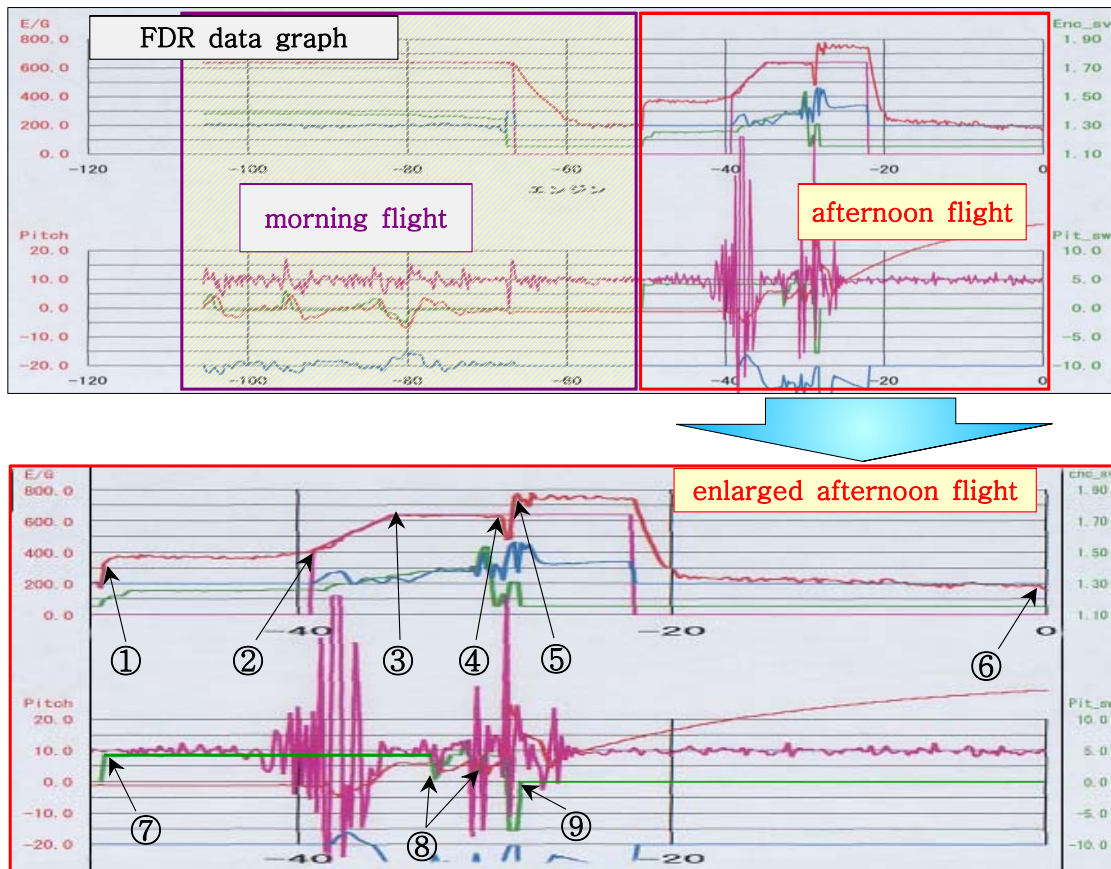
Fig. 2. Major event time verified with the flight record data

- ① : Time of starting data recording (engine RPM 3,250)
- ② : Engine RPM increases
- ③ : the S7044 takes off (engine RPM 6,150)
- ④ : Time at which the S7044 collides with the pilot
- ⑤ : Time at which main rotor blades are damaged (engine RPM increases)
- ⑥ : Engine stops operating (engine RPM decreases below 1,500)
- ⑦ : Point at which swashplate was pulled to pitch up: rearward flight operation
- ⑧ : Point at which swashplate was pushed to nose down (2 times): forward flight operation
- ⑨ : Time at which signal input of radio control cut off

- i. At the point of time ⑤ of -28.6 second, the engine RPM decreased to 4,800 RPM, and after 0.4 seconds it increased to 7,550 RPM again. This RPM jump could be explained that it was caused by partial breaking off of the main rotor blades due to the collision with pilot and ground.

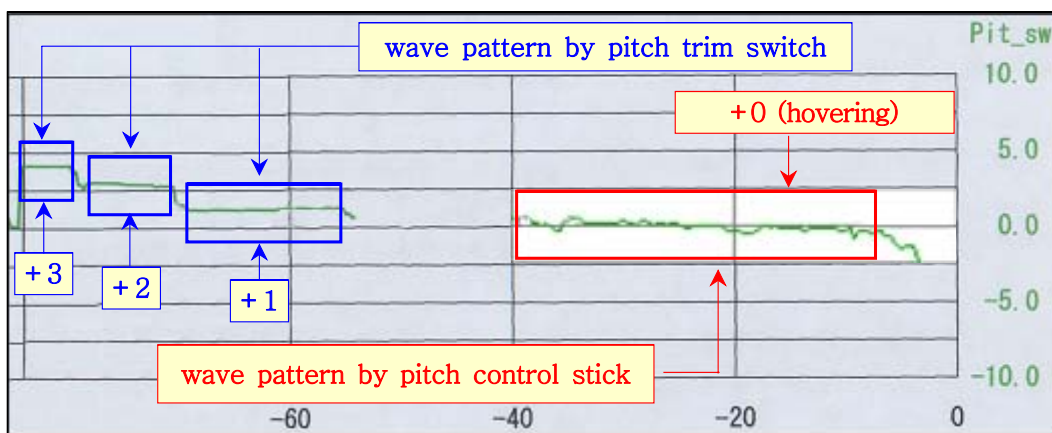
Figure 3. Flight test result pitch signal displacement graph

- a. As shown in the graph of [Figure 3], there was a prominent difference²¹⁾ in the wave pattern between the one (in the red rectangle) made by the pitch control switch and the other one (in the blue rectangle) made by the pitch trim switch. Considering the flat wave pattern, the S7044's swashplate pitch up attitude is judged as the result of operation by the signal made from the pitch trim switch rather than from the pitch control switch.
- b. The swashplate pitch up attitude of +4.8 recorded in the S7044's FDR was reproduced when the pitch trim switch was at the pitch up 3 unit.

21) By pilot's manual control, the graph wave pattern showed high amplitude and dense frequency, whereas the wave pattern by trim switch appeared flat.

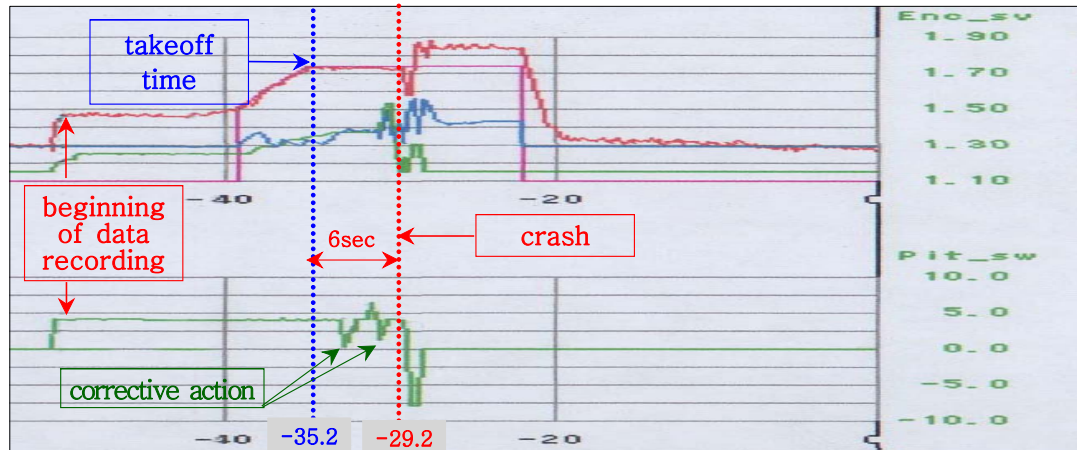
Figure 8. Pilot's corrective input taken immediately before collision

[Figure 8] below shows the corrective control input of the pitch

control stick performed by the pilot to stop the S7044's rearward-movement. The duration of one input appears a little longer than one second, and amount of the input is 4.8.

From two figures shown above, it is revealed that the two momentary control stick inputs made by the pilot were not enough to stop the S7044's rearward movement in its quantity and time duration.

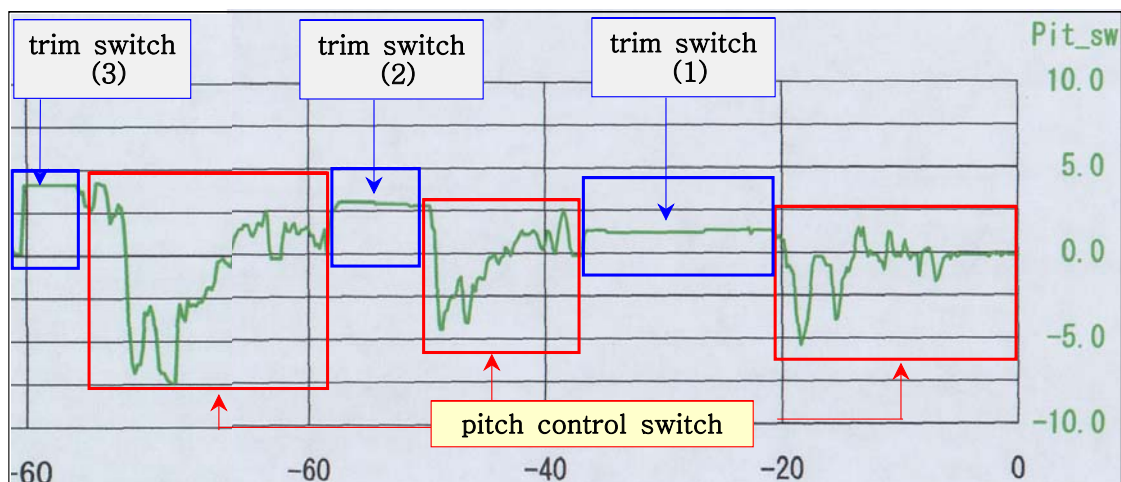
Figure 9. Corrective inputs shown in the test flight

[Figure 9] below shows the movements of the pitch control stick taken by pilot to stop the S7044's rearward flying in which the pitch trim switch is set at 1, 2 and 3 unit respectively in the test flight. It is shown that in order to stop the S7044's rearward-movement when the pitch trim switch is set at 3 unit, pitch control stick input of 12.3 (from swashplate position 4.8 to -7.5) is required.

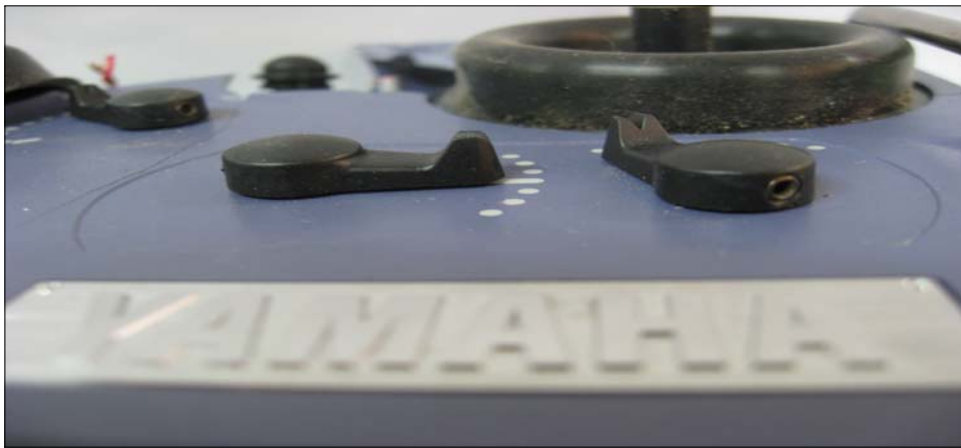
Photo 9. Convex trim switches on the panel of radio control box

All the trim switches are convex feature on the surface of the radio control box as shown in [Photo 9] below, so that there exists a high possibility of setting change caused by careless handling. To prevent the risk of unintentional change of switch setting by mistakes, the design of trim switches and panel and/or relevant software modification should be considered.

1. Consider the improvement of the trim switches and panel of the radio control box and/or modification of relevant software , including the disabling of engine start if the trim switches are inadequately set, to prevent the risk of unintentional switch setting by an inadequate handling (UAR0903-5);
2. Provide the unmanned rotorcraft operators with the detailed grounds which are necessary in establishing safety procedures (UAR0903-6);
3. Add a procedure for checking the position of trim switches of the radio control box in the 「Operator's Manual」 (UAR0903-7); and
4. Reconsider the appropriateness of the 15 m of current safety distance between pilot and unmanned rotorcraft (UAR0903-8).
