# Ultralight Vehicle Accident Report

**Dived and Crashed While Turning**

**ULM COSMOS (Powered Ultralight Vehicle), S1045**

**12 June 2012**

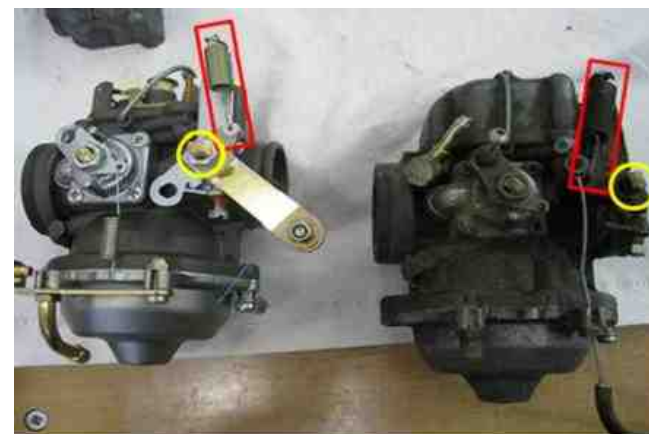
[Figure 2] Delivered Carburetor (left) &amp; Modified Carburetor (right)

The throttle valve lever, which determines the position of the throttle valve<sup>20</sup>, was altered contrary to the delivery status prescribed by the engine manufacturer's installation manual as shown by the right carburetor in [Figure 2].

The engine manufacturer set up a fail-safe<sup>21)</sup> system that functions as follows: if the Bowden cable<sup>22)</sup> is not connected or is fractured, the throttle valve will automatically move into full throttle position, but S1045's throttle valve lever was fitted contrary to the position prescribed by the manufacturer, the consequence of which is that the throttle valve will close to such an extent that the minimum thrust will be used.

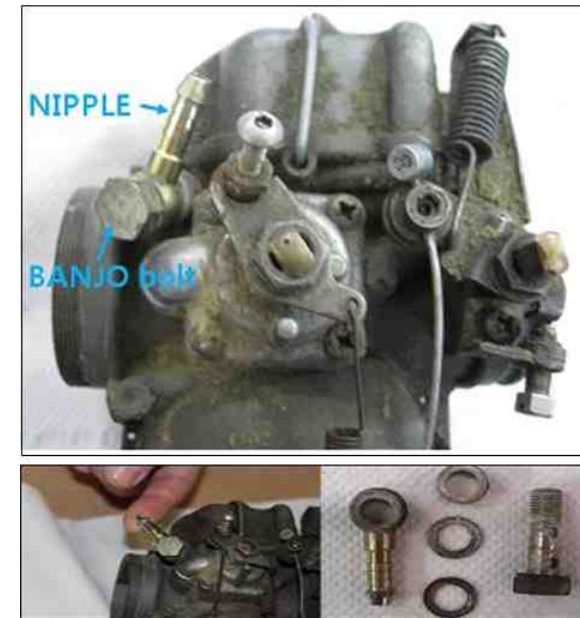
[Figure 3] Carburetor Contaminated by a Loose Banjo Bolt

As shown in [Figure 3], one<sup>23)</sup> of the four carburetors displayed severe external contamination due to a loose banjo bolt that tightens a connecting nipple. The manufacturer's experts determined that contamination resulted from the accumulated deposits of oil and dirt caused by fuel leakage for a long period of time, and that this looseness existed even before the accident.

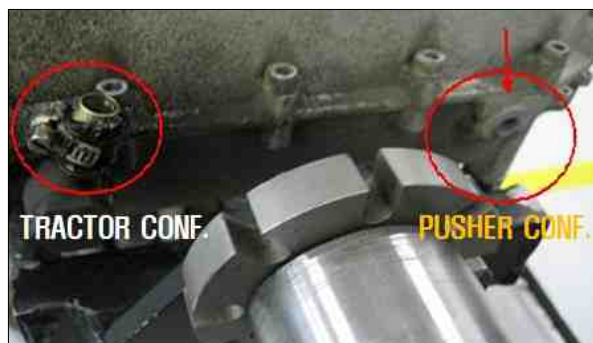
[Figure 4] Oil Return Line Installed at a different position

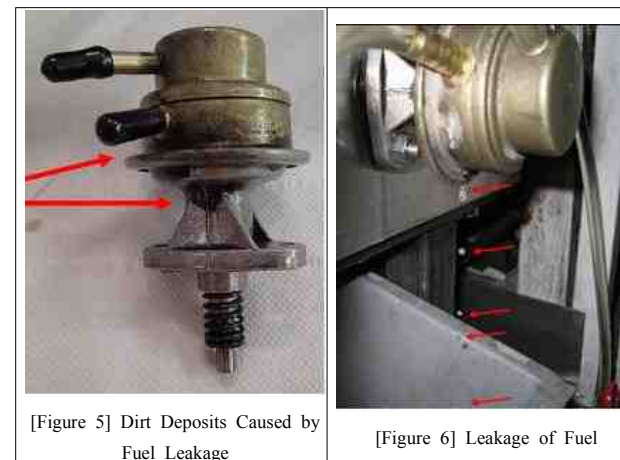
As shown in [Figure 5], dirt deposits, which formed a permanent build-up together with leaking fuel for a long period, were clearly visible on the cast housing, and thus the fuel pump was tested for fuel leakage and fuel pressure on the component test bed. As shown in [Figure 6], the test revealed that fuel leaked from the fuel pump, and that fuel pressure was measured at 0.3 bar, which was within tolerated pressure range from 0.15 bar to 0.4 bar. It was analyzed, however, that the leakage did not affect the function of the pump.

[Figure 5] Dirt Deposits Caused by Fuel Leakage

[Figure 6] Leakage of Fuel

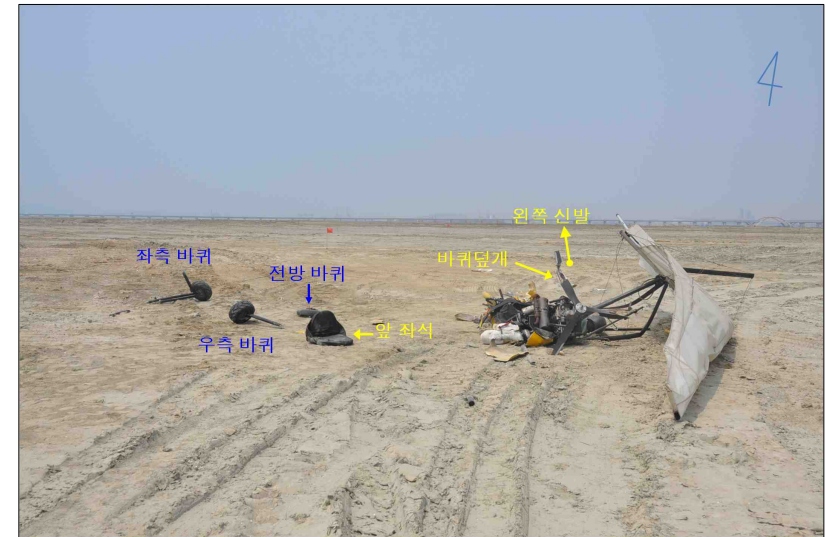
[Figure 7] Wreckage Distribution on the Accident Site

As shown in [Figure 7], the fuselage tilted to the right at about 60° with its longitudinal axis in a north-north-west direction. Wings were located about 70° more to the right from the longitudinal axis in an east-east-north direction. The leading edge of the right wing was in touch with the ground, and its trailing edge was lifted towards the air at about 60° from the ground.

The wreckage was found on the accident site as follows: the left landing gear was found about 10 m west from the longitudinal axis of the fuselage; the forward landing gear and the right landing gear about 6 m west; the operator's seat about 4 m southwest; the forward landing gear cover about 5 m north-north-west; and the left shoe of the passenger about 8m north-north-west. A skid mark and a mark created when the vehicle was dragged on ground were not found on the site.

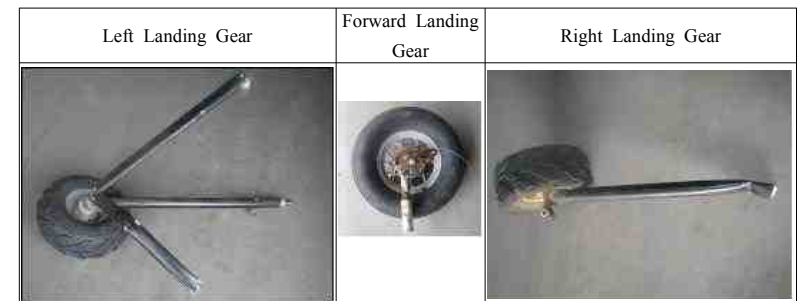
[Figure 8] Landing Gear Damage

As shown in [Figure 8], connecting rods were damaged, and the right landing gear went flat.

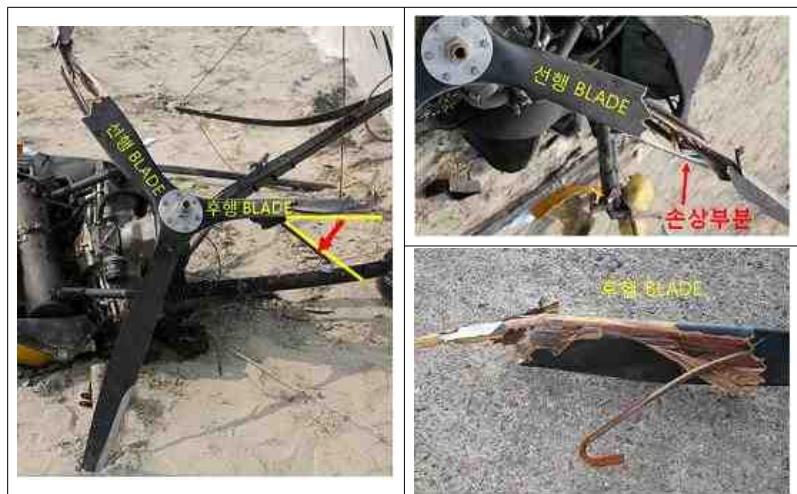
[Figure 9] Propeller Damage

As shown in [Figure 9], two of the three propeller blades were damaged. The preceding blade was damaged mainly at the center from 1/3 point from the central axis of the propeller to the end of the inner wire, but the tip of the blade still remained attached. The succeeding blade sustained more severe damage, and the support rod inside the blade penetrated through it and bent about max. 40° in the opposite direction to the rotation and about 20° in the direction of the rear.

If the engine had been in normal operation in maximum thrust position, all three propeller blades might have been damaged due to high speed rotation since they must have contacted the ground and part of the vehicle during crash. Yet, two blades sustained damage, whereas one was intact.

In addition, S1045's engine must have malfunctioned during ground impact given the following facts: the preceding blade was damaged mainly at the center, with the tip of the blade still remained attached; the succeeding blade sustained more damage than the preceding one; and the teardown inspection of the engine gearbox and the manufacturer's close examination of the engine found no impact mark caused by rotation.

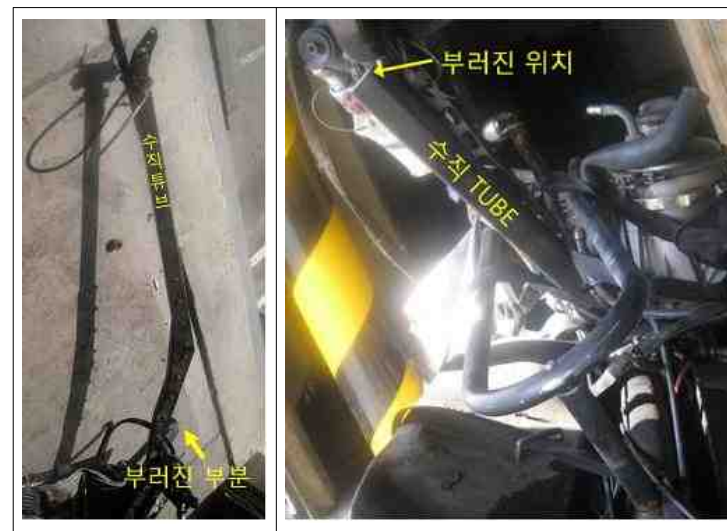
[Figure 10] Broken Vertical Tube

As shown in [Figure 10], the vertical tube was found broken at the bottom and attached. The upper portion of the tube was bent to the operator's right and

twisted clockwise.

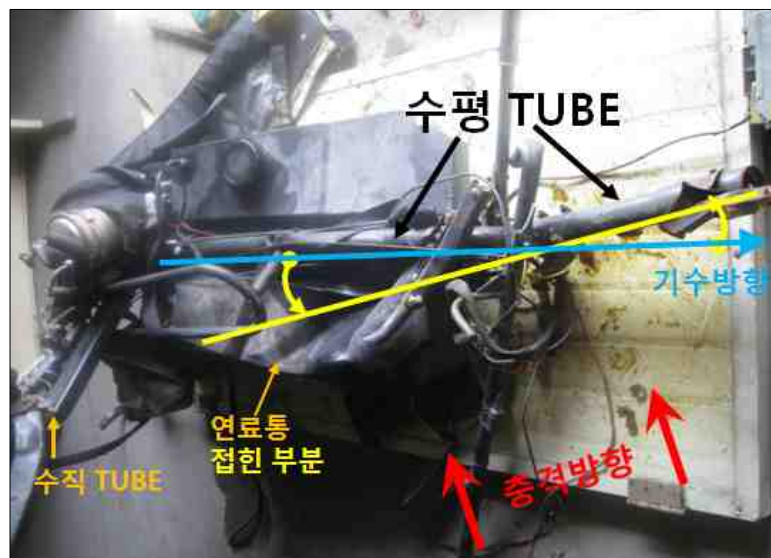
[Figure 11] Bent Horizontal Tube

As shown in [Figure 11], the horizontal tube, which indicates the axial line in the direction of flight, bent at the point situated forward of the fuel tank, about 20° to the left and about 5° upwards. The direction of the bending almost coincided with the direction of the folding line of the distorted fuel tank immediately at the back.

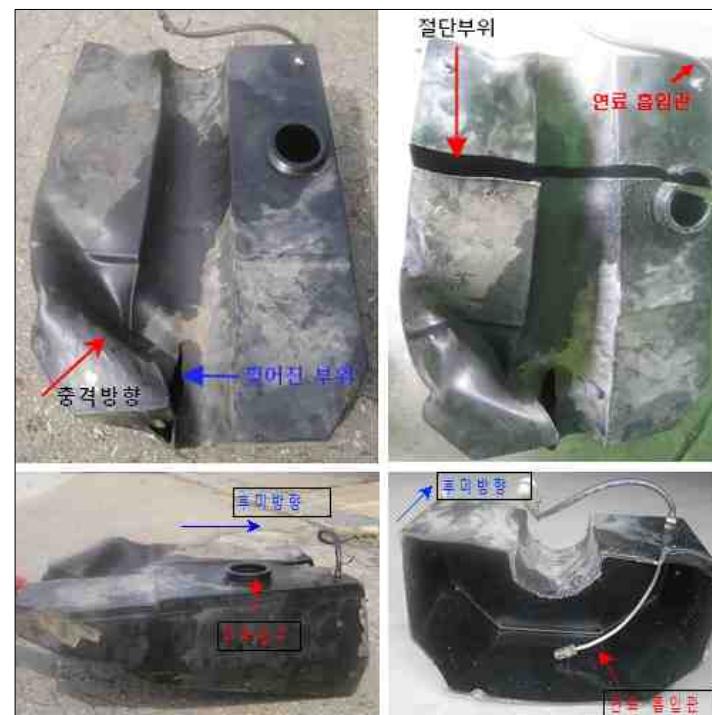
[Figure 12] Damaged Fuel Tank (left) and the Tank Cut (right)

As shown in the right images of [Figure 12], the fuel tank was cut in two pieces to investigate the inner structure. One fuel supply tube with a diameter of 1 cm was installed 6 cm forward from the rear center, and the tip of the pipe inside the tank was located about 2.5 cm from the bottom.

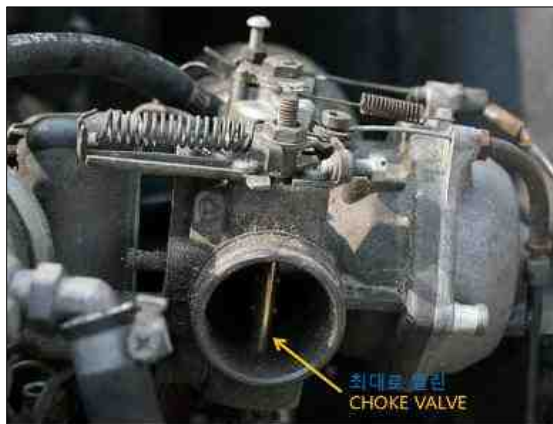
[Figure 13] Choke Valve in the Full Open Position

As shown in [Figure 13], a choke valve<sup>29)</sup>, a throttle valve of the carburetor, was open to the full position, which means that the Bowden cable was not fractured and in full throttle position.

If the Bowden cable had been fractured, the choke valve of the affected vehicle should have been in the closed position because the fail-safe system was not in place as previously mentioned in 1.6.5.1.1.

Wreckage investigation revealed that the Bowden cable was not fractured and in normal operation, and thus, the throttle valve was in full throttle position during impact.

On the accident site, a choke valve was found open to the full position, which means that the Bowden cable controlling engine thrust was not fractured, and that the operator wanted maximum thrust.

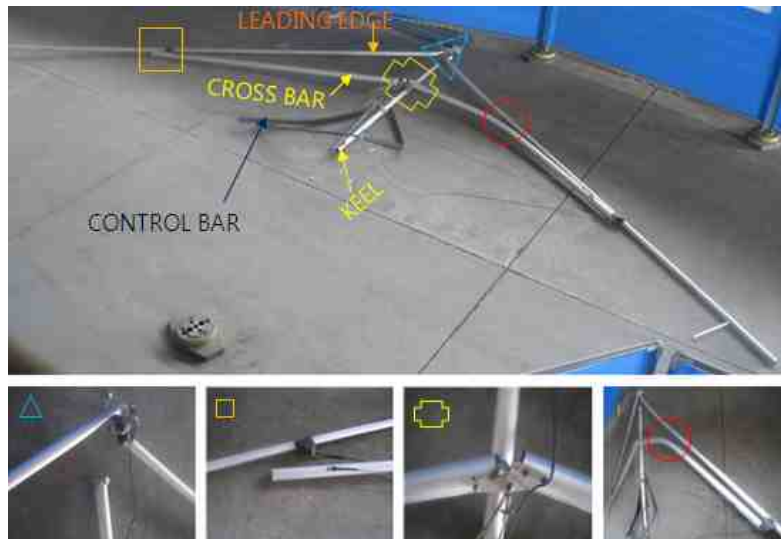
[Figure 15] Inner Structure of the Wings and its Damage

As shown in the blue triangle of [Figure 15], the left leading edge was fractured at the nose plate and remained attached. The keel was separated upon initial impact, and when it impacted the left leading edge again, its mouth was crushed to the right.

As shown in the orange rectangle of [Figure 15], the left cross bar was separated from the left leading edge, and as shown in the red circle, the center of the right cross bar was bent to the right. At the plate, intersection point of the cross bar and the keel, the left cross bar was connected to the keel and the right cross bar, with one bolt missing.

As shown in [Figure 15], the upright bar of the control bar in a triangular shape was bent at the center, and the left portion of the base bar at the bottom was separated. Four landing wires and six flying wires of the vehicle were connected with the wing frame and the control bar, and no functional anomaly was found.

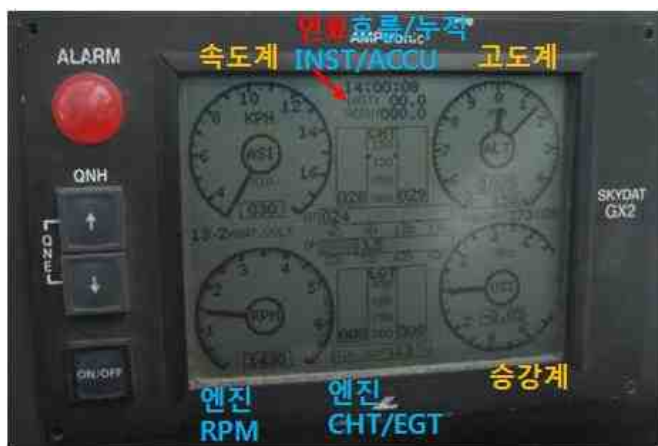
[Figure 17] S1045's SKYDAT GX2 Instrument Panel

As shown in [Figure 17], S1045 was equipped with SKYDAT GX2 instrument panel manufactured by AMPtronic. On the LCD screen, indications of flight instruments including speedometer, altimeter, and variometer are displayed along with engine instrument indications such as RPM, EGT, and CHT.

There were also fuel instrument indications such as INST and ACCU on the LCD, but they were not usable since a fuel flow sensor was not installed.

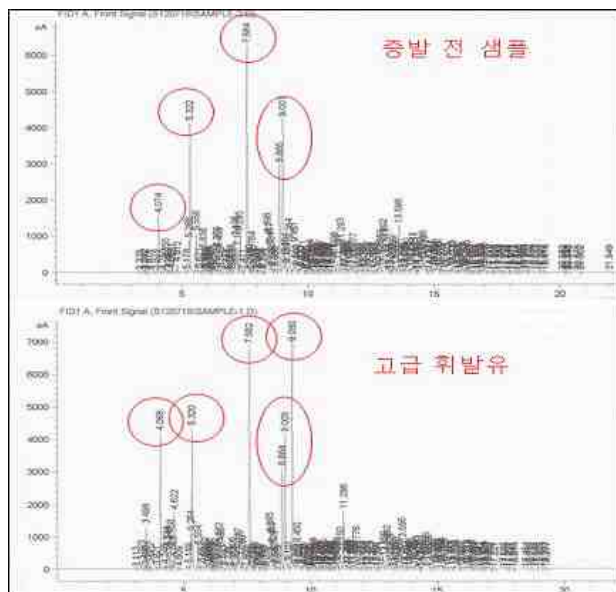
[Figure 19] Analysis Results of Fuel Sample before Evaporation (GC-MS)

The fuel sample before evaporation was analyzed by FTIR and GC-MS. The analysis results revealed that as, shown in [Figure 19], elements of the fuel sample were similar to those of high-grade gasoline.

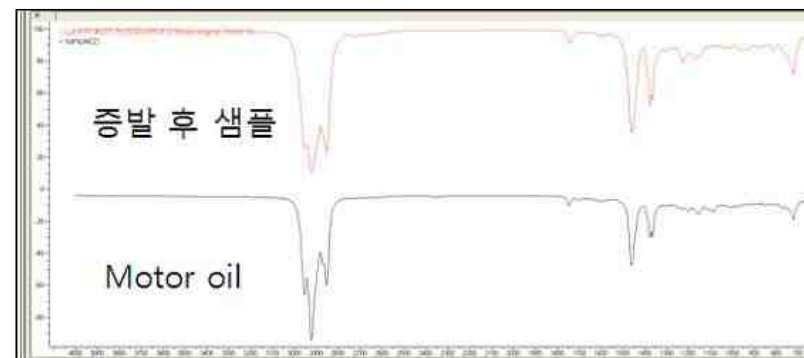
[Figure 20] Test

A large quantity of deposits remained after fuel was evaporated, and they were analyzed by FT-IR, which revealed that, as shown in [Figure 20], elements of the deposits were similar to those of motor oil.

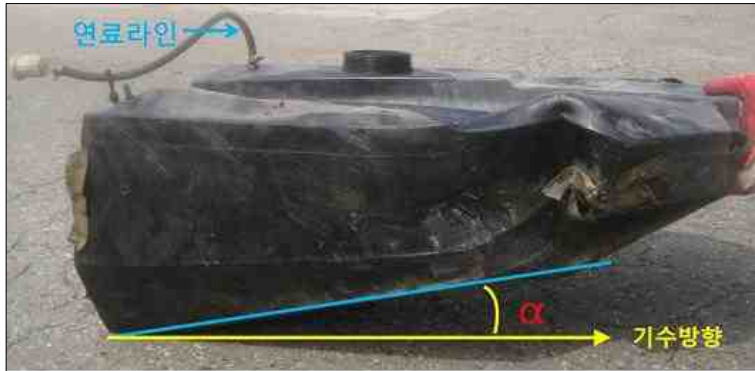
[Figure 21] Fuel Tank Viewed from the Side

As shown in [Figure 21], when S1045 maintains a level flight attitude, the base side of the fuel tank forms a dihedral angle of  $\alpha$  (about  $20^\circ$ ) with a virtual horizontal line running from the nose to the tail, and thus, fuel settles to the rear where the fuel supply tube is located. When the vehicle descends at an angle of  $\alpha$  (about  $20^\circ$ ), fuel is distributed evenly at the bottom, but when the vehicle descends at more than  $\alpha$ , fuel settles to the front.

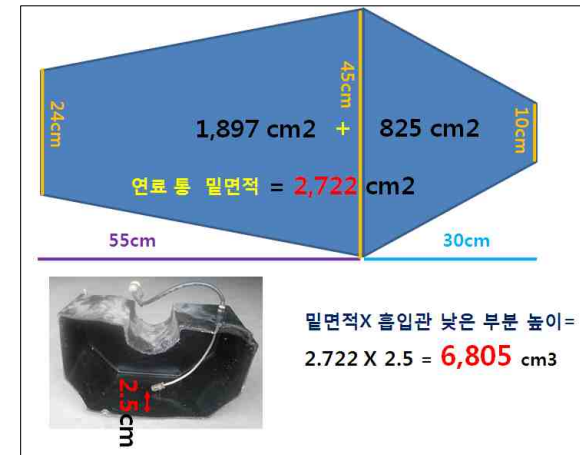
[Figure 22] Calculation of the Minimum Fuel Quantity  
When the Base of the Tank Is Horizontal

As shown in [Figure 22], the area of the fuel tank's base is approximately

2,722 cm<sup>3</sup>. As the tip of the tube inside the tank was located about 2.5 cm from the bottom, there should be at least minimum 6.8 liters of fuel ( $2,722 \times 2.5 = 6,805$  cm<sup>3</sup>) to be fed to the engine when the vehicle descends at about  $20^\circ$ . If the descent angle or bank angle of the vehicle increases in this flight attitude, there should be more fuel than 6.8 liters.

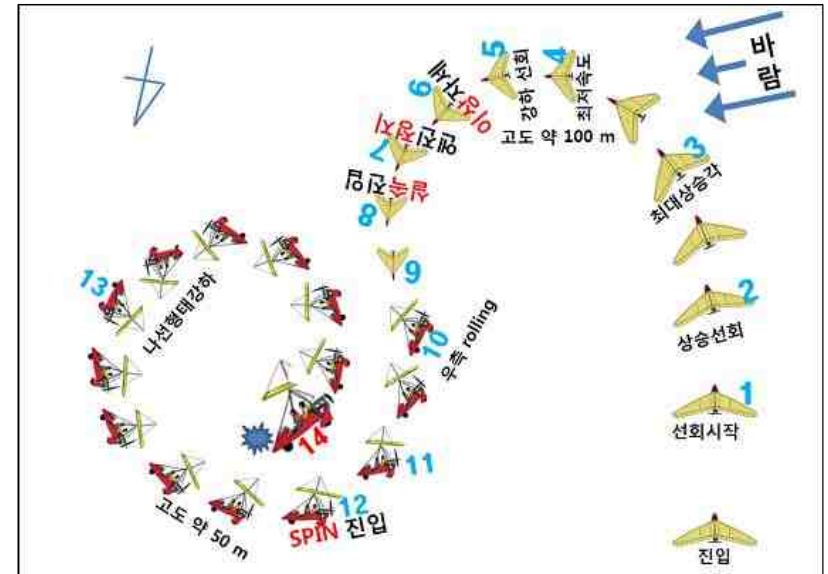
[Figure 23] Process from Entry into the Turn to the Impact

It is assumed that, at location #13, the vehicle circled in a spiral as its bank and descent angles reduced, and that, at location #14, it was subjected to the roll moment due to the right spin and crashed into the ground at about 20° descent angle and about 5° right bank angle.
