AIRCRAFT ACCIDENT REPORT

CRASH INTO A OBSTACLE DURING A DESCENT FOR LANDING
LG ELECTRONICS

S-76C⁺⁺, HL9294

16 NOVEMBER 2013

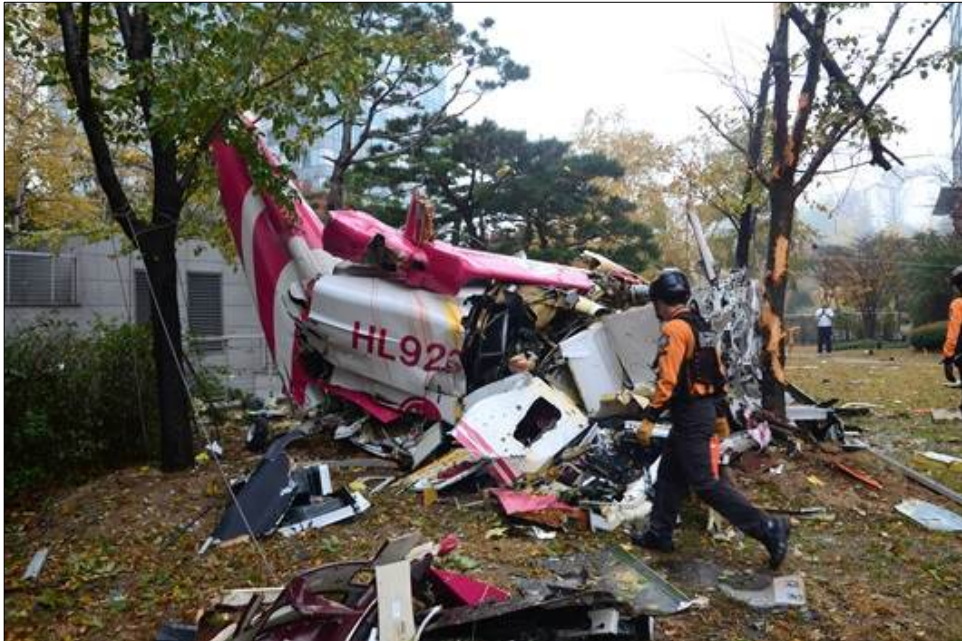
[Figure 2] Wreckage of the Event Aircraft

As shown in [Figure 2], HL9294 was destroyed by the crash impact. HL9294 was insured against hull damage,²⁰⁾ crew and passenger injury,²¹⁾ and bodily injury and property damage,²²⁾ effective²³⁾ at the time of the accident.

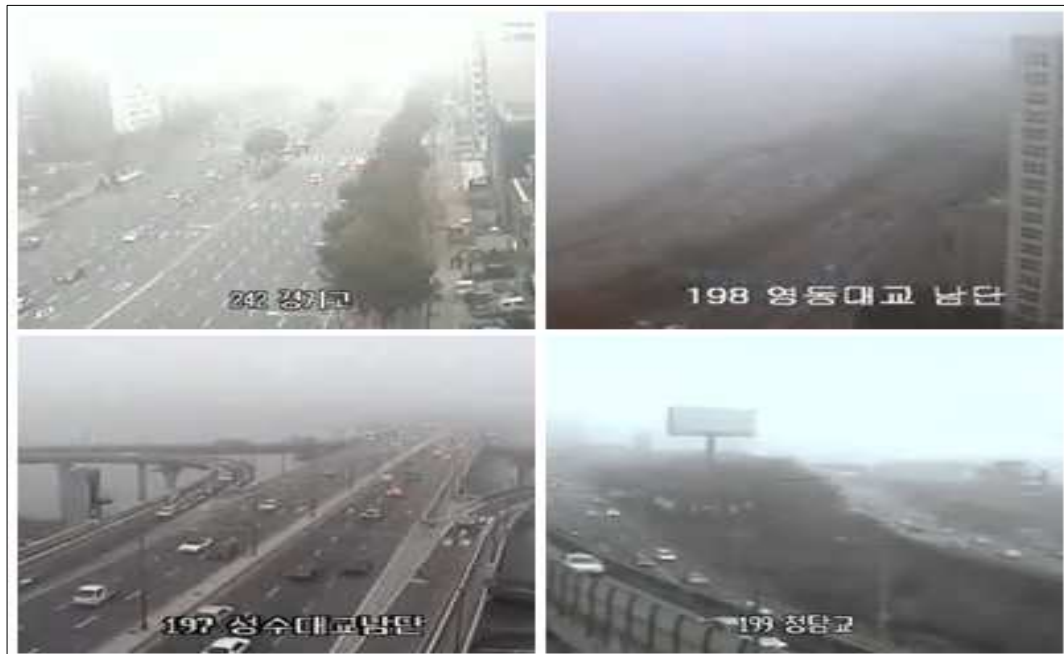
[Figure 3] CCTV Images of Olympic Expressway about 08:30 on the Event Day

※ CCTV Height (about 30 m), Visibility (about 100 - 200 m)

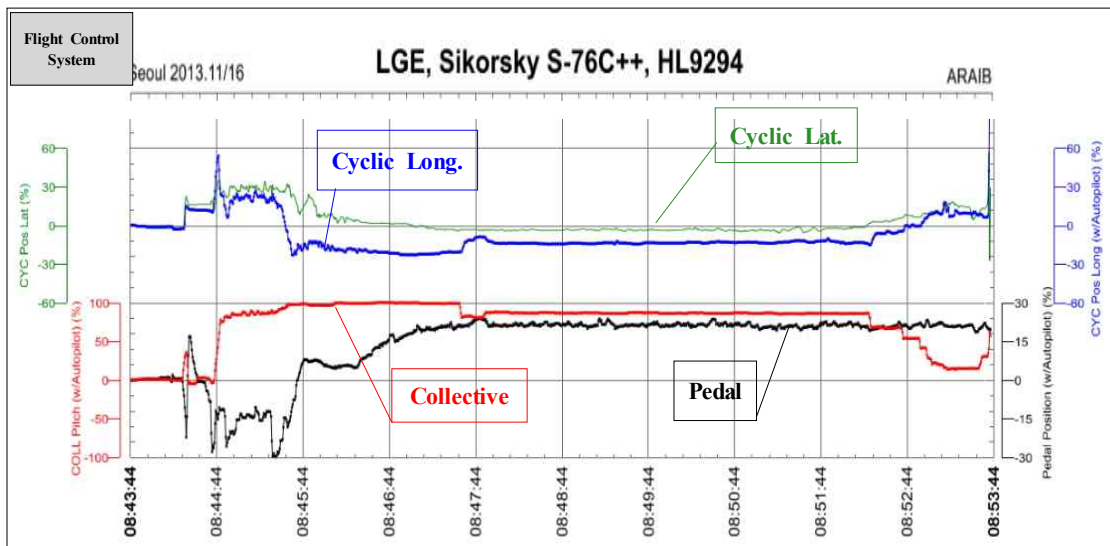
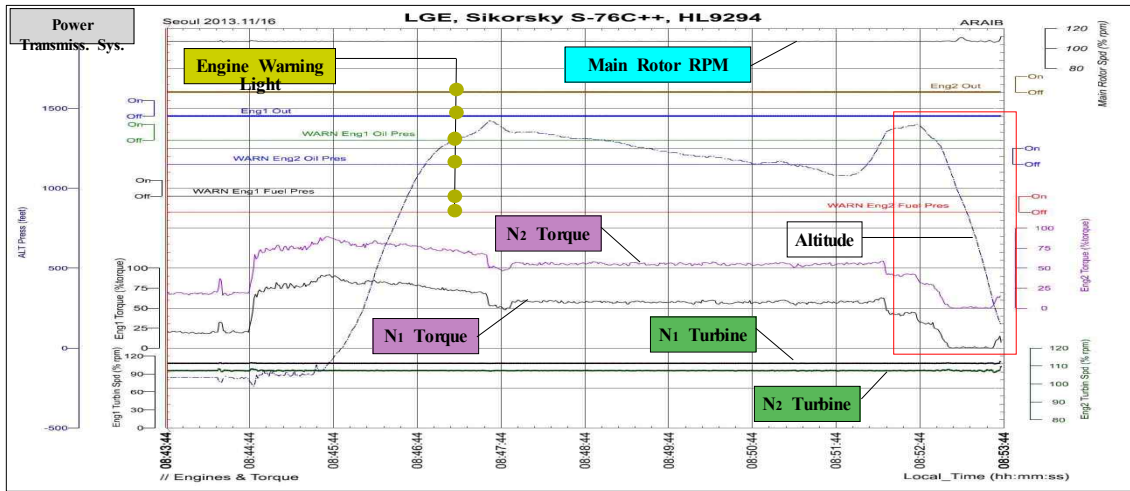
[Figure 7] FDR Parameters

Analysis of the FDR parameters related to engines, flight control system, and power transmission system revealed that there was no evidence of defects in them. Review of the CVR transcript also failed to find that the pilots detected any failures with the aircraft.

As shown in [Figure 7], on the flight leg before the accident, HL9294's engine turbine RPM (green box) and main rotor RPM (light blue box) were maintained normal, and engine N1 and N2 torques (pink box) decreased (red box) due to power decrease caused by altitude drop. No engine-related warning lights⁷¹⁾ were illuminated.

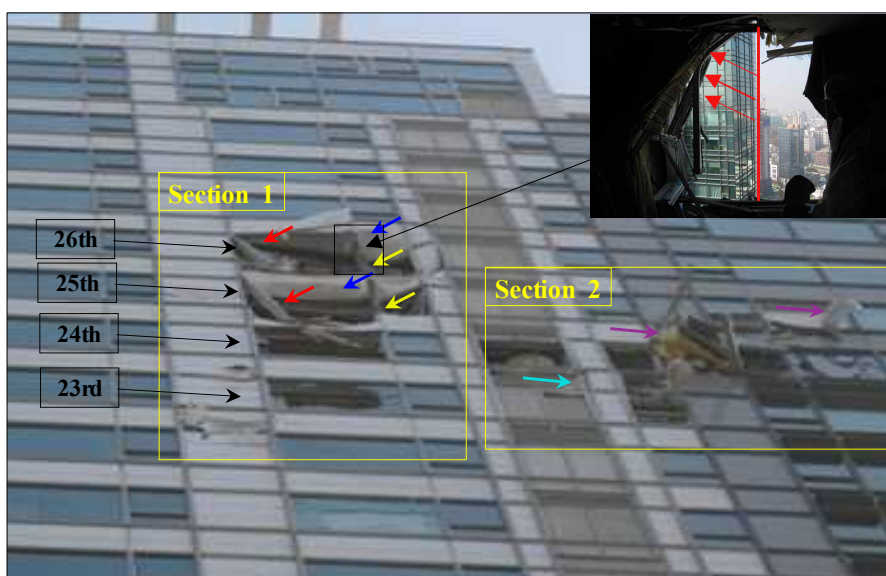
[Figure 10] Condominium Building Damage

The area damaged by a direct impact with HL9294 mainly contained the 23rd, 24th, 25th and 26th floors on the north side of building 102, and it is divided into two sections as shown in [Figure 10]. Apart from this area, other damages to the building were caused either by fragments of the main rotor blades generated by the initial impact or by fuselage debris scattered during the crash into the ground.

As shown in [Figure 10], the lower part of the window frames (red arrow) in Section 1 was bent from left to right and fractured, and centerline window frames (yellow arrow) were bent from bottom left to upper right. Exterior panels (blue arrow) on the 25th and 26th floors were compressed and bent upwards from the bottom.

In Section 2, mainly exterior panels or window frames (light blue arrow) were torn out from left to right, and some window frames (purple arrow) sustained damage when pushed to the right.

Judging from the damage to the condominium building, the left side of the climbing aircraft initially crashed into Section 1, then, as its tail boom was rotated by inertial force, the aircraft impacted Section 2 for the second time.

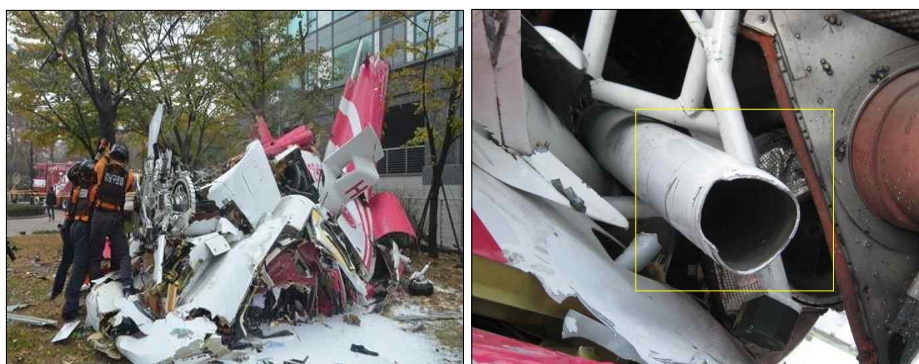
[Figure 11] Compressed Fuselage and Damaged Tail Rotor Driveshaft

As the main fuselage fell to the ground, right down from Section 2 shown in [Figure 10], the upper and lower sections of the main fuselage were crushed in, and the gearbox with its middle portion broken was separated from its assembled position and placed on top of the cockpit along with the hub. Please, refer to [Figure 11].

The tail boom was fractured at the junction with the main fuselage and the horizontal stabilizer. The tail rotor driveshaft was fractured by a strong rotational overload, and damage from rotation (scratches) was found around its fracture surface.
