# AIRCRAFT SERIOUS INCIDENT REPORT

**Reentry to Runway after Runway Excursion on Landing**

**B737-800, HL8224**

**Guam International Airport, Runway 6R**

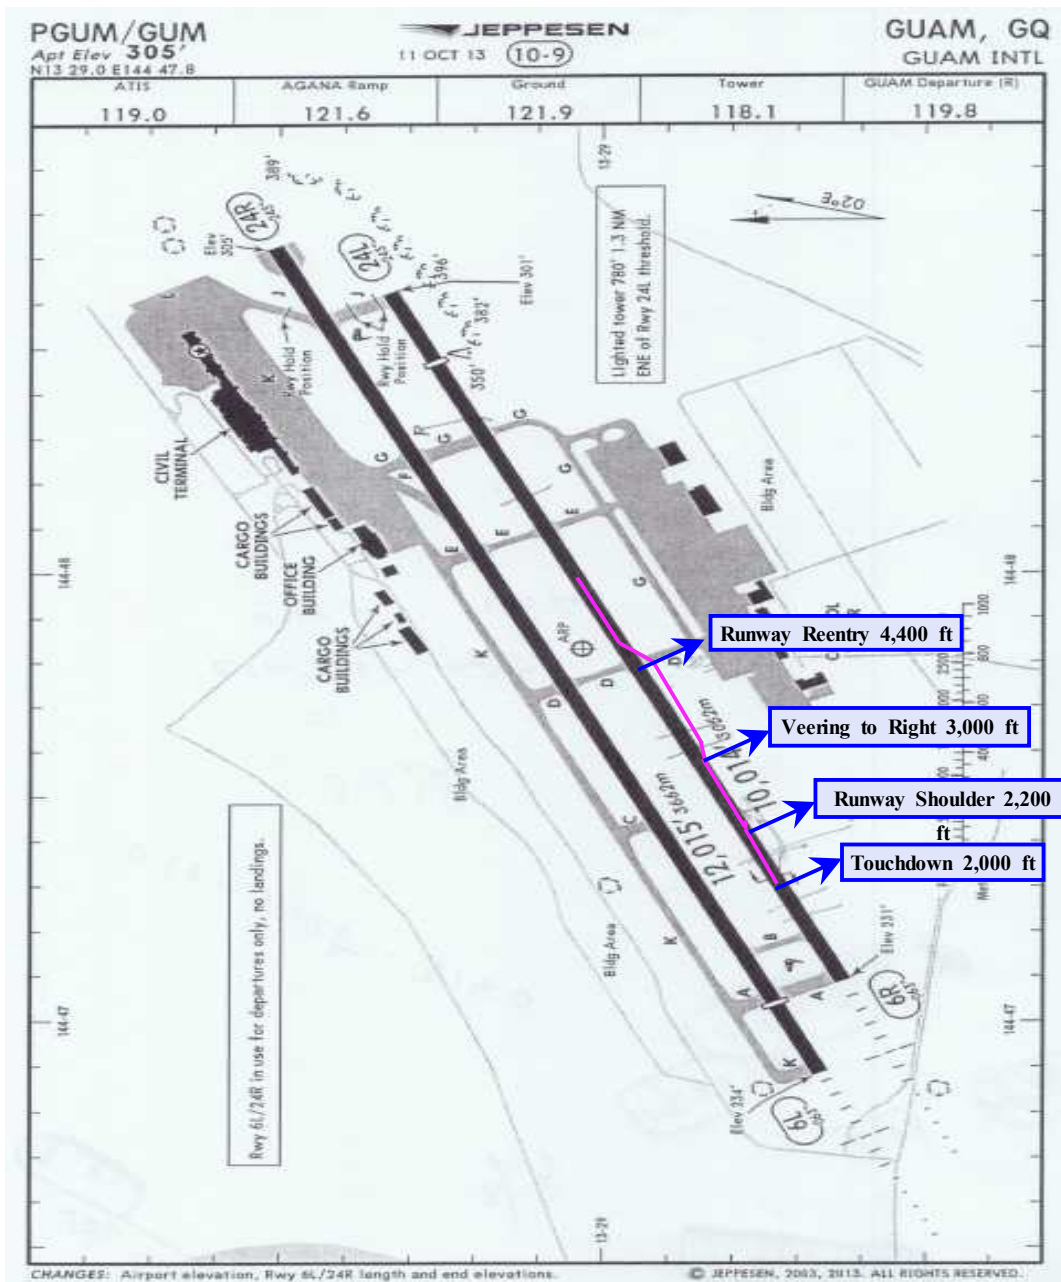
[Figure 1] Runway Excursion and Reentry Path

The aircraft was inspected on the runway before #2 engine was shut down, and was towed to the ramp. HL8224's runway excursion and reentry are summarized in [Figure 1] and [Figure 2].

<p>Skid Marks at 2,000 ft</p>	<p>Skid Marks at 2,000 ft</p>

The aircraft started to veer right about 2,200 ft past the runway threshold and departed the paved surface of the runway. Both main landing gears were completely off the runway about 3,000 ft past the runway threshold before the aircraft reentered the runway about 4,400 ft past the runway threshold. Judging by this fact, the ARAIB believes that, immediately after touchdown, the captain failed to steer the aircraft back towards the centerline.

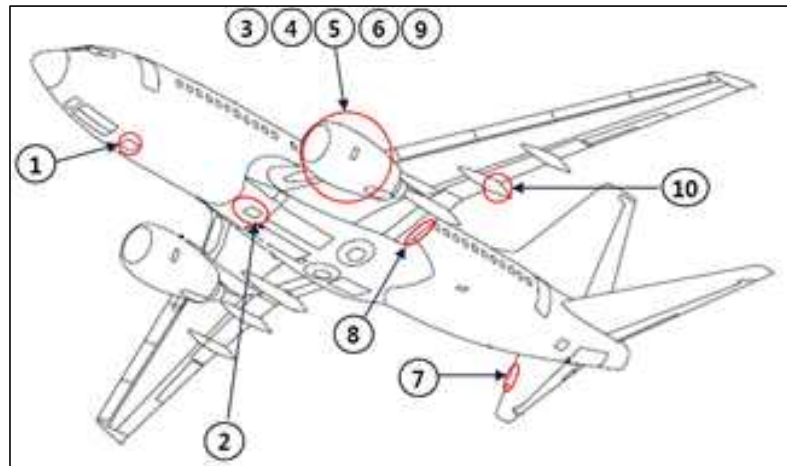
[Figure 3] Damage to Aircraft

As shown in [Figure 3], as the aircraft veered off the runway and ran through grass, #1 engine, electronic equipment (E/E) compartment access door, and wing-to-body fairing sustained damage, about 1.4 billion KRW worth.

The E/E compartment access door was inspected and reinstalled, and the wing-to-body fairing was replaced. Dent in RH horizontal stabilizer leading edge skin was judged to be within the allowable range of damage in the manual, so left unrepaired. Dent on the bottom skin of LH wing aft flap and crack in LH wing #2 flap support fairing tail cone were temporarily<sup>5)</sup> repaired to be closely examined at the company base.<sup>6)</sup>

All tires, brake, #3 VHF<sup>7)</sup> antenna, LH & RH landing retractable light and outflow valve<sup>8)</sup> were replaced, and the main landing gear temperature sensor bracket was repaired.

All blades of #1 engine, engine inlet cowl, and RH thrust reverser cowl were replaced, and as a temporary repair,<sup>9)</sup> a crack stop hole was drilled into #1 engine RH fan cowl. Also, #1 engine abradable shroud rubbing damage was deferred according to the maintenance manual, and #1 and #2 engines were on borescope inspection (BSI).

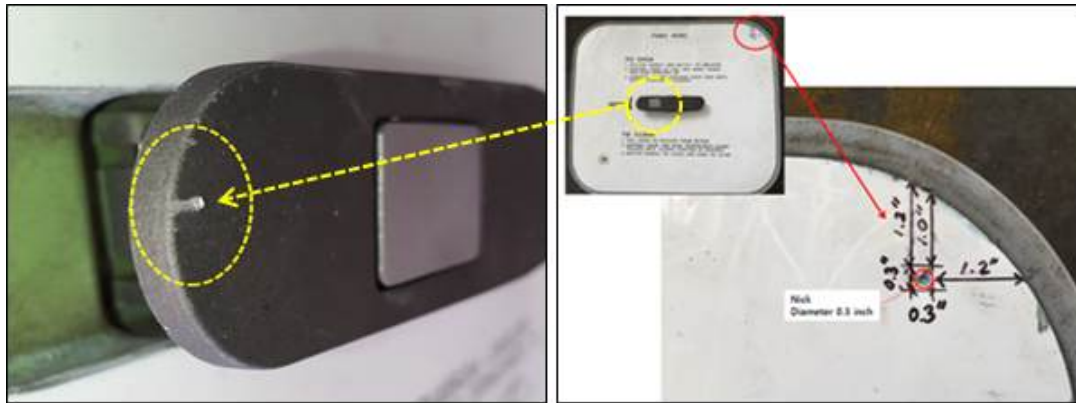
[Figure 4] Damage to E/E Compartment Access Door

As shown in [Figure 4], the E/E compartment access door opened because the door handle turned when the aircraft struck foreign objects during runway excursion, which caused grass and soil to ingest into the E/E compartment.

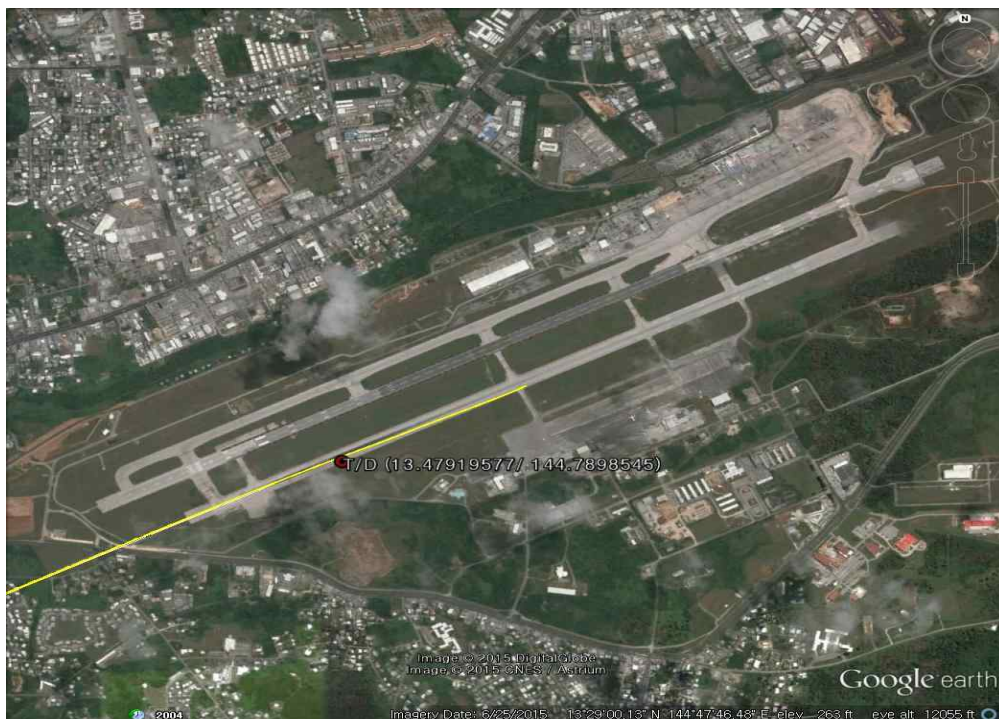
[Figure 12] HL8224 Touchdown Point

Just before touchdown, crosswind from the left caused the aircraft to veer right and touch down on the right hand edge of the runway about 2,000 ft past the runway threshold. Judging by the fact that the FO advised the captain twice to steer the aircraft left after touchdown, the ARAIB concludes that they probably did not recognize that the aircraft would touch down at the right hand edge of the runway.

The ARAIB concludes that the reason why HL8224 touched down at the right hand edge of the runway while veering right under the influence of crosswind from the left at a low altitude was that the captain failed to apply not only upwind aileron sufficiently to prevent the aircraft from veering right but also downwind rudder adequately to align the aircraft longitudinal axis with the runway centerline.

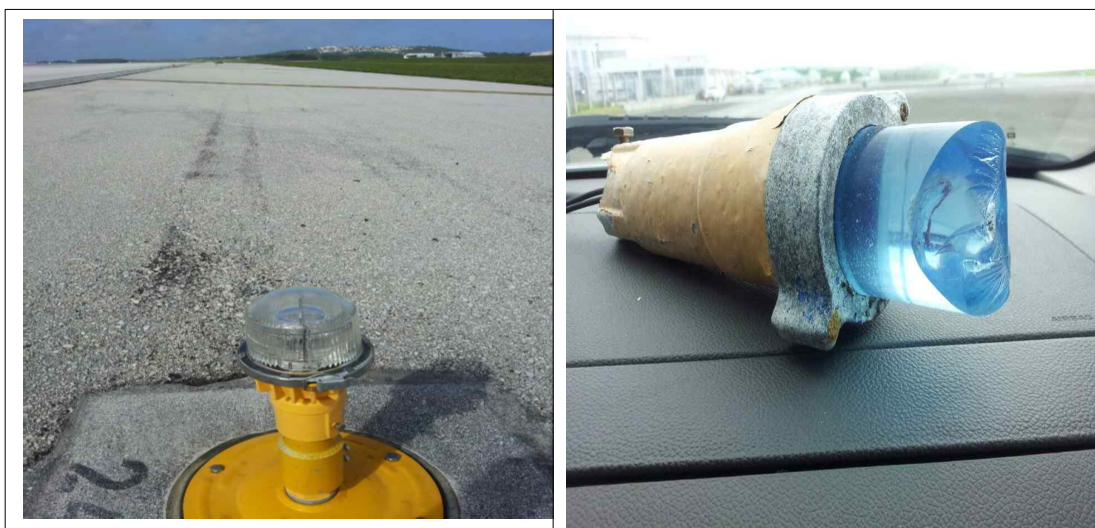
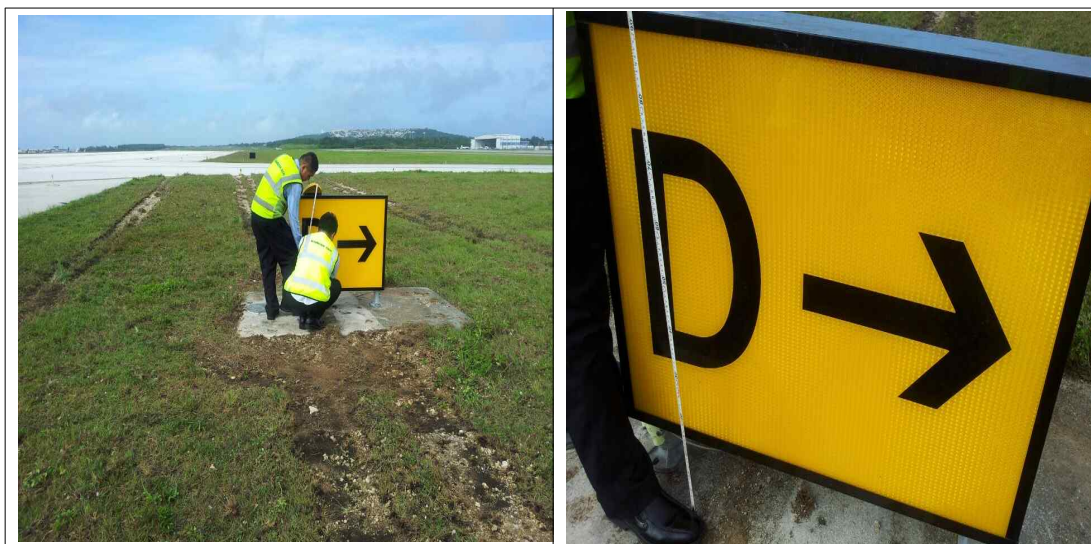
[Figure 13] Airport Facilities Damage

As HL8224 veered off the runway and ran through grass, the aircraft engine and part of the fuselage sustained damage, and two runway edge lights, two taxiway lights, and a taxiway D sign were damaged, as shown in [Figure 13].
