Aviation and Railway Accident Investigation Board

Aviation Accident Preliminary Report

HL8088 (B737-800) belly landing, runway overrun and crash to embankment

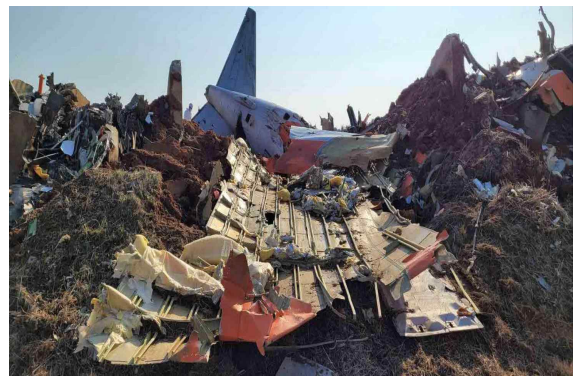
Lower fuselage

aligning with the runway centerline. The airplane belly-landed without its landing gear deployed, overran the runway, and crashed into the embankment, including the installed localizers, bursting into flames.

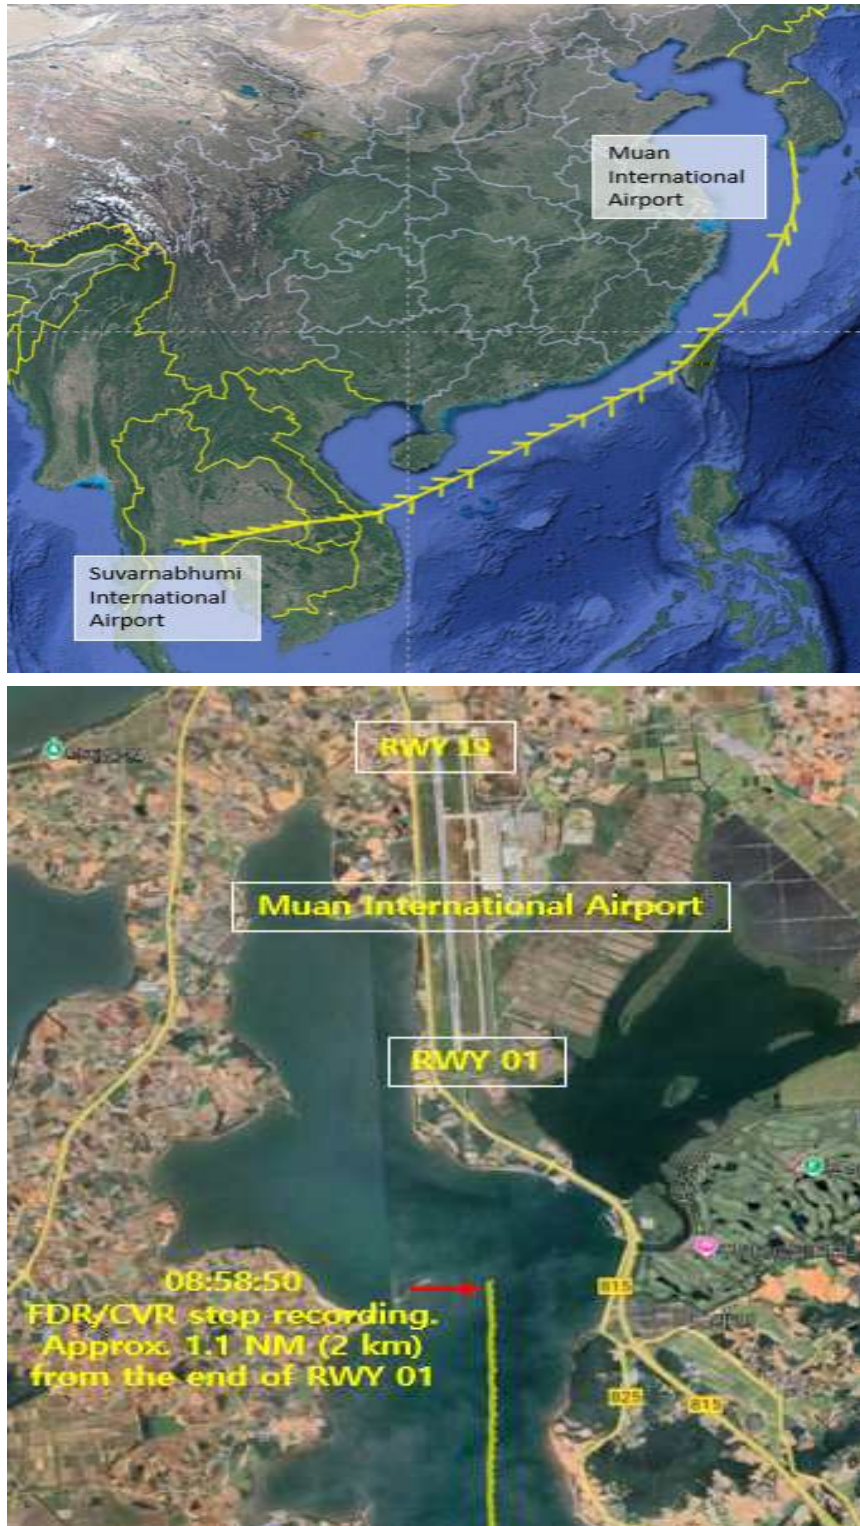
Figure 2. Flight path while the CVR/FDR are in operation

Flight data recorder (FDR) and cockpit voice recorder (CVR) were installed in HL8088. However, both recordings stopped at 08:58:50 on December 29, 2024. The airplane impacted with the embankment at 09:02:57, meaning the last 00:04:07 recordings were missing. The airplane

speed and pressure altitude when the recorders stopped were 161 kts and 498 ft, respectively. Figure 2 shows the flight path of HL8088 from its takeoff to where its flight recording stopped.
