Aircraft Serious Incident Report

Runway Excursion During Landing Roll

B737-800, HL7780

Gimpo International Airport, Runway 14R

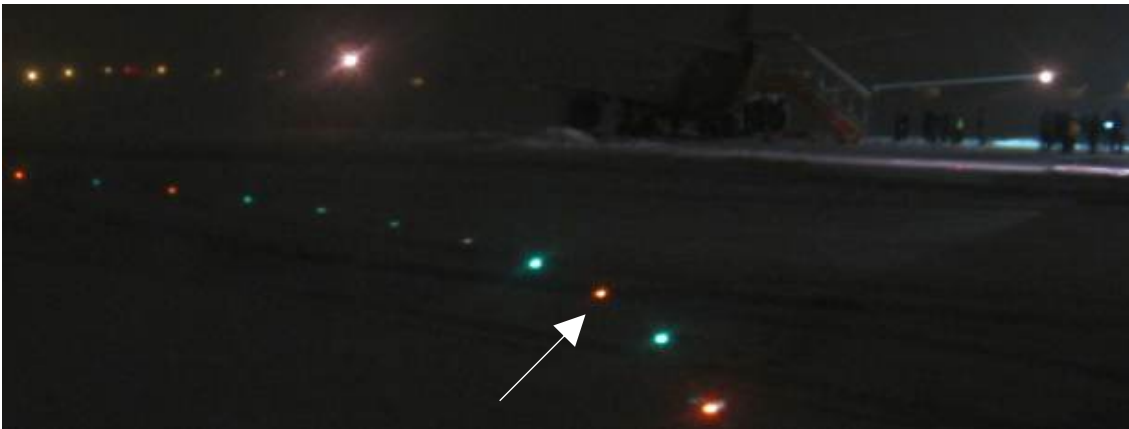
[Figure 3] Runway and Taxiway Centerline Lights

The lighting, which guides the aircraft landing on runway 14R to taxiway B1 connected to the end of the runway, is shown in [Figure 3].

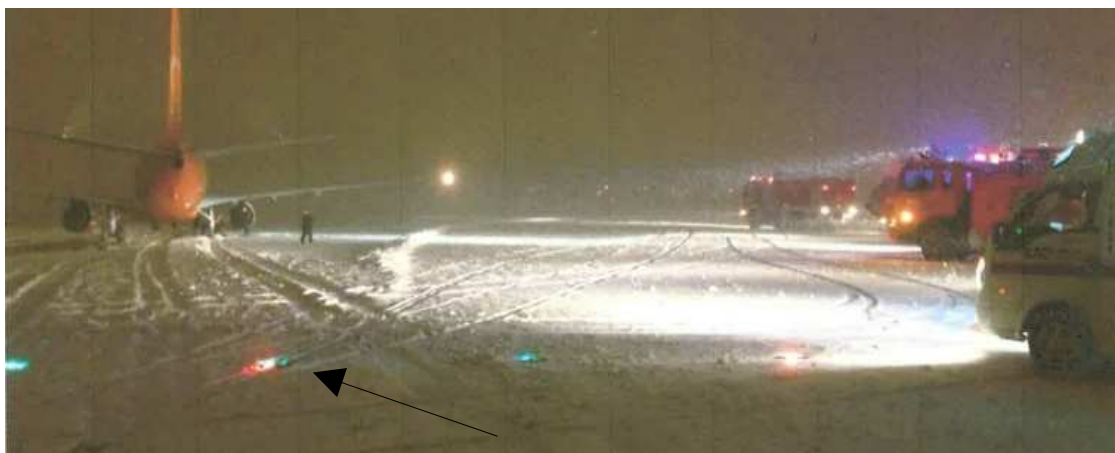
[Figure 4] Runway 14R's End Lights

The illumination of runway 14R's end lights and the paved area beyond the end of the runway are shown in [Figure 4].

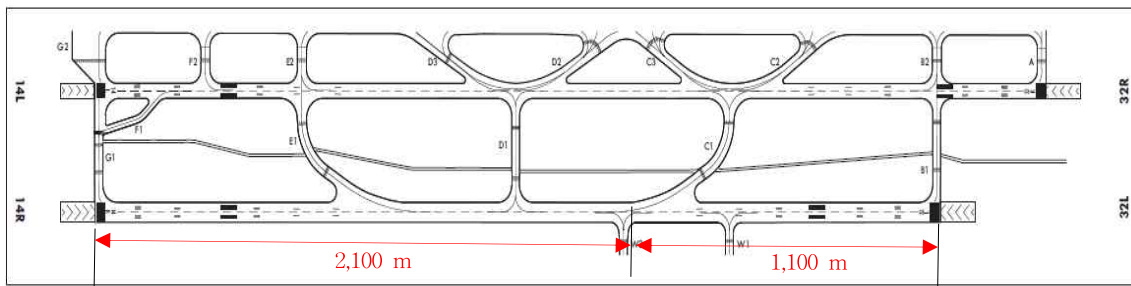
[Figure 5] Gimpo Airport's Runway Layout

Gimpo Airport's runway layout is shown in [Figure 5], and runway 14R is 3,200 meters long and 60 meters wide, paved with asphalt. The distance between runway threshold and rapid exit taxiway, C1, and between C1 and right angle exit taxiway, B1, is about 2,100 meters and about 1,100 meters, respectively.

In addition, if the landing distance had been calculated based on the "Poor" braking action, HL7780 could have reduced enough speed to fully stop at the position, 380 - 410 meters from taxiway C1 as shown in [Figure 5], regardless of the selection of "Auto Brake 3" or "Auto Brake Max." At this position, HL7780 could have safely vacated the runway via taxiway B1 at the end of the runway since the distance from HL7780 to the end of the runway was still 688~718 meters, but the airplane failed to reduce enough speed to vacate via B1 and veered off the runway.

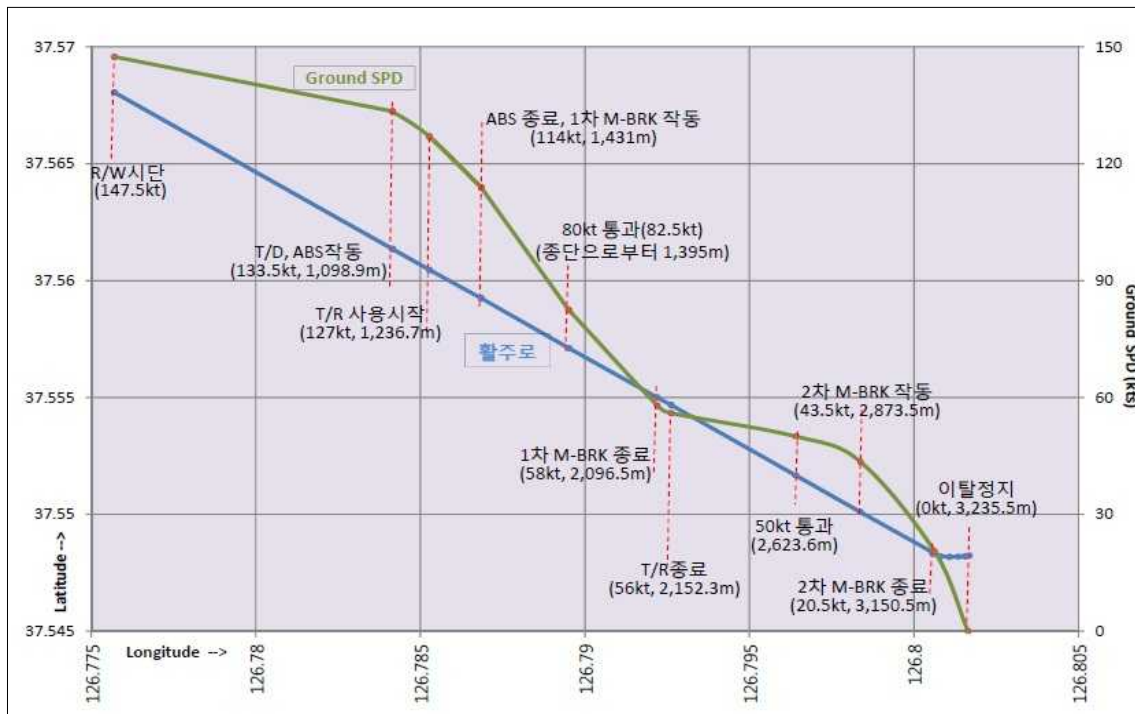
[Figure 10] Major Landing Maneuvers Marked from Runway Threshold

ARAIB retrieved this 25 hours worth of raw data, from which it collected about 1,100 parameters, and major parameters³⁴⁾ in relation to landing maneuvers are shown in [Table 7]. Major landing maneuvers and ground speed marked from the runway threshold based on the parameters are shown graphically in [Figure 10].
