AIRCRAFT ACCIDENT REPORT

CRASH WHILE APPROACHING THE WATER SURFACE
FOREST AVIATION HEADQUARTERS
S-64E, HL9467
IMHA-DAM IN ANDONG-SI, GYEONGSANGBUK-DO
9 MAY 2013

NOVEMBER 2014

AVIATION AND RAILWAY ACCIDENT INVESTIGATION BOARD

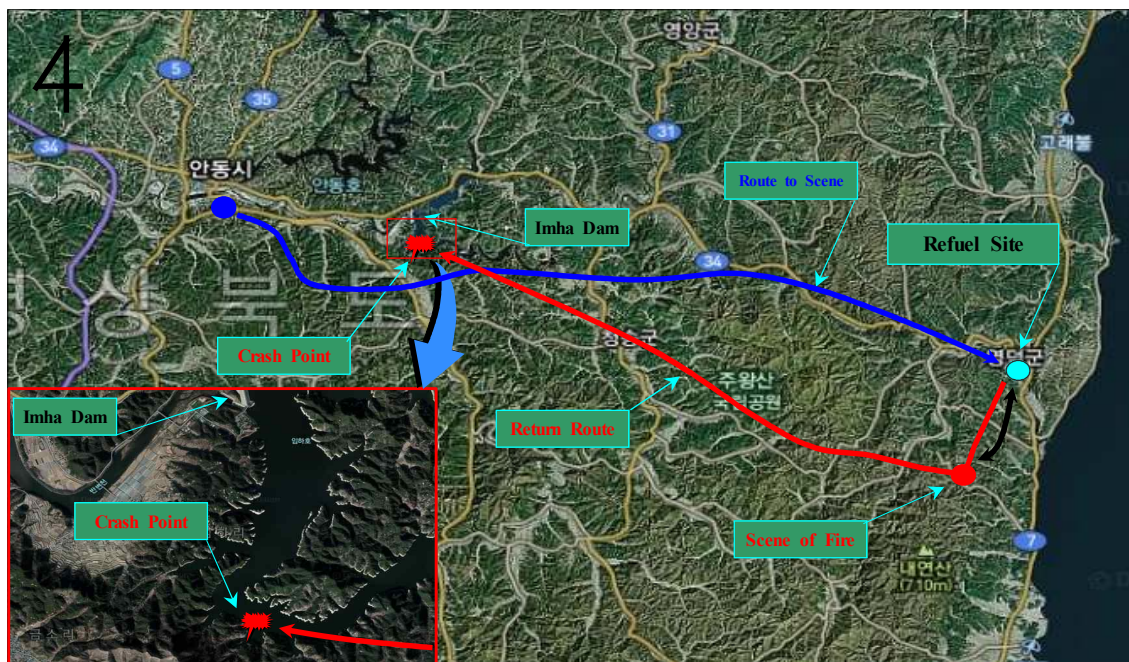
Subsequently, as shown in [Figure 1], HL9467 departed⁹⁾ the AFAO about 06:15, arrived on scene via refuel site about 06:33, then started¹⁰⁾ to suppress the fire.

[Figure 1] Flight Track and Crash Point of HL9467

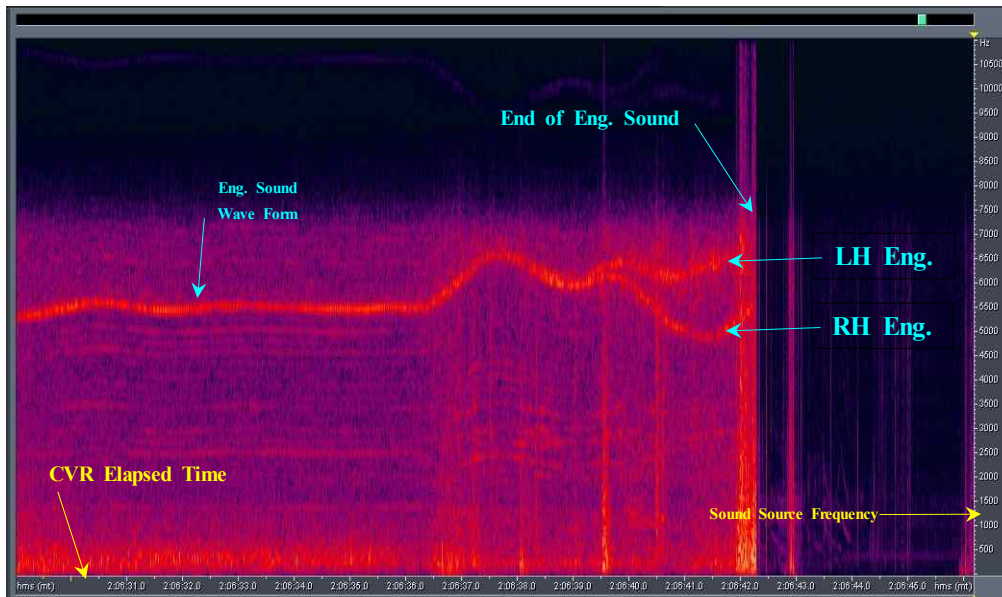
Also, the spectrum image of the engine sound recorded during the crash is shown in [Figure 3].

[Figure 3] Spectrum Image of the Engine Sound

Yet the captain, as evidenced by the analysis of the CVR engine sound, continued to descend at a consistent sink rate until 1.1 seconds before the crash, in that the engine sound did not change until this moment after passing a decision height of 250 ft set on the radio altimeter indicator as well as 100 ft.

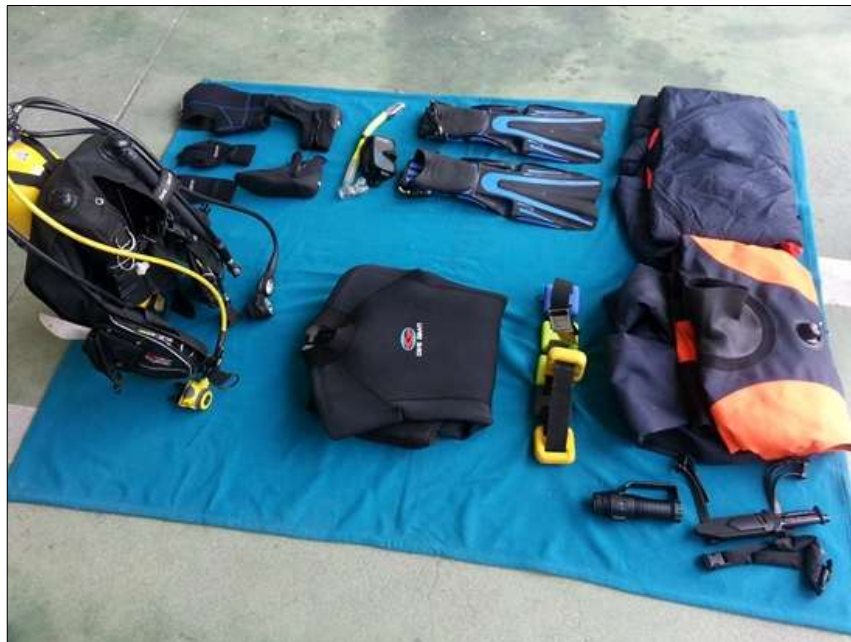
Both agencies were equipped with the divers⁷⁷⁾ capable of conducting rescue operations in water about 10 meters deep and relatively various underwater rescue equipment⁷⁸⁾, without deep-sea diving equipment as shown in [Figure 17]. In addition, the divers were regularly trained, but mainly in shallow waters 10 meters deep, without deep-sea diving training.

[Figure 17] Diving Equipment Owned by Youngju 119 Rescue Service

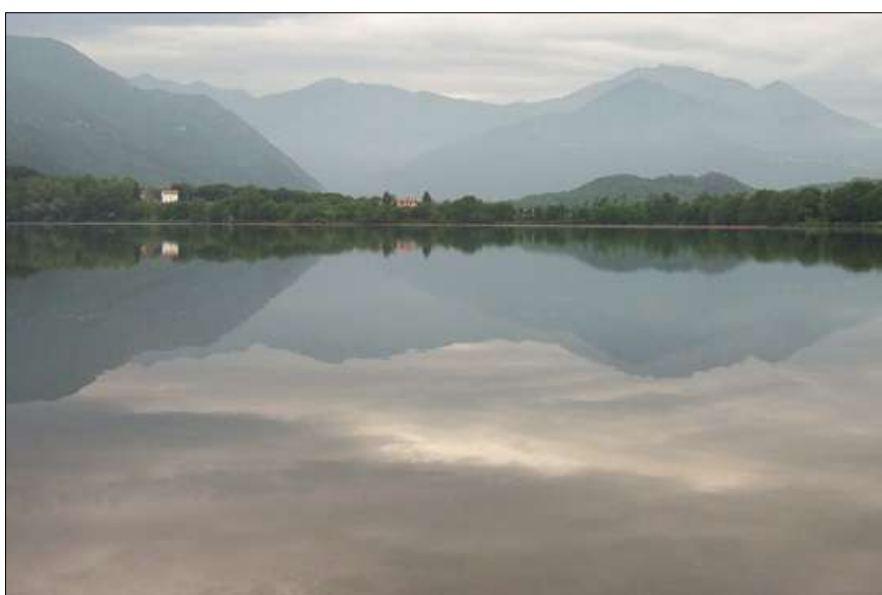
When the pilots, who attempt to land at or take off from a wide and quite lake or sea with no visual reference points nearby, approach the water at shallow angles, they will have difficulty perceiving exact depth of it because nearby terrain and sky are reflected in the water as shown in [Figure 18], which is called the "glassy water effect."

[Figure 18] Reflection on the Quite Water (Glassy Water)⁹²⁾

If the pilot mistaken about the altitude approaches the surface of the glassy water while performing decelerating and hovering maneuvers at a high altitude, there will be no special danger, but if he performs the same maneuvers at an extremely low altitude, it is likely that the aircraft's tail rotor will first hit the water due to its tail low attitude, and that the pilot will fail to perform decelerating maneuvers, thereby causing the aircraft to crash straight into the water.

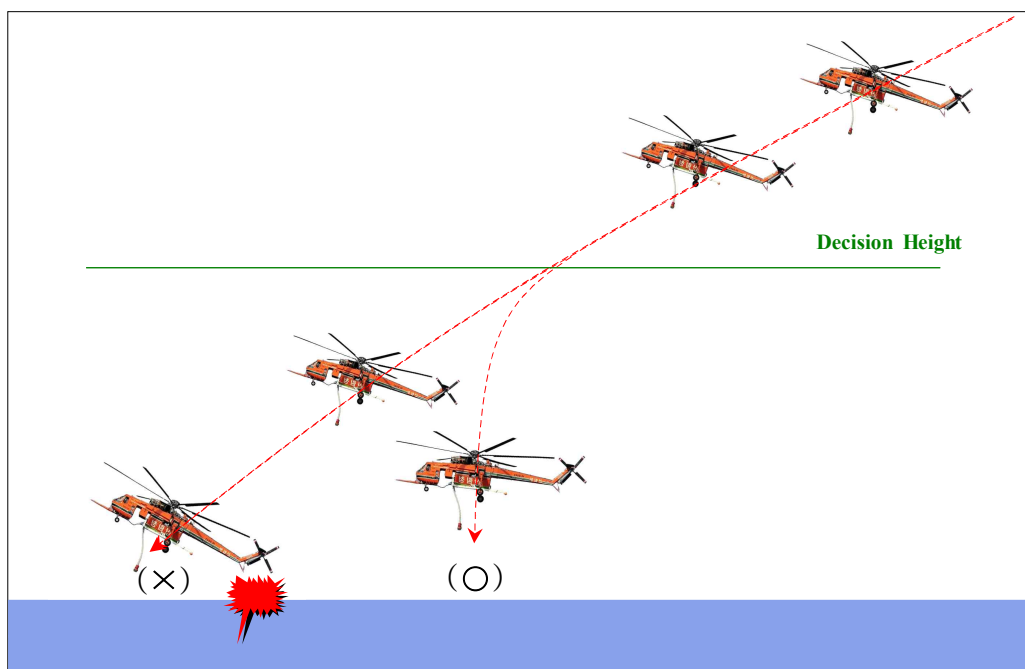
as follows: there are no limitations until 200 ft AGL, but the pilot should maintain a descent rate of less than 800 ft/min at an altitude of less than 200 ft. According to the statement of the FAH instructor pilot in the same type aircraft, the pilot should perpendicularly descend hovering, with almost no speed of advance, from 200 ft AGL to the ground.

[Figure 23] Normal Approach of S-64
