NATIONAL TRANSPORTATION SAFETY BOARD
Office of Aviation Safety
Washington, D.C. 20594

POWERPLANT GROUP CHAIRMAN'S FACTUAL REPORT

NTSB No: ENG13IA033

Aircraft: Korean Airlines Boeing B777-300ER, registration HL8275

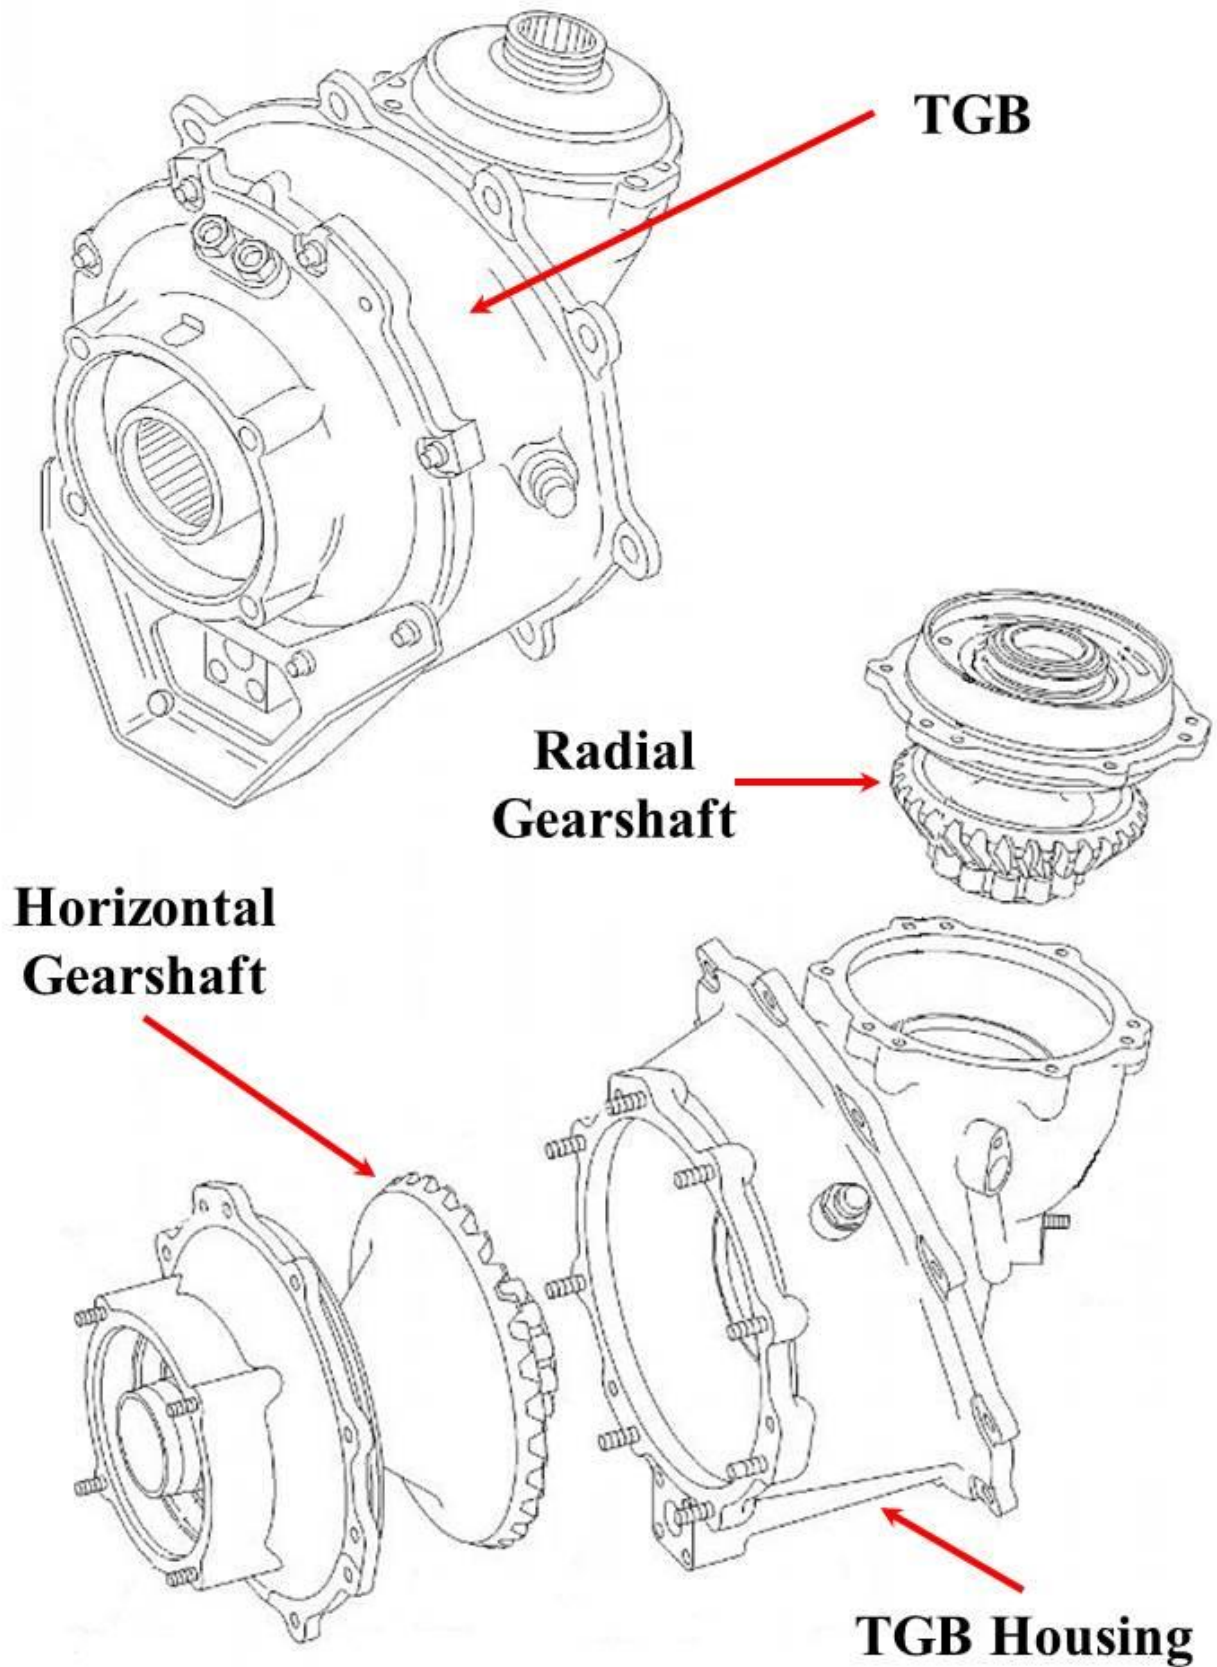
FIGURE 1: TRANSFER GEARBOX EXPLODED VIEW OF INTERNAL PARTS

The transfer gearbox (TGB) is part of the fan hub assembly which is the first static structure of the engine. The TGB is attached to the bottom of the fan hub assembly and directs/transfers torque from the inlet gearbox (IGB) to the accessory gearbox (AGB) (**FIGURE 1**). The TGB also acts as a separate sump and has its own oil scavenge outlet to the lube pump/oil system.
