Aircraft Accident Report

Crash While Transporting Cargo

Ka-32T, HL9400

April 4, 2011

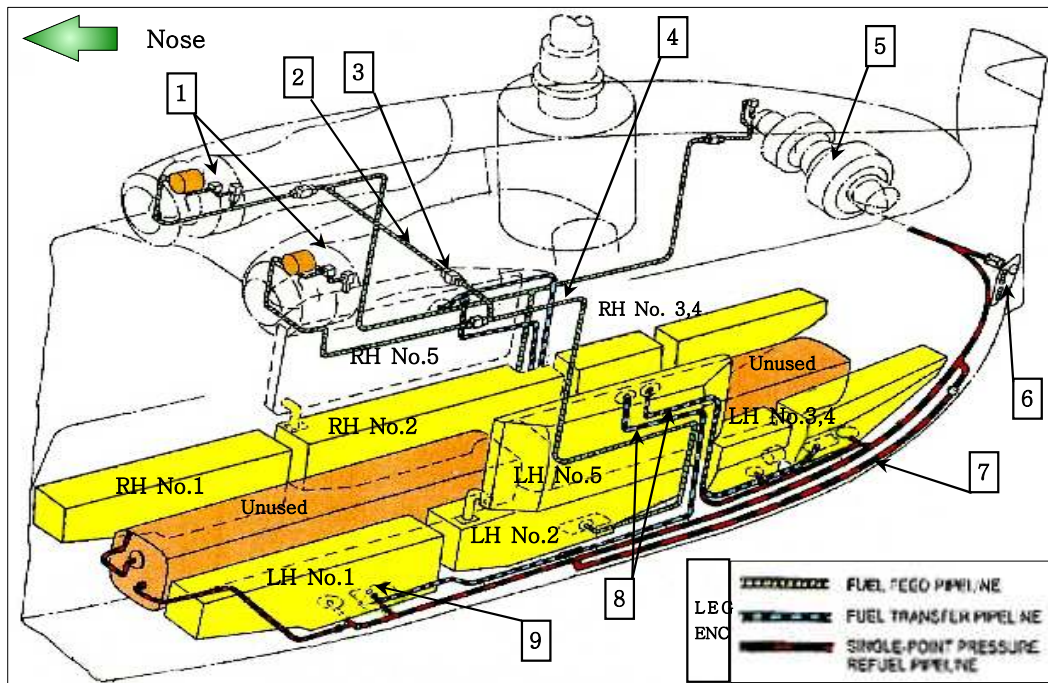
[Figure 2] Fuel Tanks and Pipelines

The fuel tanks are arranged along the fuselage LH and RH sides and in the cargo compartment as shown in [Figure 2]. The tanks located along the fuselage LH side and the forward external tank installed in the cargo compartment make up the left tank group, whereas the tanks arranged along the fuselage RH side and the aft external tank in the cargo compartment constitute the right tank group.

1	Engines	2	Cross feed valve
3	Fuel feed pipeline	4	Fuel supply pipeline
5	Auxiliary engine	6	Single-point pressure fueling connection
7	Single-point pressure fueling pipeline	8	Fuel transfer pipeline
9	Fuel transfer pumping unit
