**Report No. ARAIB/AAR0904**

# **AIRCRAFT ACCIDENT REPORT**

HELICOPTER CRASH DURING AIRLIFTING OF CARGO  
THE CHANGWOON AVIATION, REPUBLIC OF KOREA  
KA-32A, HL9405  
MT. JEOMBONG, INJE-GUN, GANGWON-DO  
6 NOVEMBER 2009

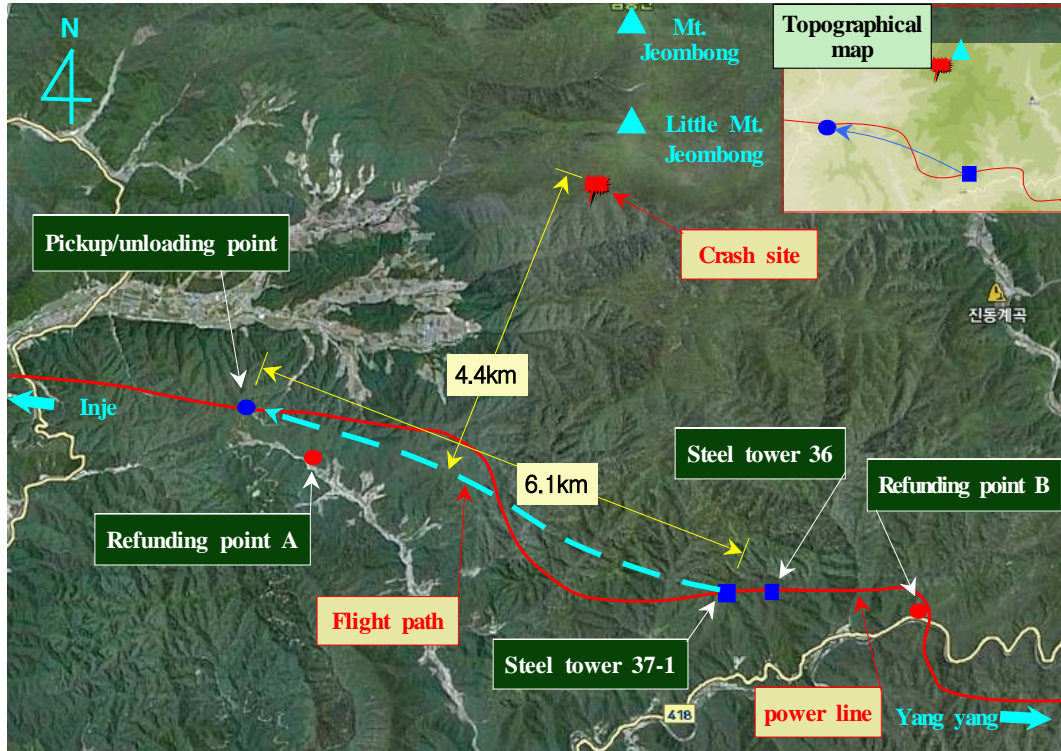
[Photo 1] Mission area map and flight path of HL9405

On the day of the accident, a mission, in which HL9405 carry up the compressor from the pickup point<sup>4)</sup> to the installation point of power line steel towers No. 36 and No. 37-1, and lift down lumbered trees from the same point to the unloading point<sup>5)</sup> (hereinafter referred to as "pickup and unloading point"), was planned<sup>6)</sup>. See Photo 1.

Around 09:00~10:00, HL9405 carried up one compressor from the pickup and unloading point to No. 36 steel tower, and lifted down lumbered trees six times from No.36 steel tower to the pickup and unloading point. And at about 10:10 it moved to No. 37-1 steel tower and lifted down lumbered trees three times.

When the HL9405 captain called the junior maintenance person A of the pickup and unloading point or the senior maintenance person at the refueling point A at the final flight section immediately before the accident, the senior maintenance person responded immediately but contact was not made, and also when he made the last call to ask the weather condition of the pickup and unloading point, senior maintenance on the ground responded to this call but contact was not made. See Photo 1.

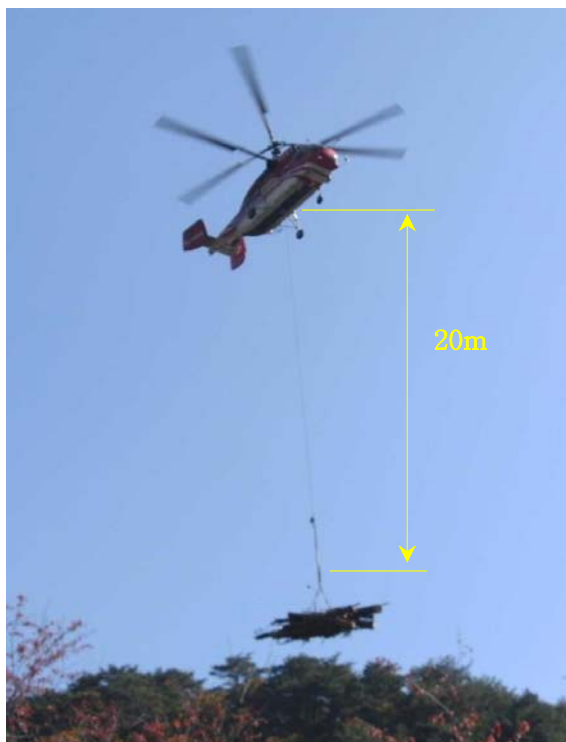
[Photo 5] HL9405 at external pickup

At the time of accident, HL9405 was carrying external load in which 3.5 tons of lumbered trees were tied with two magic ropes<sup>39)</sup> and hooked to the wire rope<sup>40)</sup> that is connected to the cargo hook under the fuselage as shown in Photo 5.
