Aircraft Serious Incident Report

Runway Excursion during Landing Roll
Jade Cargo International Company Ltd., People's Republic of China
B747-400F
B2440
Incheon International Airport, Republic of Korea
16 April 2009

8 June 2010

Aviation and Railway Accident Investigation Board
Ministry of Land, Transport and Maritime Affairs
Republic of Korea

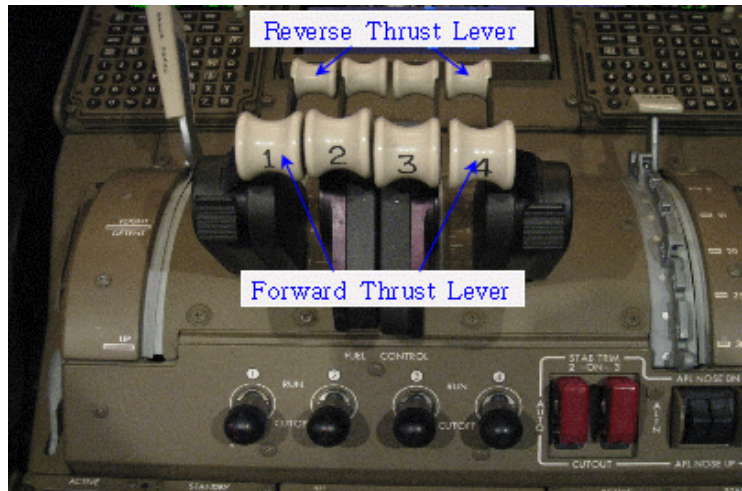
[Photo 2] Thrust levers

As shown in [Photo 2] and [Photo 3], the thrust levers were composed of the forward thrust control levers and the reverse thrust control levers, respectively, for four engines, two Takeoff/Go-around switches (TO/GA switch)²⁶⁾ and two autothrottle disconnect switches²⁷⁾.

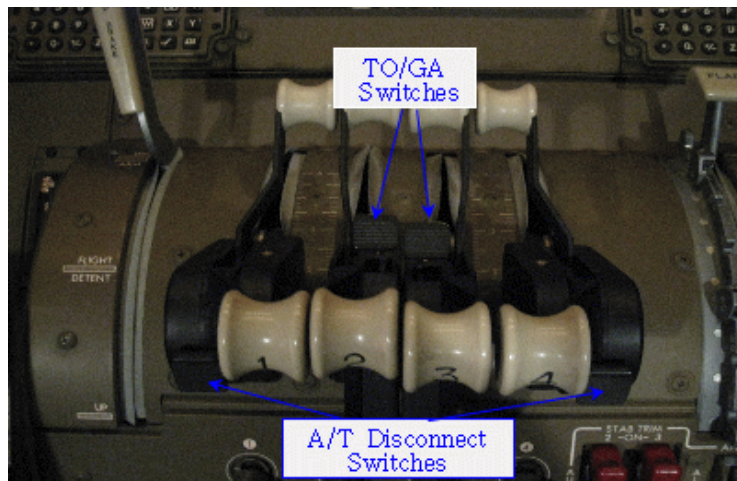
[Photo 3] TO/GA and A/T disconnect switches

The autothrottle system can be disconnected manually by positioning the autothrottle arm switch to the OFF position [Fig. 2] or by pushing any one of two autothrottle disconnect switches [Photo 3].

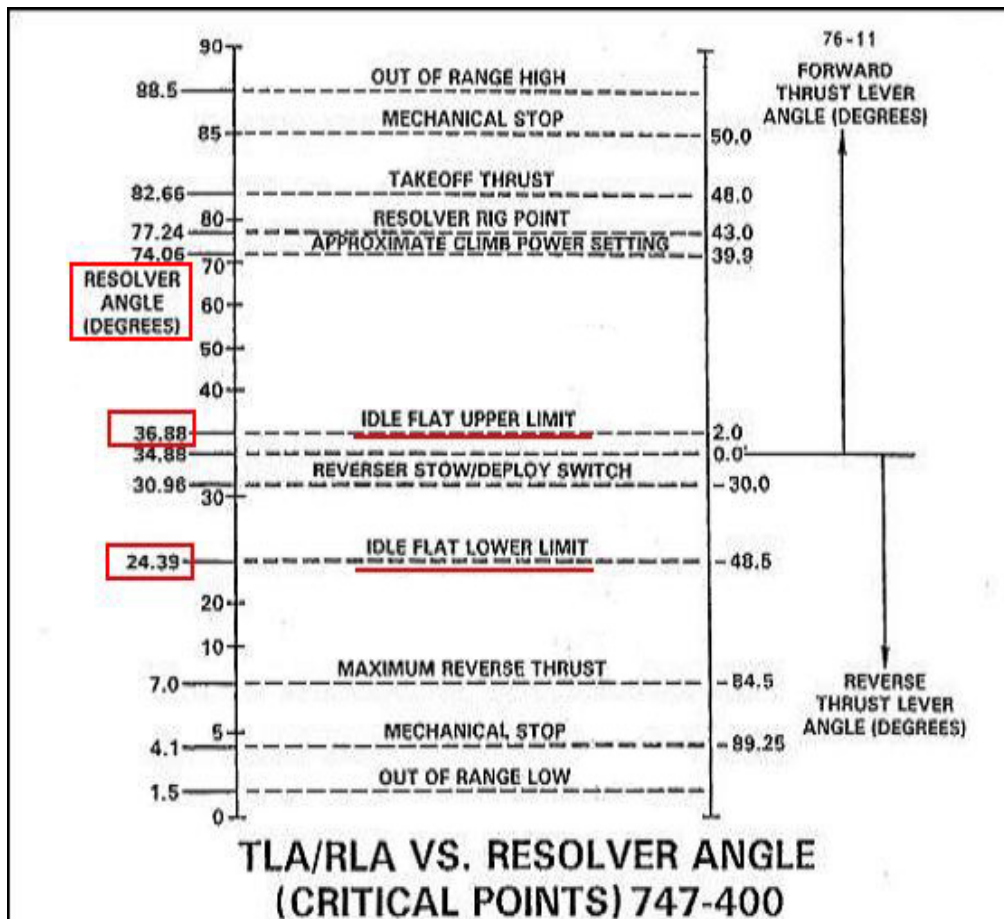
[Fig. 1] Thrust lever angle

Controlling these levers up/down²⁹⁾ controls reverse thrust. Each reverse thrust lever can only be moved when the respective forward thrust lever is in the closed position. For this aircraft, as shown in [Fig. 1], in order for any reverse thrust lever to move, the forward thrust lever angle shall not be in the position exceeding 36.88°.

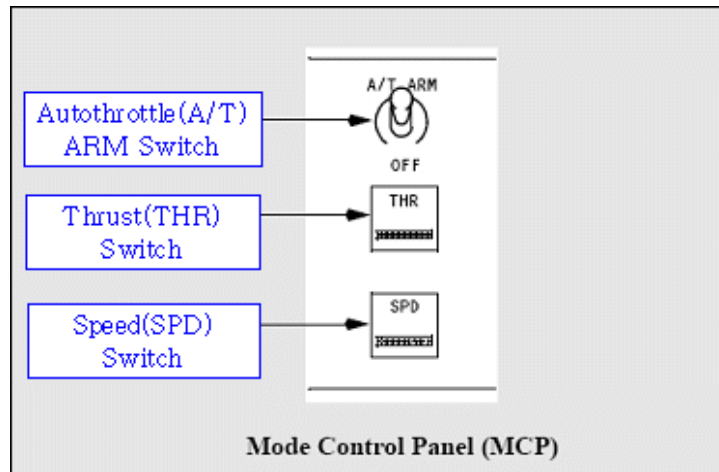
[Fig. 2] Automatic thrust control system switches

The autothrottle also disconnects and cannot be reactivated if both the FMCs (Flight Management Computers) fail or two or more engines are shut down. The autothrottle disconnects when the FMC Master switch is switched, but can be reactivated. Electrical faults or interruptions may also cause the autothrottle to disconnect.

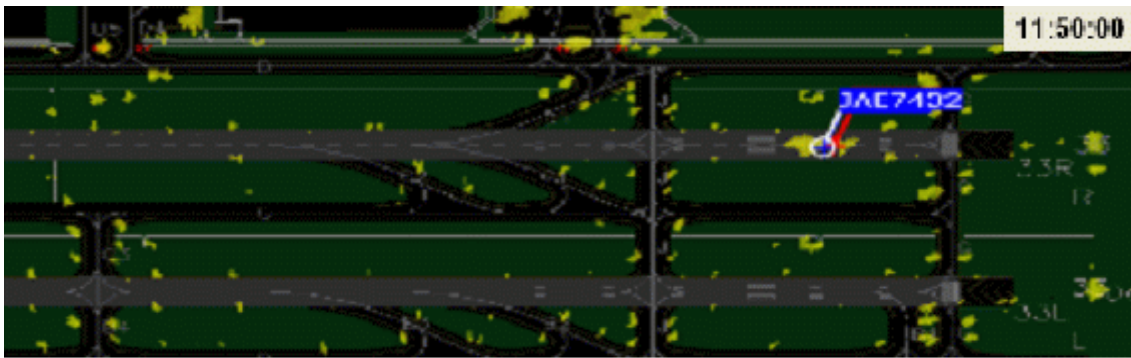
[Fig. 4] Touchdown on the runway 33R

According to the video record of ASDE, B2440's touchdown and landing roll on the runway 33R are as shown in [Fig. 4] and [Fig. 5], and deviating to left from the runway centerline, excursion and stopping on grass are shown in [Fig. 6] to [Fig. 8].

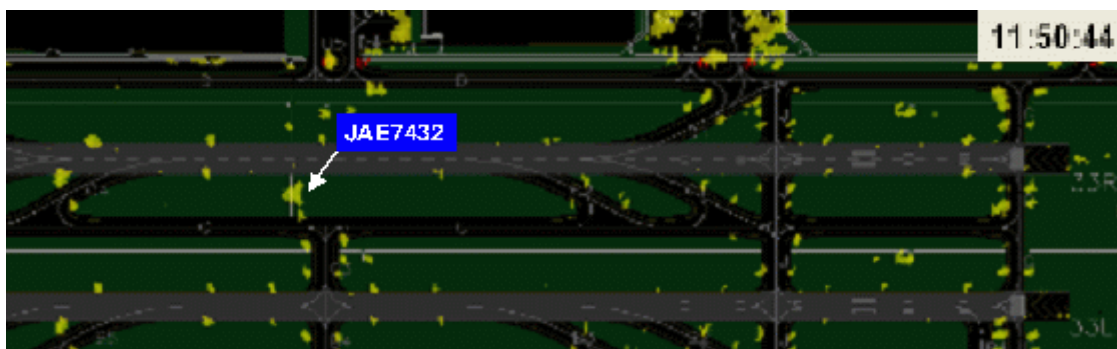
[Fig. 8] Position at which it stopped after excursion

B2440 made excursion to the left of the runway hitting the 6,000 feet runway distance marker sign, and as shown in [photo 4], stopped near about 2,170 m from the runway 33R threshold.

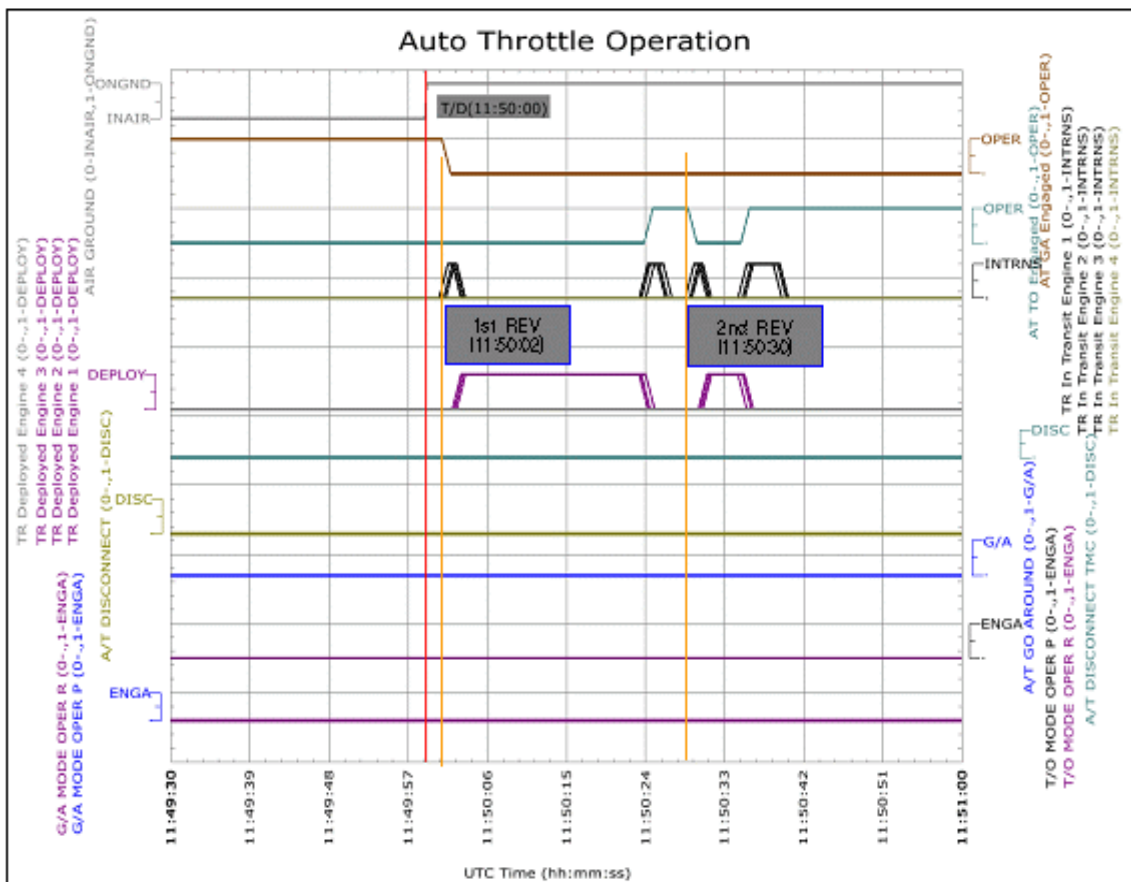
[Fig. 9] Major mode parameters

As shown in [Fig. 9], B2440 touched down at 11:50:00 and the autothrottle, which was standing by in the GA mode during approach, stood by⁴²⁾ in the TO mode after touchdown. After landing, the No. 1, 2 and 3 reversers operated two times, and the No. 4 reverser did not function at all.
