AIRCRAFT SERIOUS INCIDENT REPORT

ENGINE IN-FLIGHT SHUTDOWN

B737-800, HL7786

3 SEPTEMBER 2010

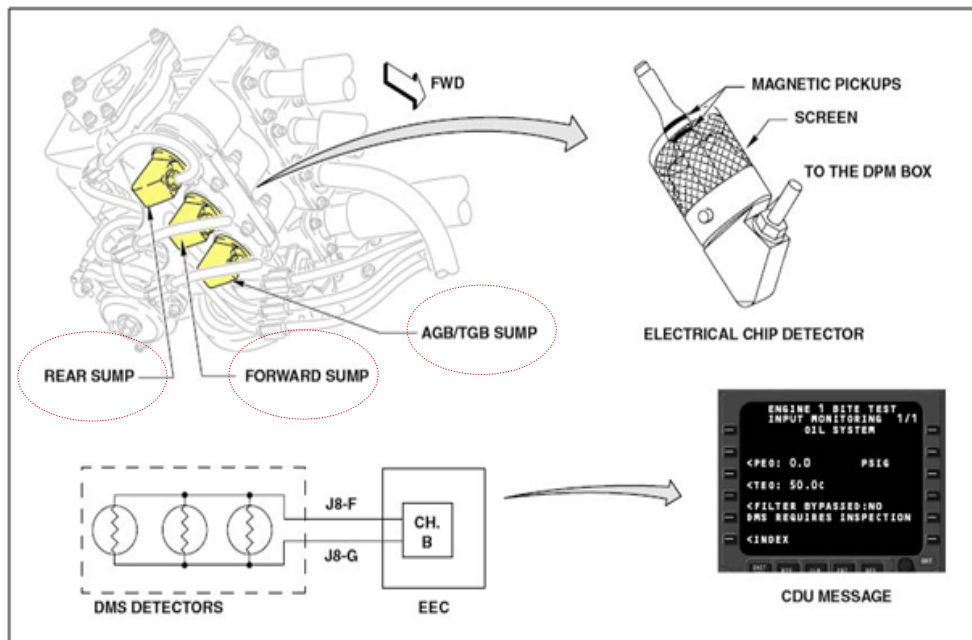
[Fig. 2] Illustration of the Metal Chip Detector (MCD)

CFM56-7B engine was equipped with three Magnetic Chip Detectors¹⁷⁾ [hereinafter referred to as "Magnetic Chip Detector (MCD)"] to inspect whether metal chips are detected in the gear box and engine bearing system as shown in [Fig. 2].

The manufacturer's Maintenance Planning Document provides the Metal Chip Detector (MCD) to be checked at every 500 hours, but Korean Air shortened the period to check at every 250 hours¹⁸⁾.

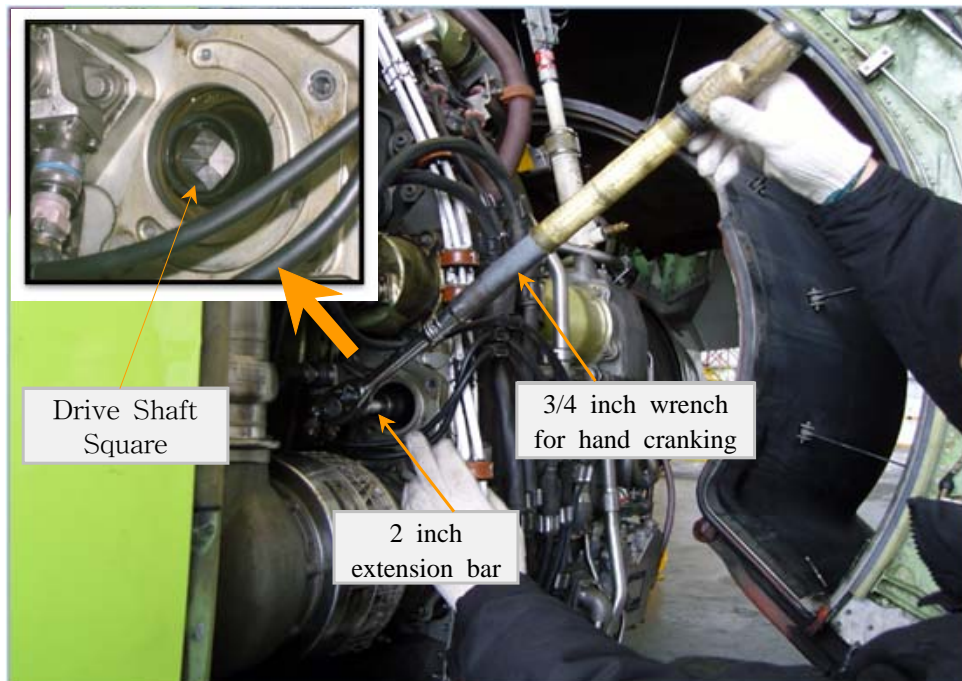
[Photo 1] Hand cranking for the engine borescope inspection

As shown in [Photo 1], the Borescope Inspection (BSI) is to inspect blades by using the borescope equipment while rotating the high-pressure compressor, and to rotate this high-pressure compressor, the hand cranking shaft of the accessory gear box should be turned manually.

To turn this hand cranking shaft manually, open the drive shaft square cover and insert a two-inch extension bar into the drive shaft square and then connect the wrench.

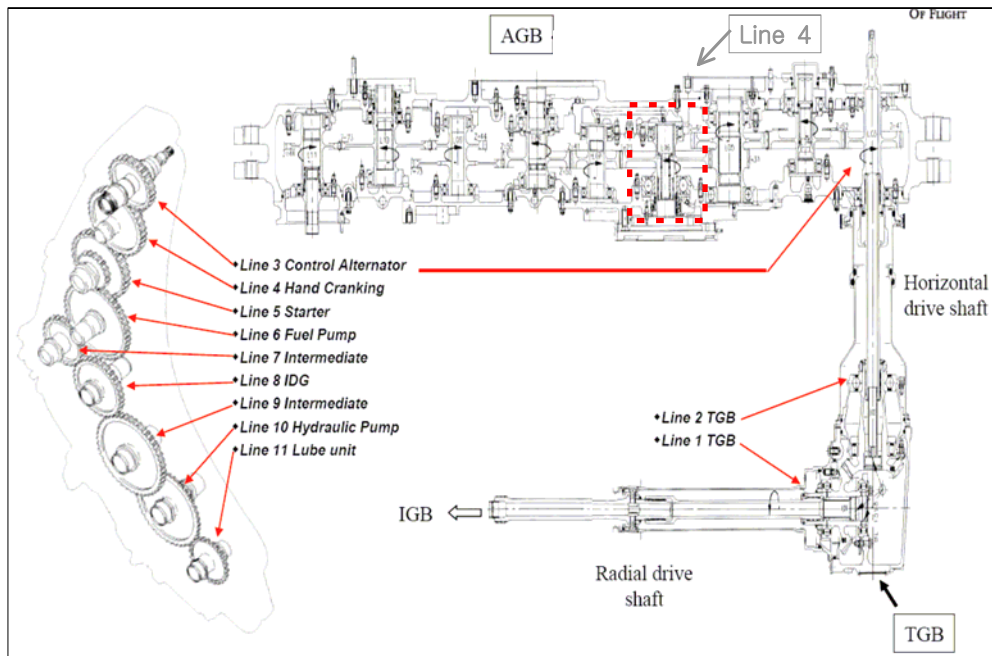
[Fig. 8] Gear box

In the Koran Air's Power Plant Maintenance Center, the relevant gear box was torn down for the inspection to find that the number 4 line of the accessory gear box (AGB) was damaged as shown in [Fig. 8]. The damaged parts were sent to the engine manufacturer for the close inspection on 4 October 2010, and the results of the inspection by the engine manufacturer were as follows;
