# AIRCRAFT SERIOUS INCIDENT REPORT

**MULTI TIRE DISINTEGRATION DURING TAKEOFF ROLL**

**B747-300SF, N749SA**

**INCHEON INTERNATIONAL AIRPORT**

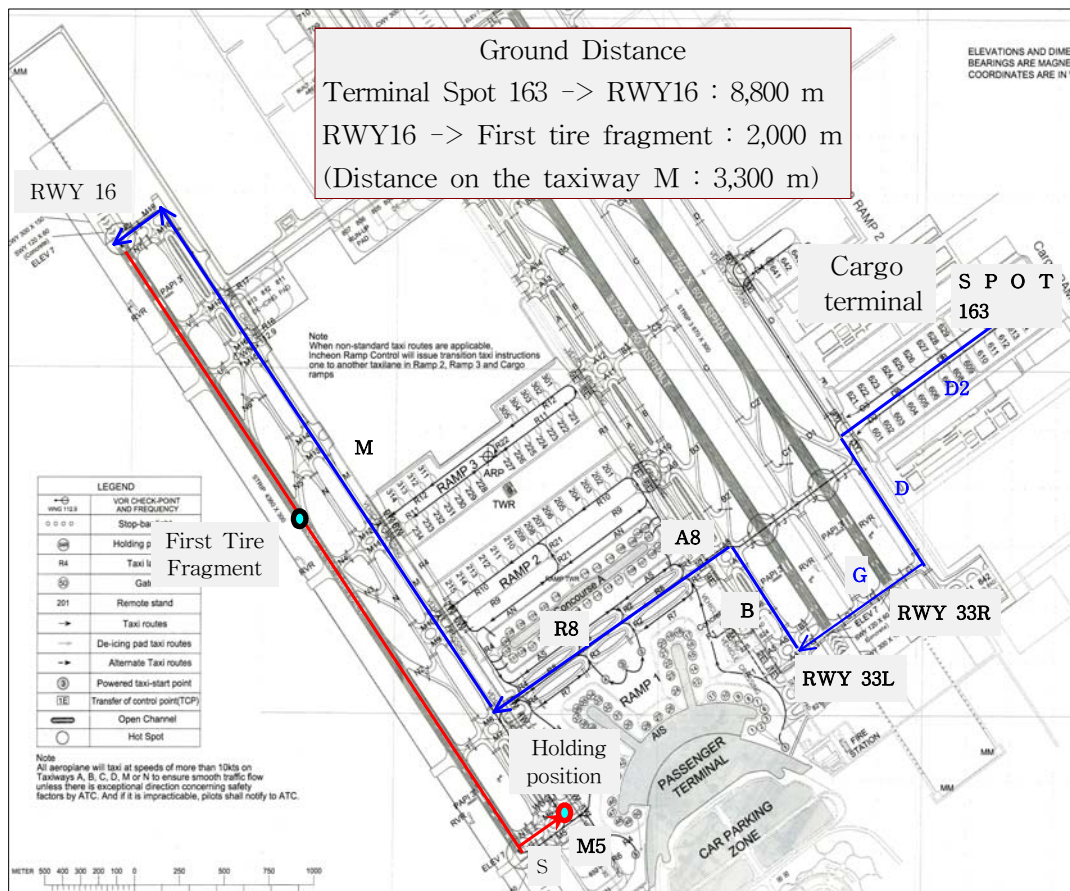
[Fig. 1] Taxi route and distance

### 1.1 History of Flight

As shown in [Fig. 1] above, the Flight 720 Freighter traveled 8,800 m (28,871 ft) at an average taxi speed of 25 kts to go to the takeoff position, and ran 2,000 m (6,561 ft) at a high speed for the takeoff roll. According to the [Fig. 16] and [Fig. 17] above, such a long distance taxi could have increased the temperatures of all tires of the flight 720 aircraft.

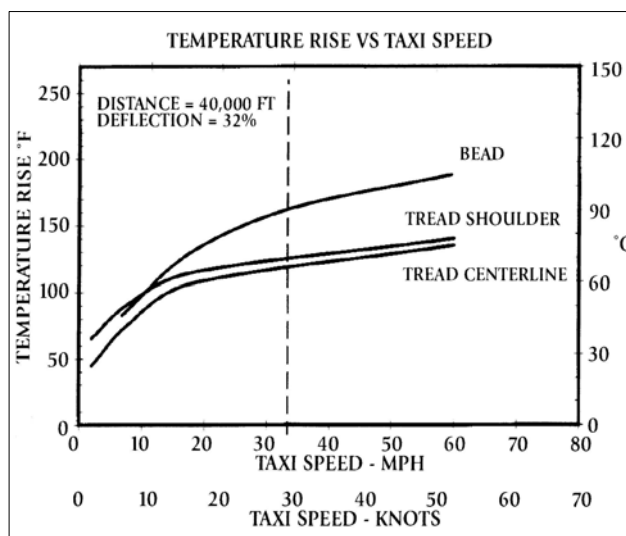
[Fig. 14] Tire temperature rise vs taxi speed

In [Fig. 14], the vertical dotted line at 35 mph (30 knots) indicates the recommended maximum taxi speed. On this chart, the curves constantly slope upward with higher taxi speeds. In other words, the faster an aircraft travels over a given distance, the hotter the tires will become.

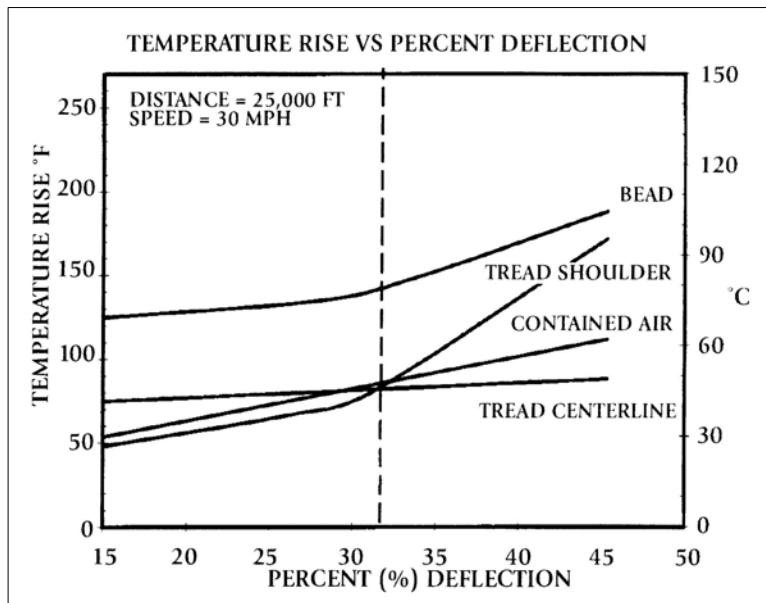
[Fig. 15] Tire temperature rise vs percent deflection

As the vertical dotted line indicates in [Fig. 15], the tire was designed to be operated at 32% deflection<sup>33)</sup>. Left of this line designates overinflation, and to the right underinflation.

When the speed and the distance traveled are constant, the more a tire is under inflated the hotter it becomes. The rate of temperature rise versus underinflation is the highest in the shoulder area due to increased flexing. The bead area, however, still remains hottest.

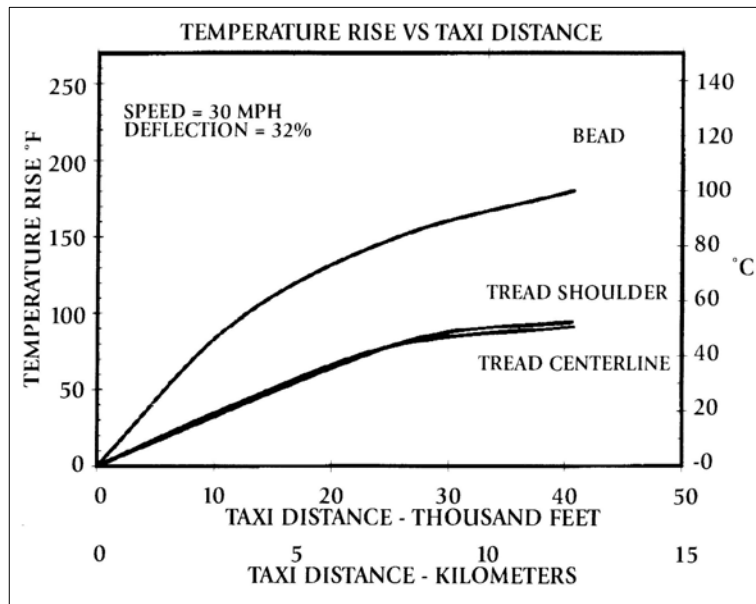
[Fig. 16] Temperature rise vs taxi distance-1

Even when an aircraft tire is properly inflated and operated at moderate taxi speeds, the heat generation will always exceed the heat dissipated. (This is indicated by the ever increasing slope of the lines.). As shown in [Fig. 16], the farther the taxi distance, the hotter the tires will be at the start of the takeoff.

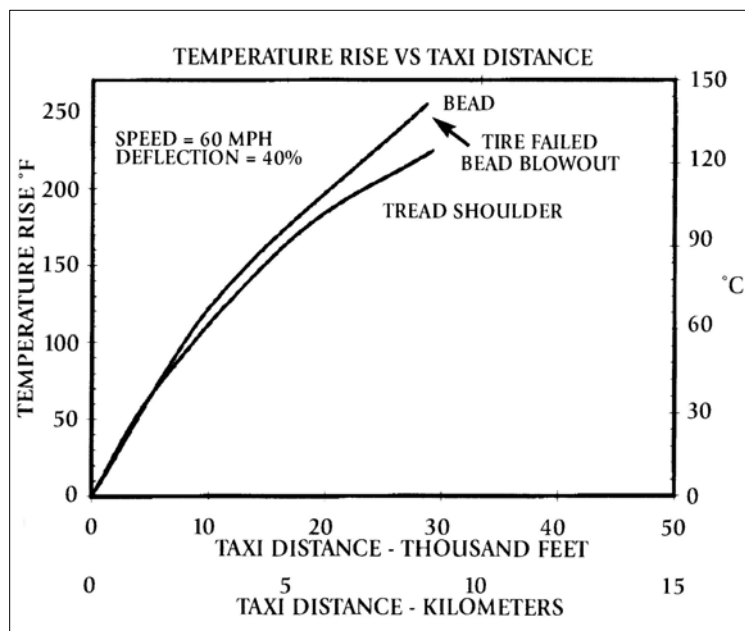
[Fig. 17] Temperature rise vs taxi distance-2

On the [Fig. 17], the effect of underinflation (higher deflection) is coupled with the high speed taxiing. A comparison is made between a tire run at 32% deflection and

one run at 40% deflection. Not only is the slope of the 40% deflection curves much steeper (due to higher rate of heat generation) than the 32% curve, but the 40% deflection tire blew out in the lower sidewall after traveling about 30,000 feet.

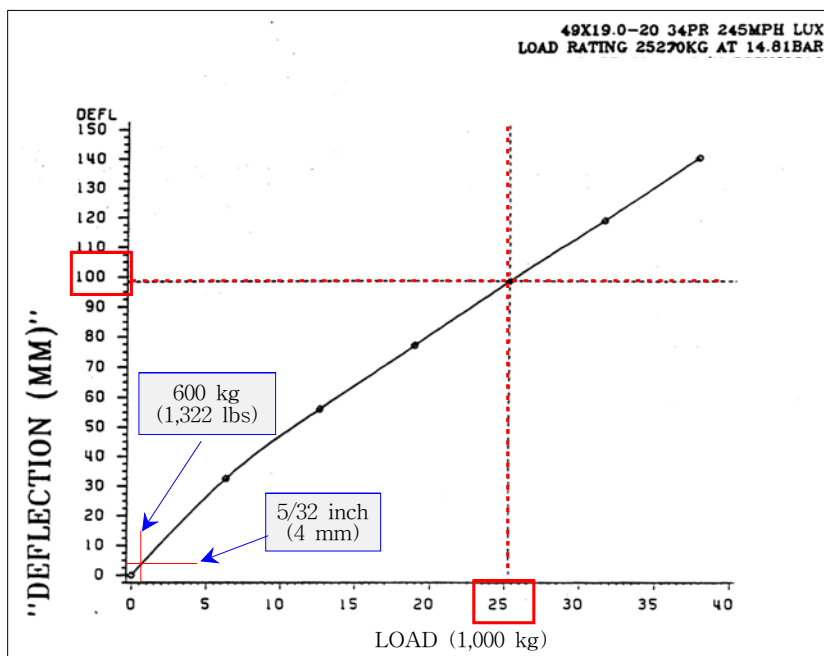
[Fig. 18] Deflection vs load under the rated pressure

[Fig. 18] shows the relationship between the tire deflection and load under the rated pressure in case of the 49×19.0-20, 34 PR, 245 mph tire.

Meanwhile, because the depth of the number 6 tire tread groove was 9/32 inches (7 mm) and that of the number 5 tire tread groove was 14/32 inches (11 mm), there was a height difference of 5/32 inches (about 4 mm) between the two tires. According to [Fig. 18] above, this could have made deflection greater by making additional load apply to the number 5 tire, thereby making the temperature and pressure of the number 5 tire increase higher than the other tires.
