AIRCRAFT ACCIDENT REPORT

CRASH WHILE MOVING FOR AIRLIFT OPERATIONS

B214B-1, HL9131

OCTOBER 19, 2011

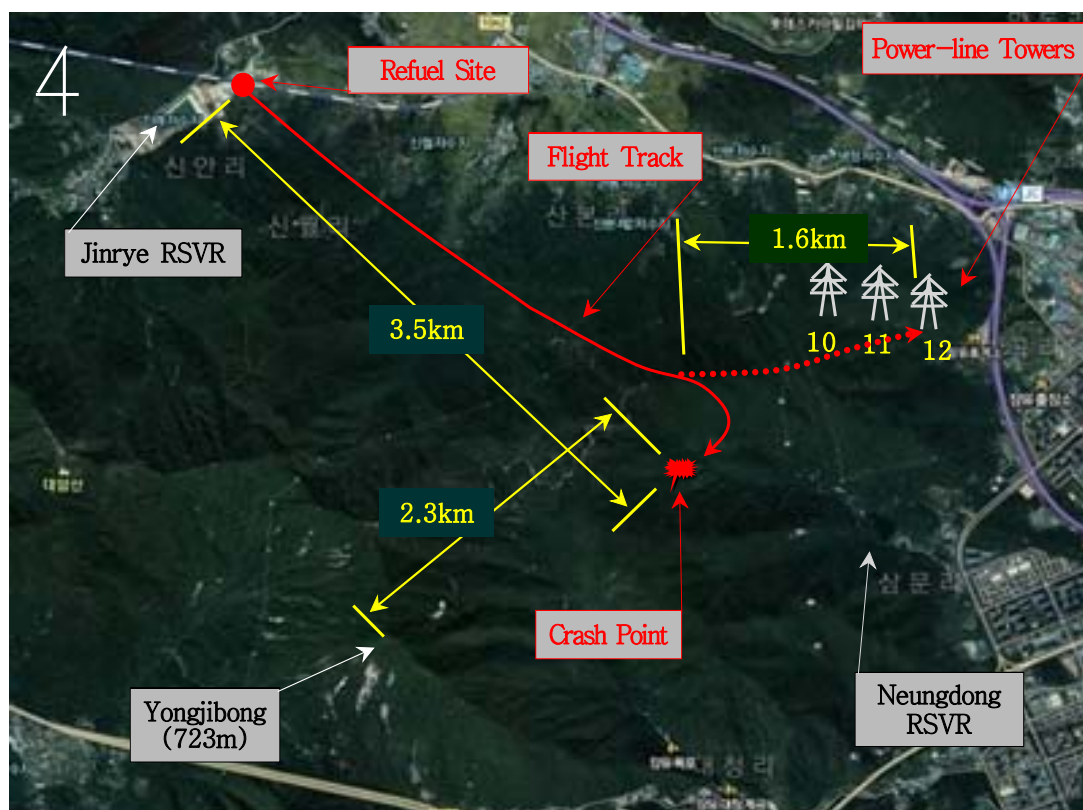
[Figure 1] Crash Point and Flight Track of HL9131

As shown in [Figure 1], the captain stated that while flying to the power-line

5) The captain initially stated that the aircraft was descending at approximately 500 ft/min at an altitude of 1,200 ft MSL or 300 - 400 ft AGL and a speed of 70 kts over the intersection between a red dotted line and a solid line in [Figure 1].

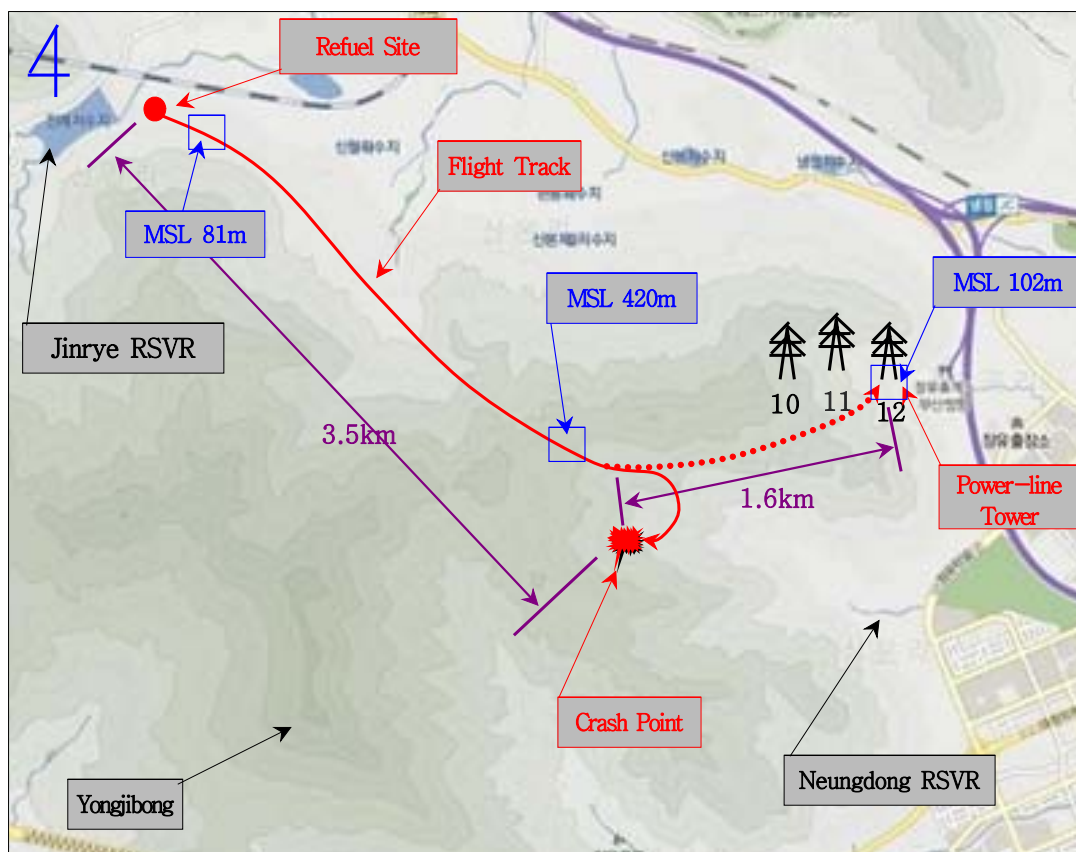
[Figure 3] Periphery of the Crash Point and the Flight Track

The accident site is located approximately 2.3 km northeast of Yongjibong, highest mountain peak in the area, as shown in [Figure 3]. Also, it is a valley located in the south and middle of the ridge which is approximately 5 km long and connected to the top of Yongjibong in the east-north-east direction.

The refuel site is located approximately 3.5 km north of Yongjibong. HL9131's flight track between the refuel site and the power-line tower #12 shows that the aircraft departed from the flatland at 81 m MSL and had to fly over the ridge at 420 m MSL to reach the power-line tower #12 at 102 m MSL.

At the crash point, oak trees aged 20 - 40 years and scrub (20 - 40 cm in diameter) were densely growing. On the waterway in the valley were rocks approximately 1 m in diameter. No water flowed on the floor of the valley, but there were some puddles of water which oozed from the floor. The terrain was a slope of about 10 to 40 degrees.
