# AIRCRAFT ACCIDENT REPORT

CRASH INTO A OBSTACLE DURING A DESCENT FOR LANDING  
LG ELECTRONICS

S-76C<sup>++</sup>, HL9294

16 NOVEMBER 2013

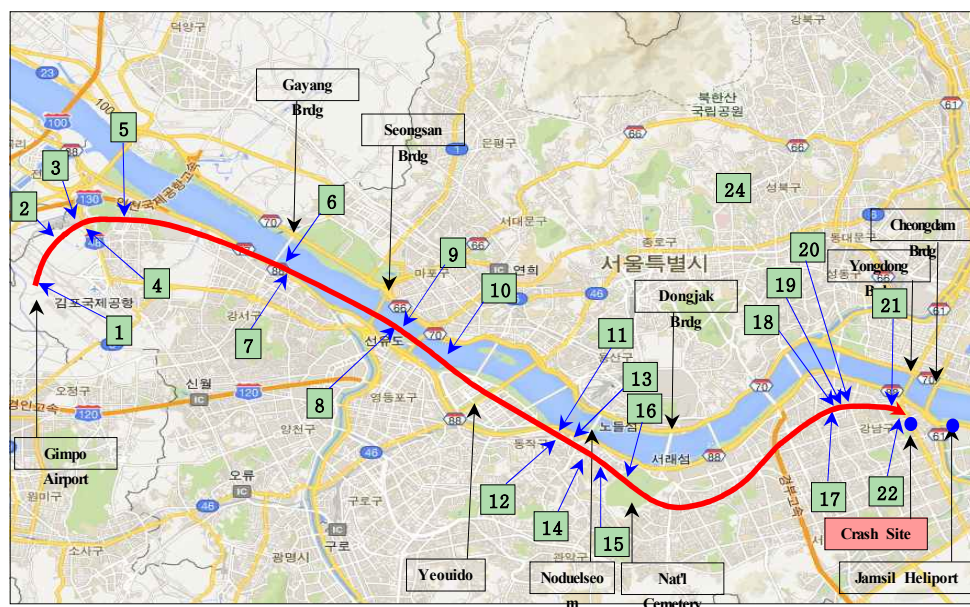
[Figure 4] Flight Track and the Major Content of the CVR Transcript

The major content of the CVR transcript in [Table 4] was numbered and marked on HL9294's flight track in [Figure 4] to match flight conditions with weather conditions recognized by the pilots during flight.

As shown in [Figure 4], however, although the pilots neither identified the ground due to poor visibility nor noted their deviation from the planned route, they continued to fly.

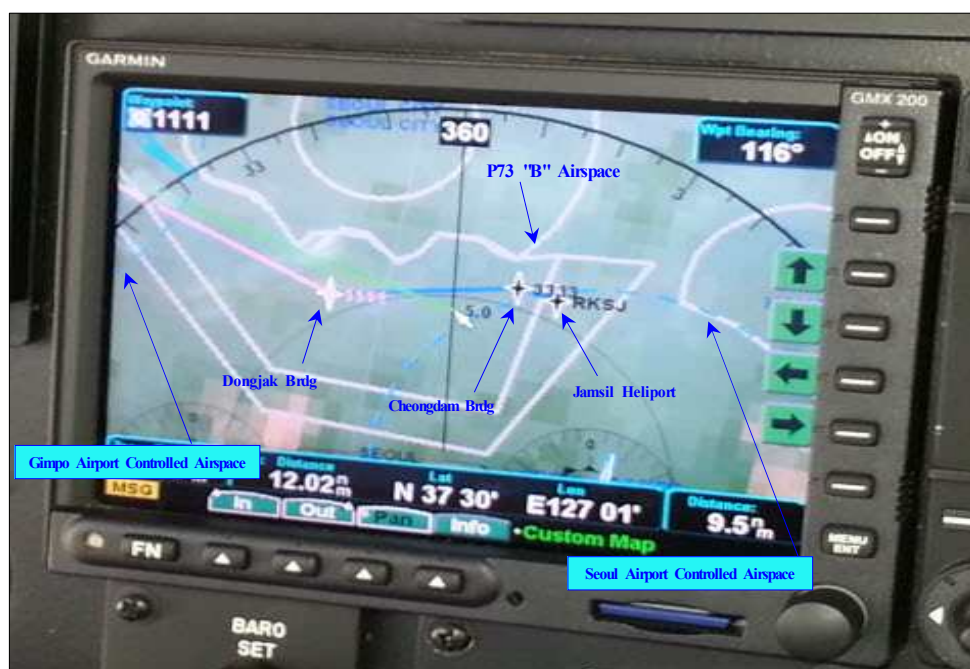
[Figure 5] Screen of the Same Model GPS on the Same Type Aircraft

As the GPS was destroyed by the crash impact, its data could not be restored. Instead, [Figure 5] shows a screen of the same model GPS on the same type aircraft which exhibits three waypoints and P73.

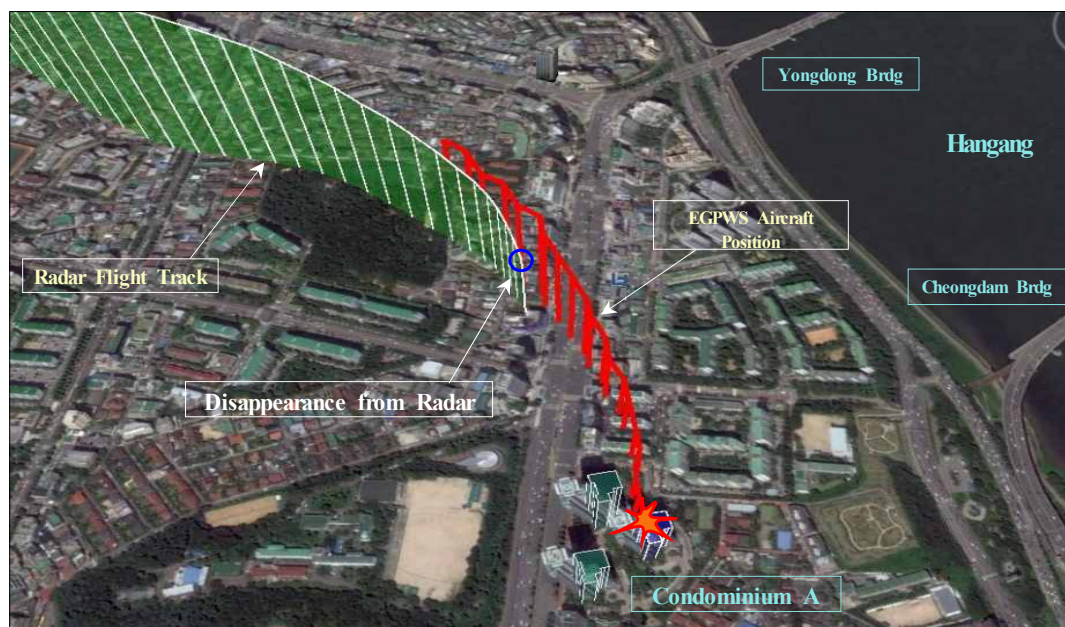
[Figure 8] Radar Flight Track and EGPWS Aircraft Position

Using Seoul Airport's radar data<sup>72)</sup> and the EGPWS aircraft position information,<sup>73)</sup> HL9294's flight track was generated as shown in [Figure 8] since the FDR data did not contain its route information.

72) From the disappearance of HL9294 from the radar screen to the crash, there is no information on HL9294's flight track (which, the ARAIB concluded, is caused by a shielding effect of ground obstacles close to the radar).

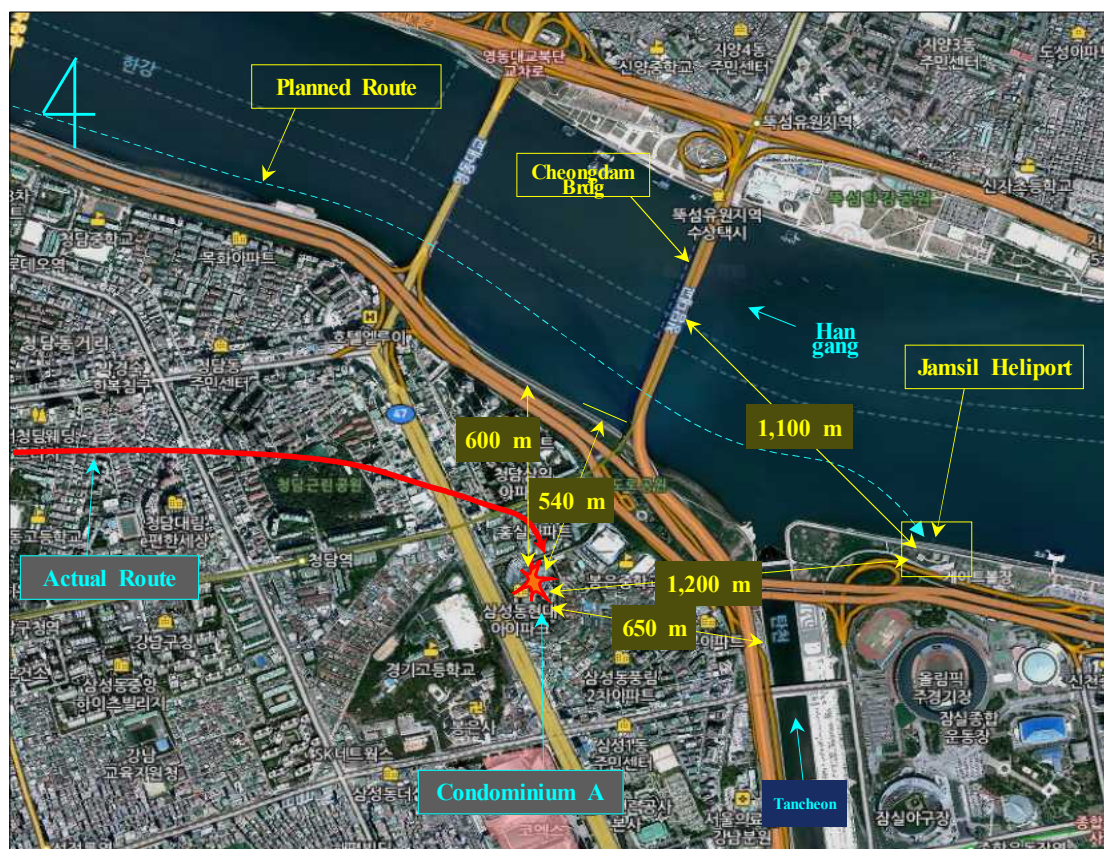
[Figure 9] Terrain in the Vicinity of Condominium A

As shown in [Figure 9], Condominium A, the crash site, is located about 540 m south of the south end of Cheongdam Bridge, about 600 m south of the Hangang, and about 650 m west of Tancheon that flows from south to north to join the Hangang.

South of the condominium is a downtown area crowded with high-rise buildings, and there is no higher building between the condominium and the Han River.
