# Aircraft Accident Report

**Tail Strike During Landing**

**Asiana Airlines Flight 340**

**A321-200, HL7730**

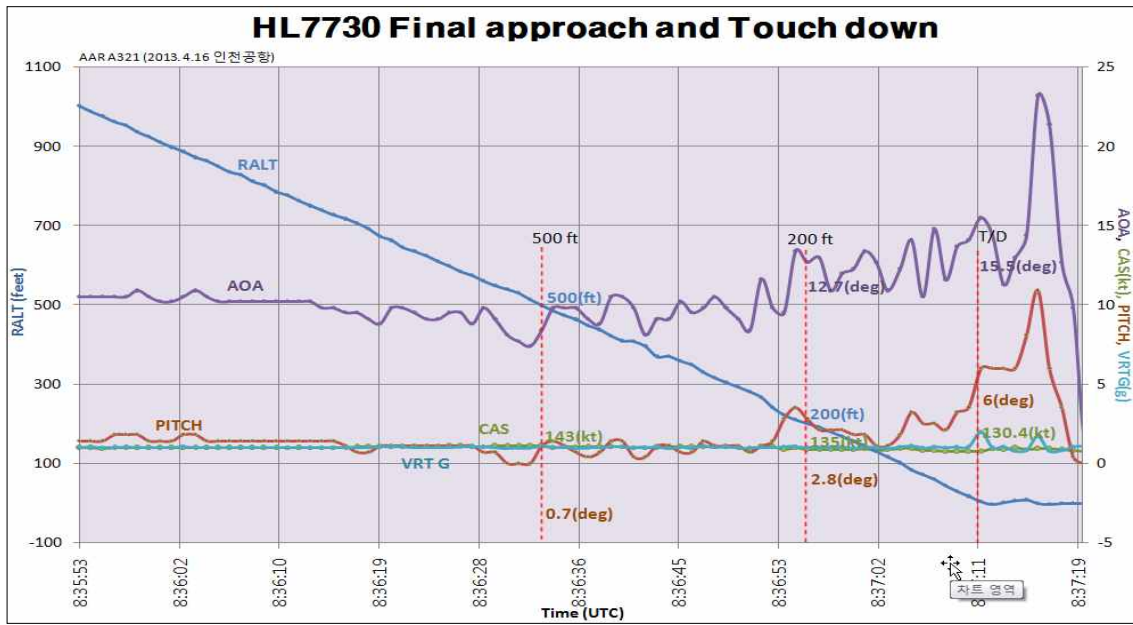
[Figure 8] Major Parameters During Final Approach and Touchdown

The FDR recorded data for the 25 hours before the engine shutdown. The ARAIB retrieved this 25 hours worth of raw data, from which it collected about 1,100 parameters. Major parameters are not only shown in [Table 2] but also displayed graphically in [Figure 8].
