# Ultralight Vehicle Accident Report

**Dived and Crashed While Turning**

**ULM COSMOS (Powered Ultralight Vehicle), S1045**

**12 June 2012**

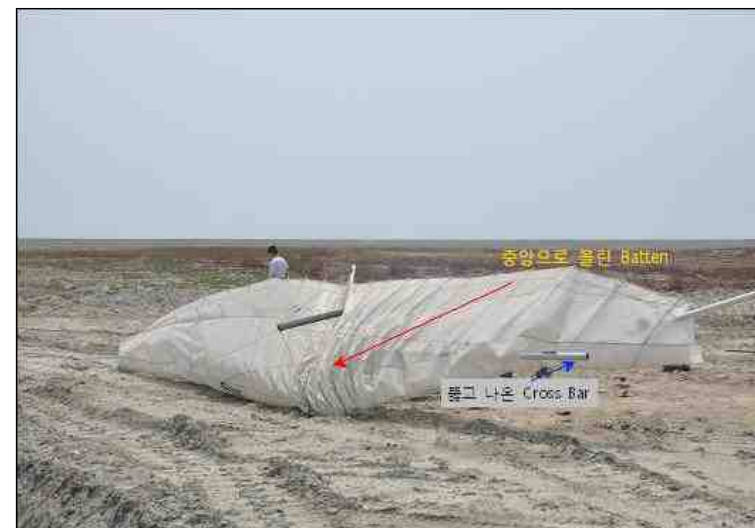
[Figure 14] Accident Site

As shown in [Figure 14], the cross bar<sup>30)</sup> on the left wing was separated from the leading edge due to the crash impact and penetrated through the sail. The battens<sup>31)</sup> supporting the left wing sail were pushed towards the keel<sup>32)</sup> at the center and bent like a bow.

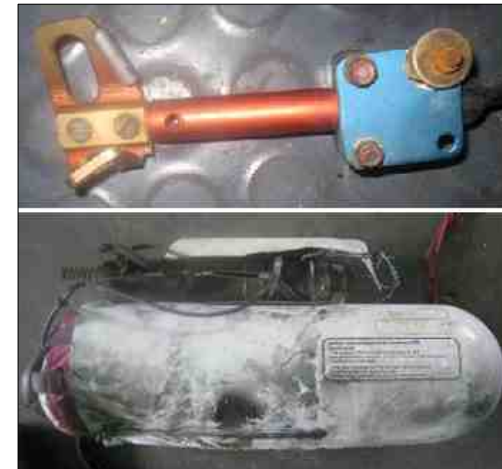
[Figure 16] Ripcord Handle (above) and  
Emergency Parachute (below)

As shown in [Figure 16], S1045 was equipped with Galaxy 450 emergency parachute, but the parachute was not used.

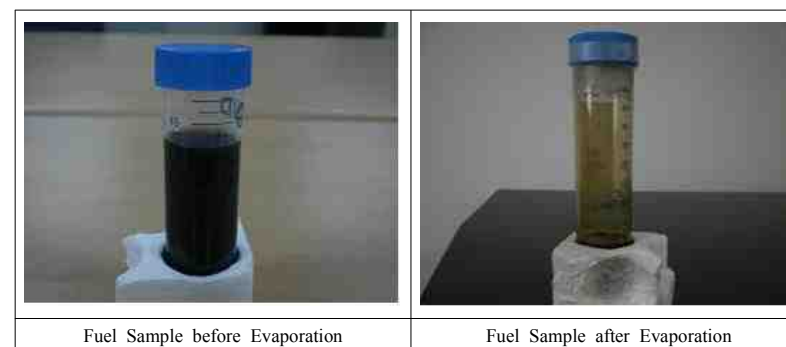
[Figure 18]

A fuel sample collected from the scene was dark brown in color. The elements of the fuel sample and of deposits left after fuel evaporation were analyzed by using Fourier Transform Infrared Spectrometer (FTIR)<sup>33)</sup> and Gas Chromatography-Mass Spectrometry (GC-MS)<sup>34)</sup>.
