AIRCRAFT ACCIDENT REPORT

CRASH INTO A OBSTACLE DURING A DESCENT FOR LANDING
LG ELECTRONICS

S-76C⁺⁺, HL9294

16 NOVEMBER 2013

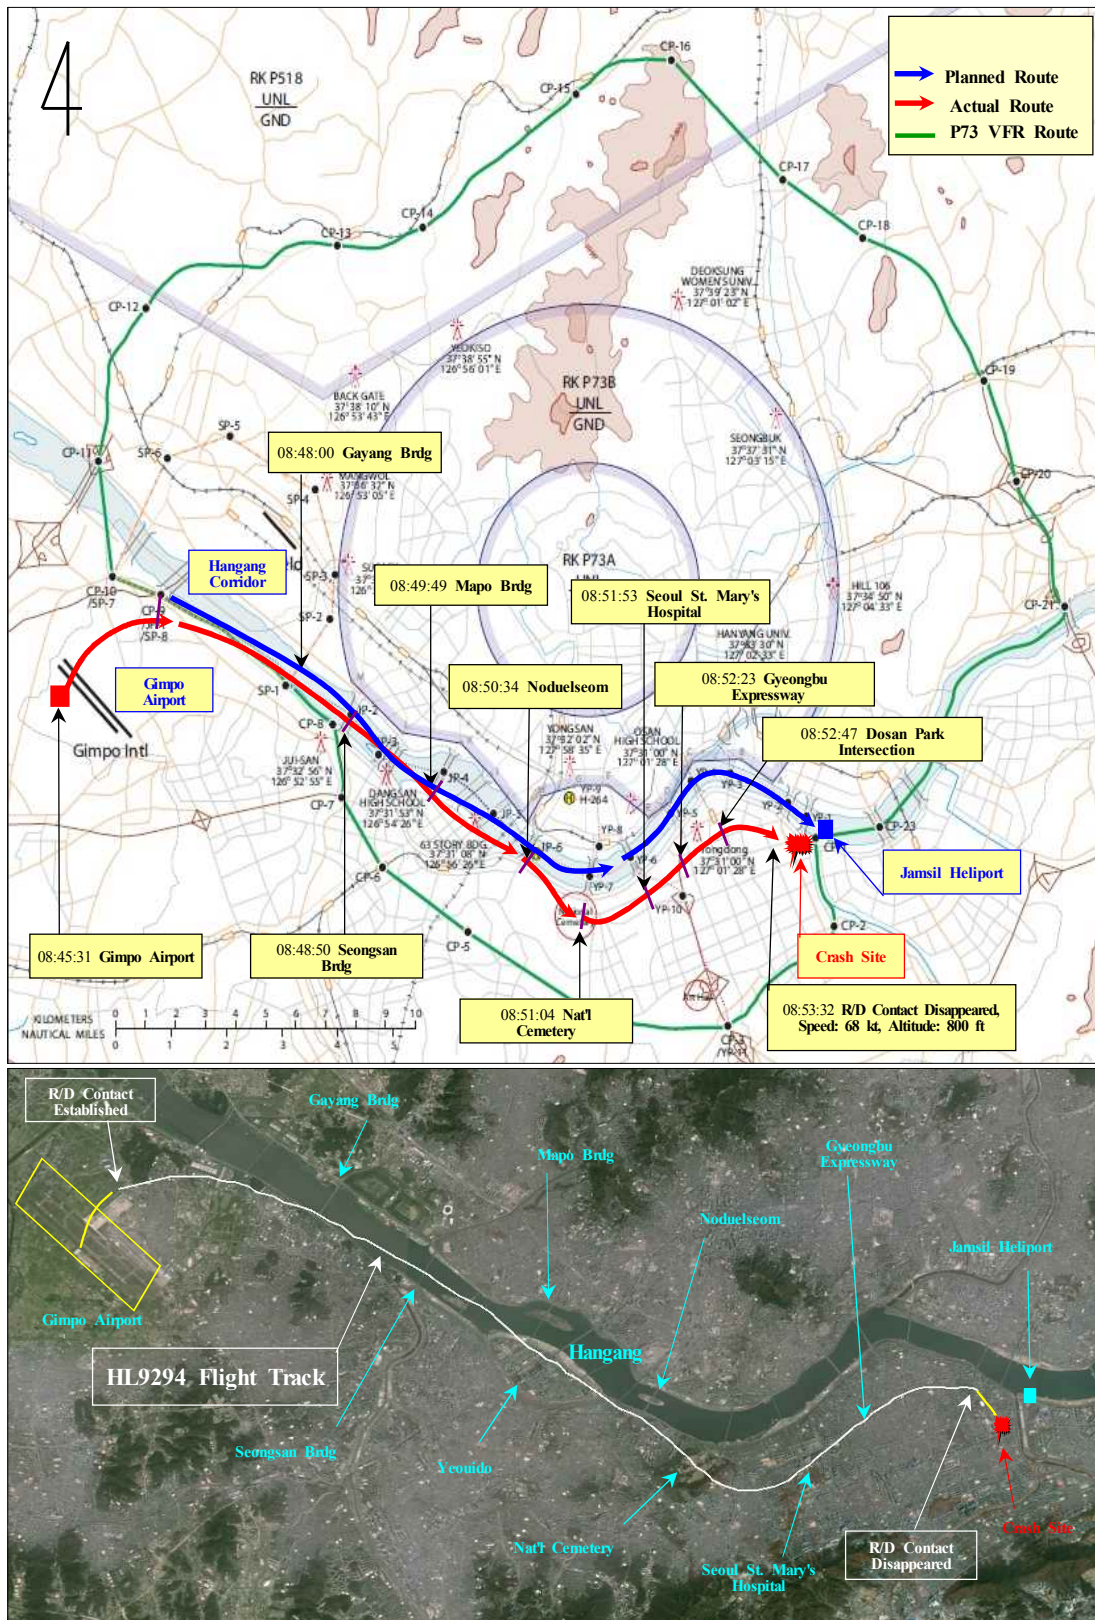
[Figure 1] Flight Route and Crash Site (Seoul Airport Radar Data)

As shown in [Figure 1], at 08:45:31, HL9294 took off from the west ramp H-3¹⁵⁾ at Gimpo Airport on a heading of about 30°, overpassed two runways,

At 08:52:47, HL9294 subsequently overpassed Dosan Park Intersection,¹⁸⁾ maintaining at 1,360 ft at a speed of 97 kt. From this moment on, the captain, with the landing point not in sight, asked the FO repetitively, "Hangang in sight?," and the FO advised, "Not yet, and if we fly to the right (south) a bit, the Hangang will be in sight."

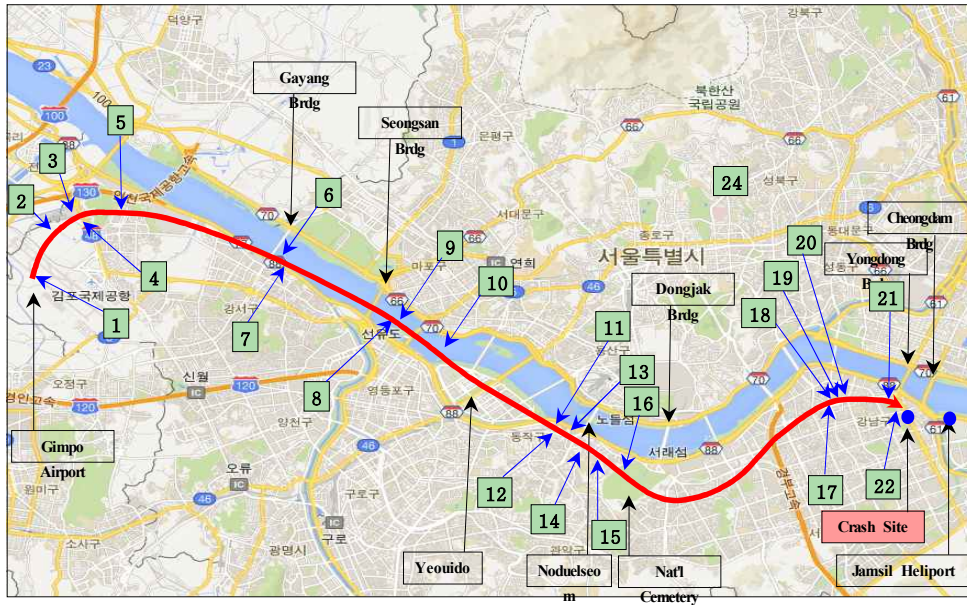
[Figure 4] Flight Track and the Major Content of the CVR Transcript

The major content of the CVR transcript in [Table 4] was numbered and marked on HL9294's flight track in [Figure 4] to match flight conditions with weather conditions recognized by the pilots during flight.

As shown in [Figure 4], however, although the pilots neither identified the ground due to poor visibility nor noted their deviation from the planned route, they continued to fly.

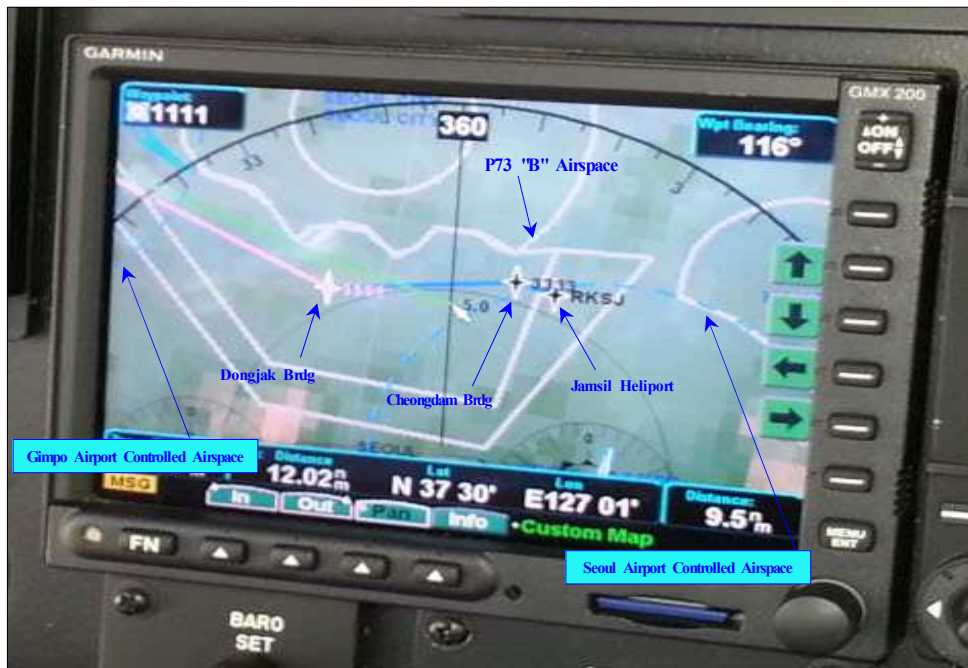
[Figure 5] Screen of the Same Model GPS on the Same Type Aircraft

According to the CVR data, they entered Dongjak Bridge, Cheongdam Bridge, and Jamsil Heliport, as waypoints along Hangang Corridor, into the GPS.

As the GPS was destroyed by the crash impact, its data could not be restored. Instead, [Figure 5] shows a screen of the same model GPS on the same type aircraft which exhibits three waypoints and P73.

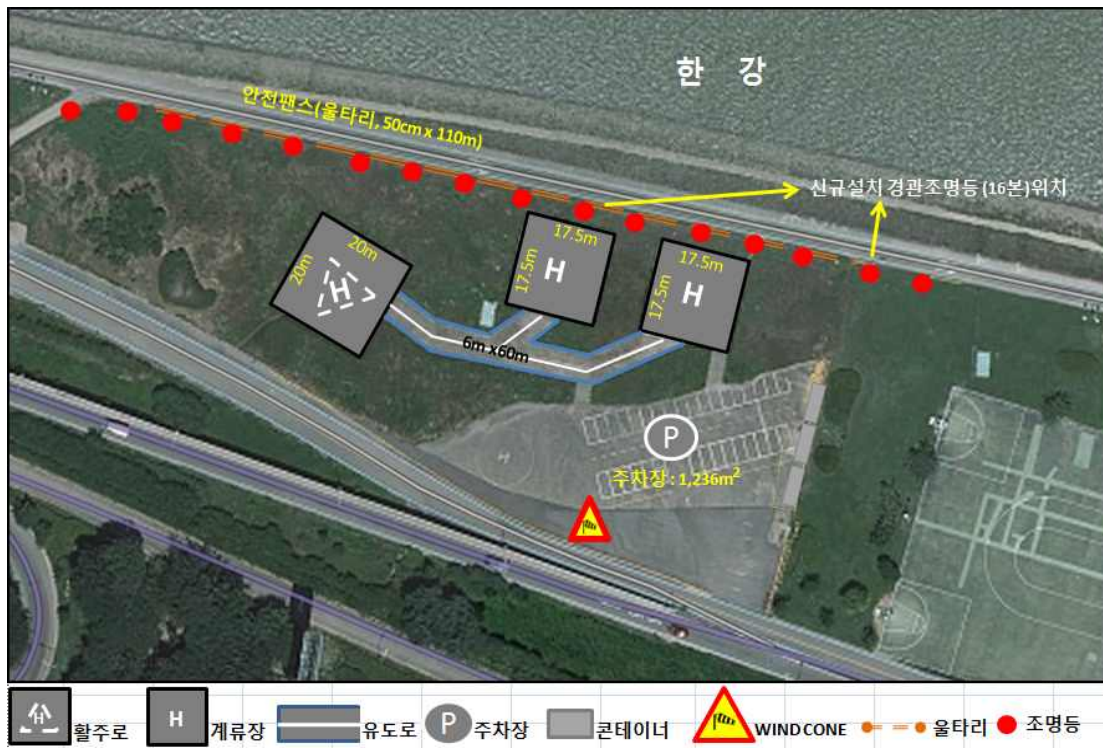
[Figure 6] Jamsil Heliport

The heliport is equipped with three helipads, taxiway, parking lot, one wind sock, and one mobile management office. Their locations and sizes are shown in [Figure 6]. One manager was working⁶²⁾ in the management office equipped with one radio used to communicate between air and ground for takeoff and landing.

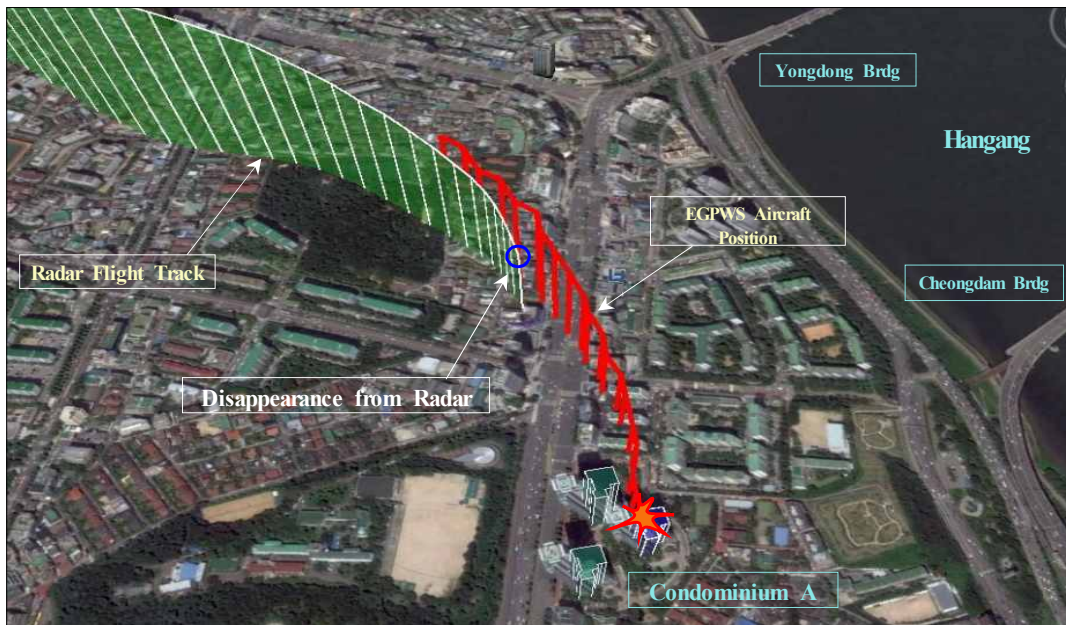
[Figure 8] Radar Flight Track and EGPWS Aircraft Position

Using Seoul Airport's radar data⁷²⁾ and the EGPWS aircraft position information,⁷³⁾ HL9294's flight track was generated as shown in [Figure 8] since the FDR data did not contain its route information.

72) From the disappearance of HL9294 from the radar screen to the crash, there is no information on HL9294's flight track (which, the ARAIB concluded, is caused by a shielding effect of ground obstacles close to the radar).

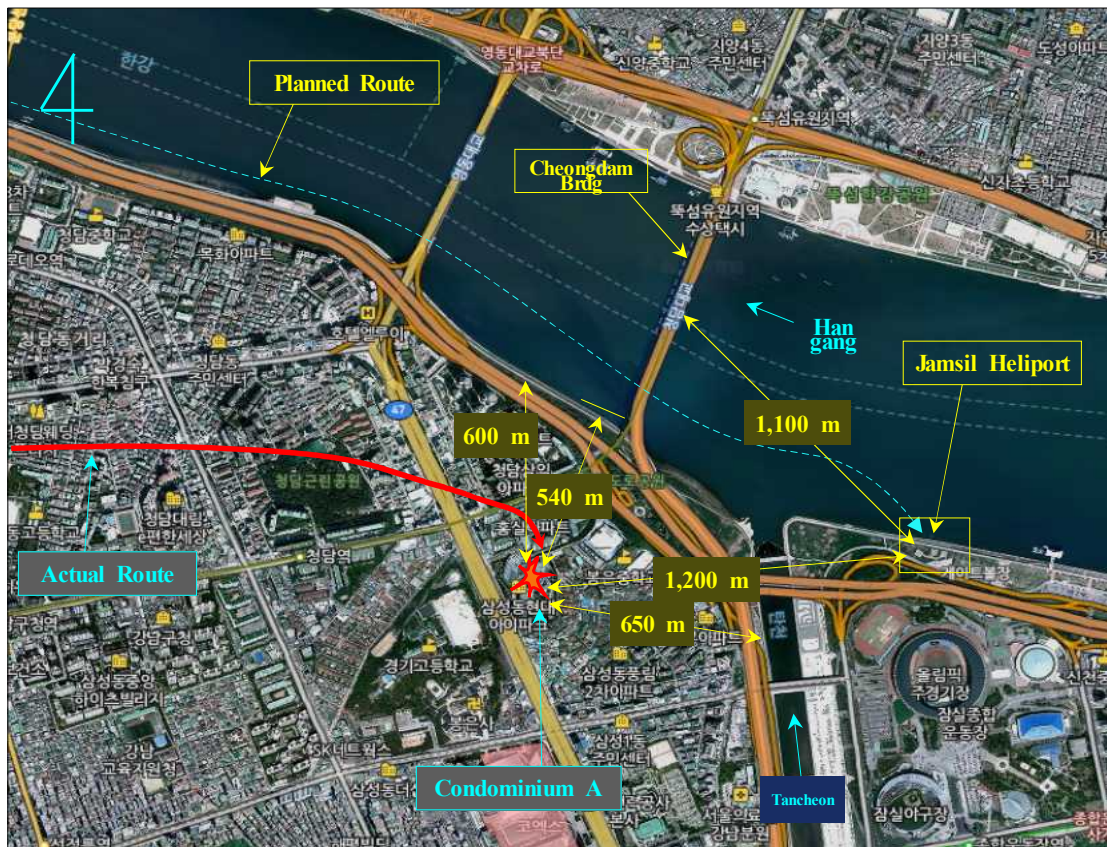
[Figure 9] Terrain in the Vicinity of Condominium A

As shown in [Figure 9], Condominium A, the crash site, is located about 540 m south of the south end of Cheongdam Bridge, about 600 m south of the Hangang, and about 650 m west of Tancheon that flows from south to north to join the Hangang.

South of the condominium is a downtown area crowded with high-rise buildings, and there is no higher building between the condominium and the Han River.

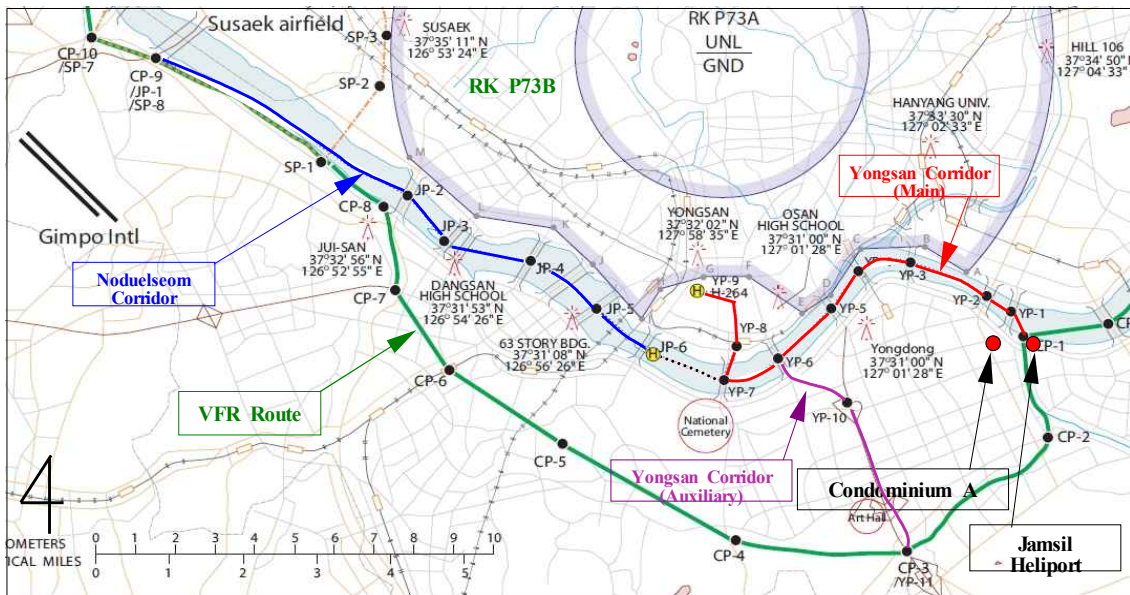
[Figure 12] VFR Route Between Gimpo Airport and Jamsil Heliport

As shown in [Figure 12], Yongsan Corridor consists of a main corridor (red line) that is from YP-1 to YP-9 and an auxiliary corridor (purple line) that is from YP-11 to YP-6 through YP-10. Any aircraft flying in this corridor should maintain 1,000 ft or above. In addition, Nodulseom Corridor (blue line) is between JP-1 (south end of Gayang Bridge) and JP-6 (Nodulseom), and any aircraft flying in this corridor should not fly in cloud and on top, maintaining 1,500 ft or above.
